# **Air Accident Investigation Unit Ireland**

**FACTUAL REPORT**

**Robinson R44 Raven I, G-HWKS  
Near Ballyshannon, Co. Donegal, Ireland**

**28 May 2016**

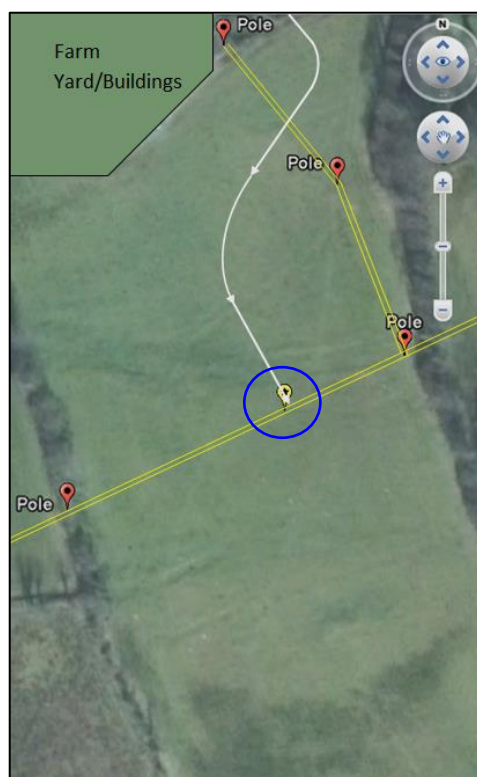
The field where the wire strike occurred was approximately 260 m long and 130 m wide. It had a considerable upwards slope along its length, in the direction of landing. It was covered in short grass, and was bounded by trees on the east and west sides, and by trees and farm buildings on the north side. Several residential dwellings were located on the south side of the field, behind which were trees. The layout of the field, the position of the poles and overhead wires, the approach path, and the site of the wire strike are shown in **Figure No. 1** below. The poles were wooden and were approximately 8.5 m in height.

**Figure No. 1:** Field layout, location of poles (red), overhead wires (yellow), final approach path (white) and site of strike (circled) (adapted from *Google Earth*)

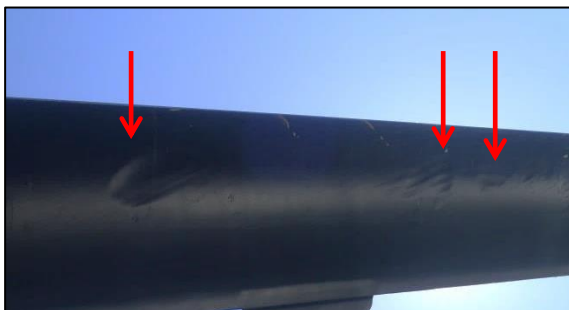
The more heavily damaged blade had several indentation marks on its leading edge (**Photo No. 1**), with an indentation also visible on its lower surface (**Photo No. 2**). In addition, several angled scrape-like marks were visible on the upper surface of the leading edge (**Photo No. 3**), with the outermost mark extending to the lower surface (**Photo No. 4**). Blade skin material was also found to have been partially torn from the upper surface of the blade’s trailing edge, approximately halfway along the blade’s length (**Photo No. 5**). Indentation damage was evident on the upper surface of this blade, following the removal of the blades from the helicopter (**Photo No. 6**).

**Photo No. 1:** Indentations on main rotor blade leading edge

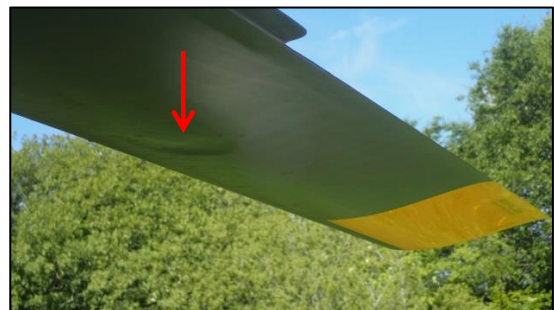
**Photo No. 2:** Indentation on main rotor blade lower surface

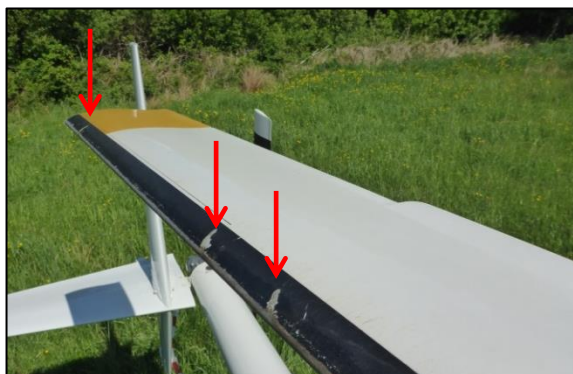
**Photo No. 3:** Damage on upper surface of main rotor blade leading edge

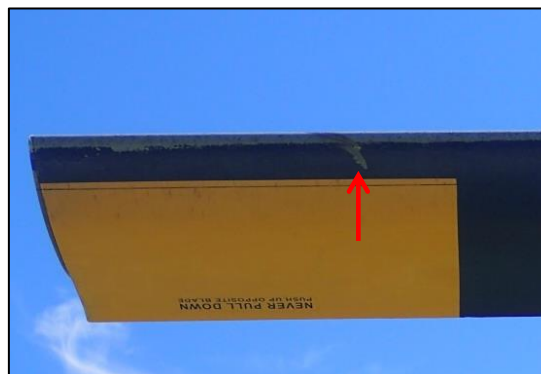
**Photo No. 4:** Damage on lower surface of outer section of the leading edge

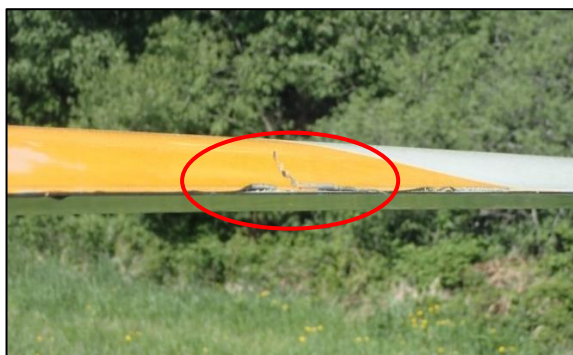
**Photo No. 5:** Damage to main rotor blade trailing edge

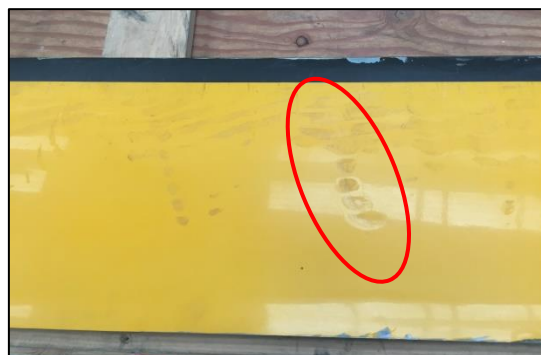
**Photo No. 6:** Indentation damage to upper surface of main rotor blade
