# **Air Accident Investigation Unit Ireland**

**FACTUAL REPORT**

**Avions de Transport Régional  
ATR 72-212A, EI-FAT  
Cork Airport**

**26 May 2017**

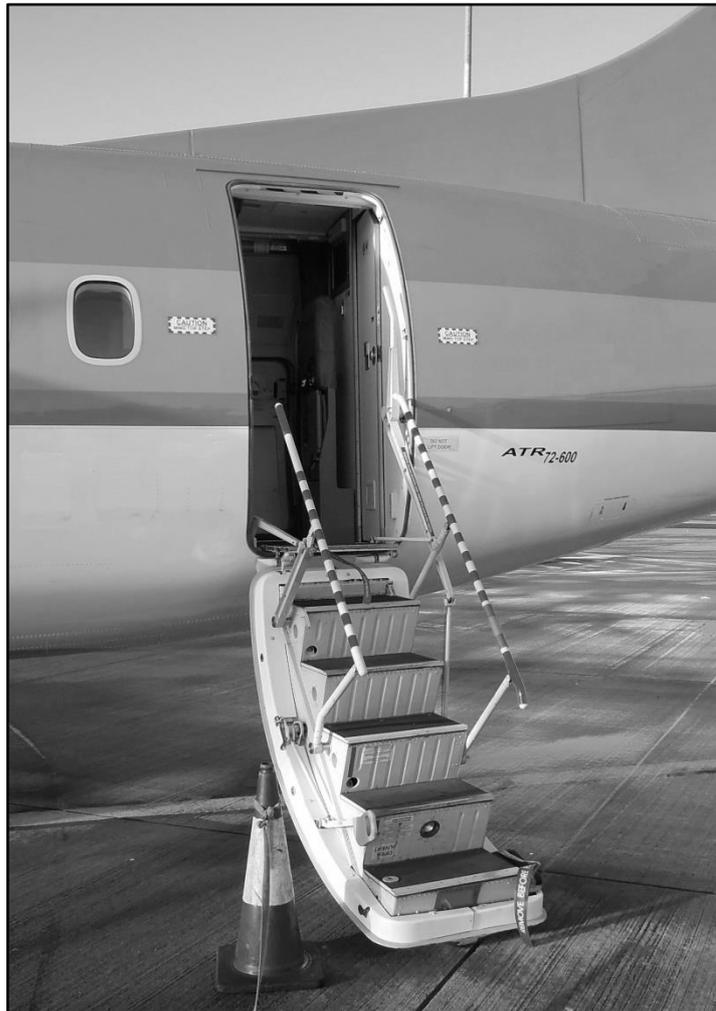
**Photo No. 1:** ATR 72-212A 600 series Passenger Stairs

The aircraft was later inspected by two Inspectors from the AAIU. The Investigation found that the stairs (**Photo No. 1**) were serviceable; the handrails were functioning correctly and the non-slip covering was in good condition. The Inspectors also noted that there were hazard markings on the edge of each stair and on the handrails.

By design, many aircraft do not have integrated stairs. Consequently, there are no EASA Certification Specifications to guide the design of such integrated stairs, except that where they exist; they must not impede the emergency evacuation of the aircraft. In other industries, typical stair design features include having suitable handrails, non-slip coverings and clearly marked edges on stairs, all of which were present in this case.
