# **Air Accident Investigation Unit Ireland**

**SYNOPTIC REPORT**

**ATR 72-212A, EI-FAV**

**23 July 2015**

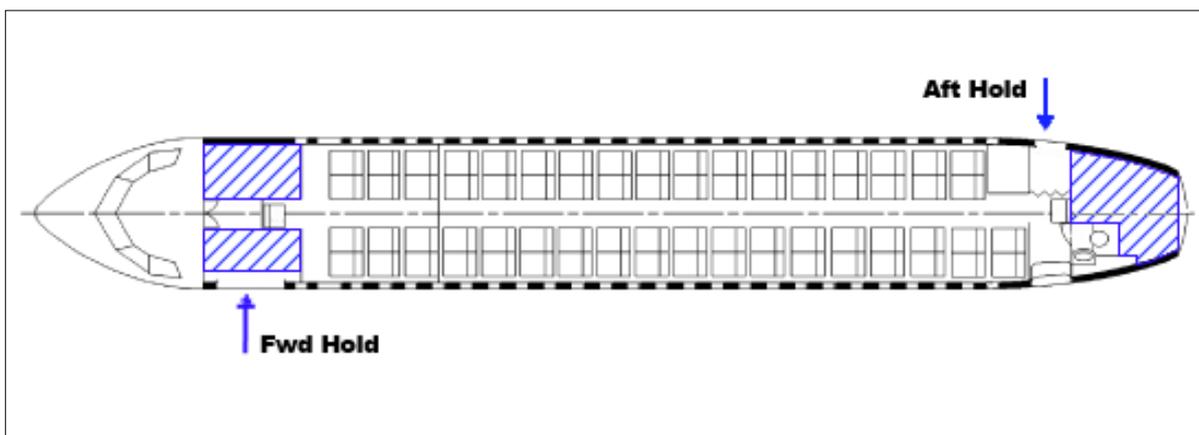
**Figure No. 1:** Access and layout of the Fwd and Aft Holds  
(ATR 72-212A Weight and Balance Manual)

The aircraft is configured with two holds for passenger baggage and/or freight items. The holds are located forward and aft of the passenger cabin; the forward hold (No. 1) and the aft hold (No. 4). The forward hold is accessed via the cargo door on the left-hand side of the aircraft (looking forward) and the aft hold is accessed via the aft service door on the right-hand side (**Figure No. 1**).

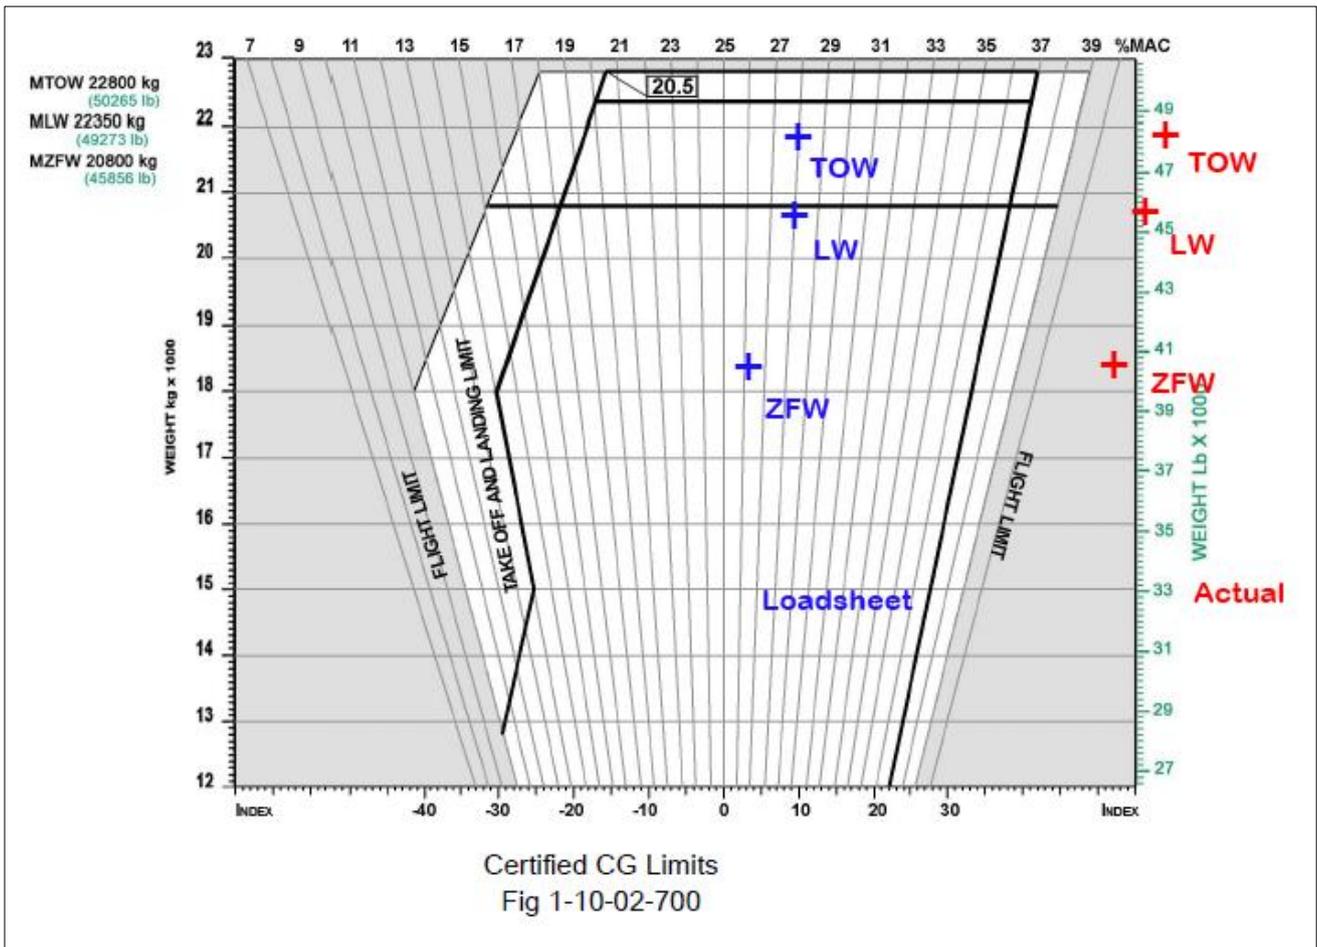
EI-FAV Weight and Balance planned and as dispatched on 23 July 2015

The aircraft was being prepared to operate a scheduled passenger service with 57 passengers and four crew from EIDW to LFRN and was towed onto Stand 131S at approximately 11.30 hrs prior to the flight. Loading of baggage commenced at 11.36 hrs. The LIR indicated that 421 kgs (32 pieces) of baggage were loaded in the forward hold; the computer generated loadsheet, which was presented to the Commander, recorded this loading. The flight pushed back from the stand on schedule at 11.45 hrs. The aircraft took off outside the certified Centre of Gravity (CG) limits (**Appendix A**).

The certified Centre of Gravity (CG) envelope for the ATR 72 with Take-off Weight (TOW), Landing Weight (LW) and Zero Fuel Weight (ZFW); plotted in blue as per Loadsheet. The actual loading values are plotted in red and are outside the certified CG limits.
