Air Accident Investigation Unit Ireland

FACTUAL REPORT

**Piper J5A (Cub Cruiser), EI-AXT
Near Shantonagh, Co. Monaghan, Ireland**

13 September 2016

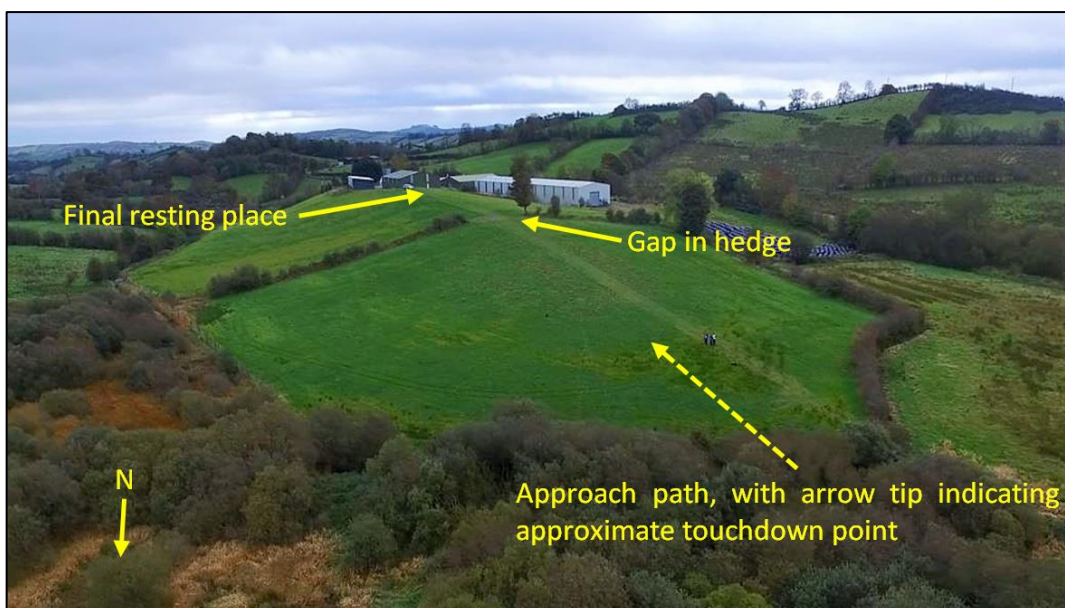
The Investigation carried out an inspection of the accident site, which included an aerial survey using a Remotely Piloted Aircraft System (RPAS). **Photo No. 1** is from this survey. The grass-covered surface sloped uphill along the intended landing path (approximately 142 degrees magnetic/south-east), and downhill to the left and right. The field was bounded by a hedgerow. Trees approximately 7 m in height were present in the hedgerow on the north-west side of the field, over which the approach was made. Another hedgerow, running north-east/south-west and approximately 135 m long, traversed the field, approximately 145 m from the north-west end. There was a 20 m gap in this hedgerow, which the Pilot stated had been prepared by the landowner around 10 days before the arrival of the aircraft. A tall tree was located immediately to the right of this gap. There were farm buildings at the south-east end of the field, approximately 245 m from the north-west end. The up-slope at the touchdown point, which was about 60 m into the field, was measured to be approximately 3 degrees. This angle increased closer to the north-west (approach) end.

Photo No. 1: Landing site (Note: The visible track along the field’s centre line was caused by farm vehicles)

The IAA's 'Aerodromes and Visual Ground Aids Order' (SI No. 355 of 2008) permits landings at locations that are not licensed as an aerodrome, provided that the landowner's permission is obtained and that the "landing and take-off at such place can be effected without undue hazard to persons and property...". In this case, the landowner was aware of the Pilot's intention to land at the site. However, the Investigation considers that the field, with its sloped nature; traversing hedgerow, which contained a gap that would only allow a maximum clearance of approximately 5 m between each wing tip and the hedgerow; trees over which the approach was made; and farm buildings at its south-eastern side, was not suitable for an aircraft landing.

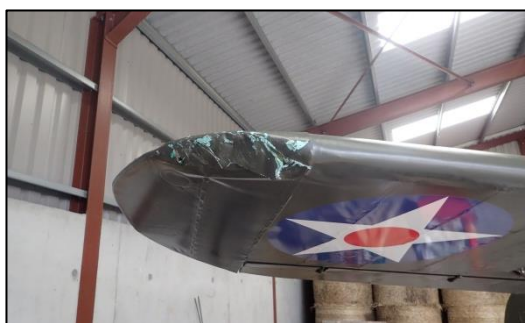
Two Inspectors of Air Accidents inspected the aircraft on 3 October 2016 at the airstrip in Co. Galway. Damage to the right hand wing tip was observed (**Photo No. 3**). Damage to the tubular steel frame surrounding the cockpit on the left hand side was also visible (**Photo No. 4**) (the aircraft's canvas covering was peeled back at this location to facilitate this inspection). A substantial crease in the fuselage fabric was also evident above the left hand main landing gear support strut. It was noted that the aircraft was leaning to the left.

- The propeller was found to be approximately 30 millimetres “out of track”, and while there was “no obvious distortion of the blades”, an engine shock load inspection was deemed necessary because the propeller had made contact with the ground.
- The right hand wing tip suffered impact damage “which will require partial disassembly, detailed structural inspections of the wing structure, struts and attachment points, associated repairs...and...checks”.
- The forward left hand side fuselage tubular structure “has a broken tube”.
- There is a “bent lower cross member tube in the rear fuselage behind the aft seat”.

Photo No. 3: Damage to right hand wing tip

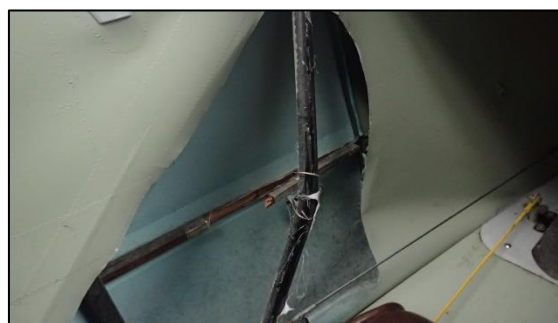
The Pilot inspected the aircraft at the field in Co. Monaghan following the occurrence and was aware that the right hand wing tip had sustained damage and that a “bar in [the front left hand side of] the cockpit” was “bulging” and “bent”. Although the aircraft had come to rest in a nose down position, the Pilot was of the understanding that the propeller was undamaged. Approximately 20 minutes after the occurrence, he turned the aircraft around, performed a take-off in the opposite direction and flew back to the airstrip in Co. Galway. During the take-off, he realised that the aircraft “was weak on that [the left hand] side” and said he kept this in mind and landed “on the right wheel” in Co. Galway.

Photo No. 4: Damage to fuselage tubular steel frame, viewed from within the cockpit (canvas peeled back to facilitate inspection)
