Air Accident Investigation Unit Ireland

PRELIMINARY REPORT

**ACCIDENT
BRM Land Africa, EI-EOH
Near Ballina, Co. Mayo
4 May 2018**

AAIU Report No: 2018 - 007
State File No: IRL00918023
Report Format: Preliminary Report
Published: 01 June 2018

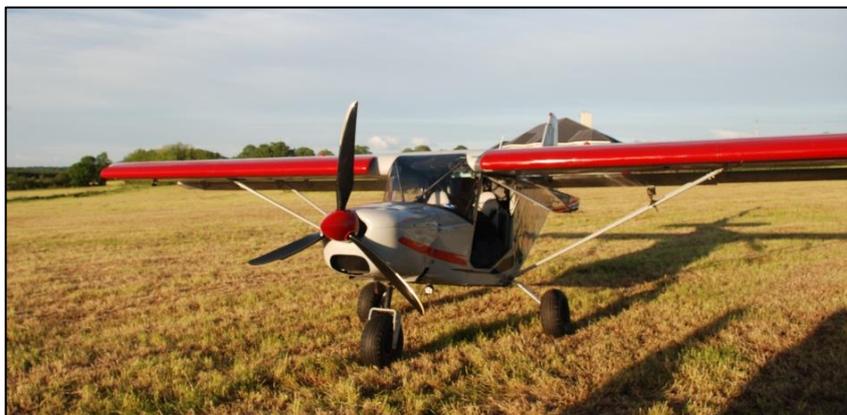
EI-EOH was a factory-built microlight aircraft of all-metal construction (**Photo No. 1**). It had a strut-braced high-wing and an enclosed cockpit with two seats, in a side-by-side configuration. It was equipped with a fixed tricycle landing gear and a Rotax 912ULS four-stroke engine.

Photo No. 1: The accident aircraft (file photo)
