Air Accident Investigation Unit Ireland

FACTUAL REPORT

**Paramania Revo 2
Kilshanroe, Co. Kildare**

30 August 2017

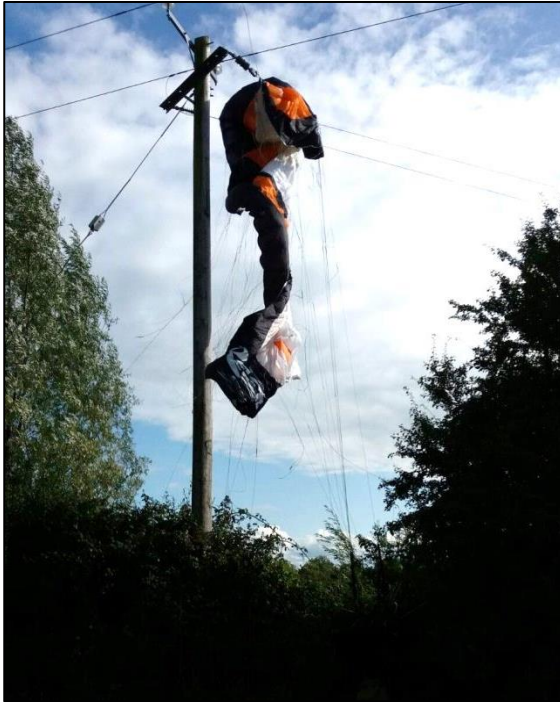
The AAIU was unable to examine the FLPA following the event as the Pilot had already returned home taking the FLPA with him. The Pilot reported that during the occurrence, the wing of the FLPA was torn and the frame was bent. **Photos No. 2** and **3**⁵ show the parachute entangled in the electricity wire and the engine and frame on the ground.

Photo No. 2: FLPA wing in electricity lines

The electricity network operator arrived at the scene shortly after the event occurred. The operator ascertained that when the FLPA struck the wires, the two fuses which controlled that section of the network blew, de-energising the lines and causing a local power outage. The electricity lines did not break and there was no permanent damage to the electricity network.

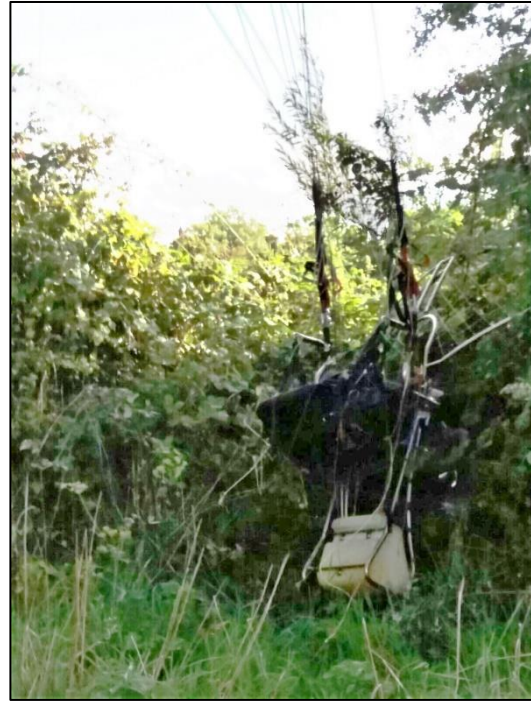
Photo No. 3: FLPA engine and harness

The cause of the engine stoppage was not determined. The Pilot informed the Investigation that after the occurrence he carried out checks on the engine which included exchanging a fuel line, and a strip and assembly of the carburettor. Following this maintenance the engine ran successfully. The Pilot informed the Investigation that he thought the stoppage during the occurrence flight may have been caused by a carburettor problem.
