Air Accident Investigation Unit Ireland

FACTUAL REPORT

**Accident
Piper PA 18-95, G-PIPR
Navan Airfield, Co. Meath**

22 January 2017

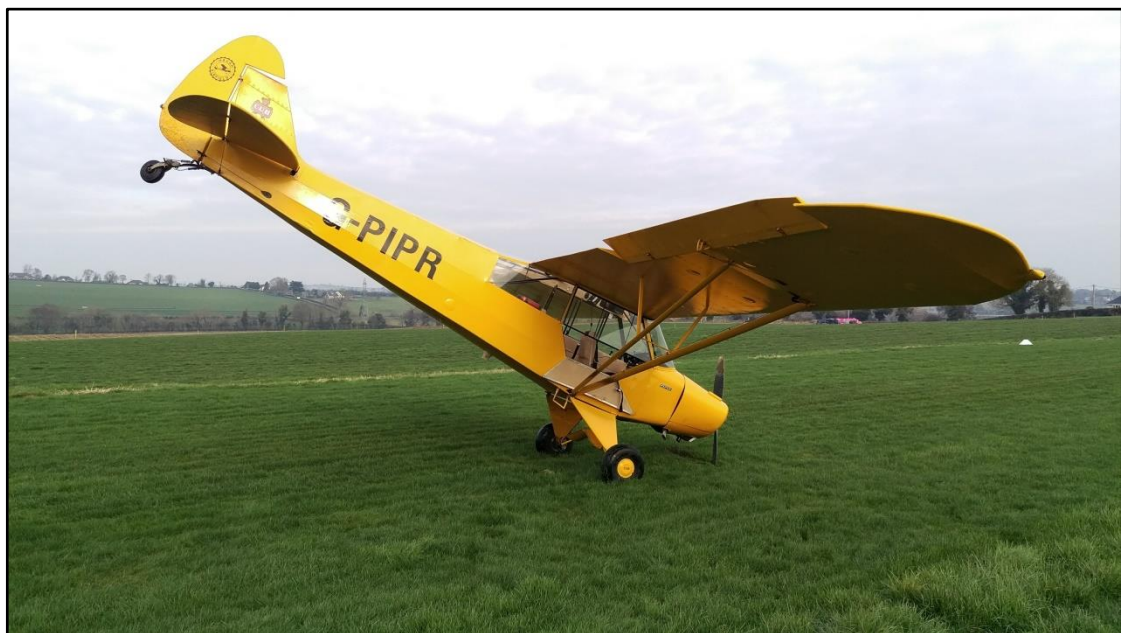
The Pilot said that throughout the taxiing phase there was increasing resistance to the aircraft’s movement and that she was applying more power than usual to maintain taxi speed. The airfield has a sloped section around the mid-point of the runway length. The Pilot stated that she “had to apply more power to move the aircraft forward up the slope at which point the aircraft tipped over and the propeller struck the ground” (**Photo No. 1**). The Pilot said that she “shut everything down and vacated the aircraft”.

Photo No. 1: The aircraft’s final resting position

During an inspection of the airfield, tyre tracks and scuffed grass surface were in evidence over the length of the eastern half of RWY 25. The Investigation noted that the distance between the tracks matched the distance between the aircraft’s two main wheels. There was evidence of propeller contact with the grass surface at the site where the aircraft pitched forward.

The Pilot noted that the aircraft required “*a lot of brake after touchdown*”. The tyre tracks and scuffed grass surface observed during runway examination suggested that the wheels had been locked and skidding during the landing. Examinations of the aircraft’s wheels and brakes did identify rotational resistance accompanied by grinding noises which could have generated significant heat during the heavy braking and backtrack taxiing which the Pilot reported. While heat generation (and dissipation) is not usually an issue with disc brakes, it appears that on this occasion, as on a previous occasion with this aircraft, the heat generated may have caused expansion leading to increasing rotational resistance. Increasing resistance, and an uphill slope, prompted the Pilot to apply more engine power which caused the aircraft to tip forward onto its nose resulting in the propeller striking the grass surface.
