Air Accident Investigation Unit Ireland

FACTUAL REPORT

**Piper PA 16 Clipper, EI-AEL
Abbeyshrule Airfield**

14 June 2017

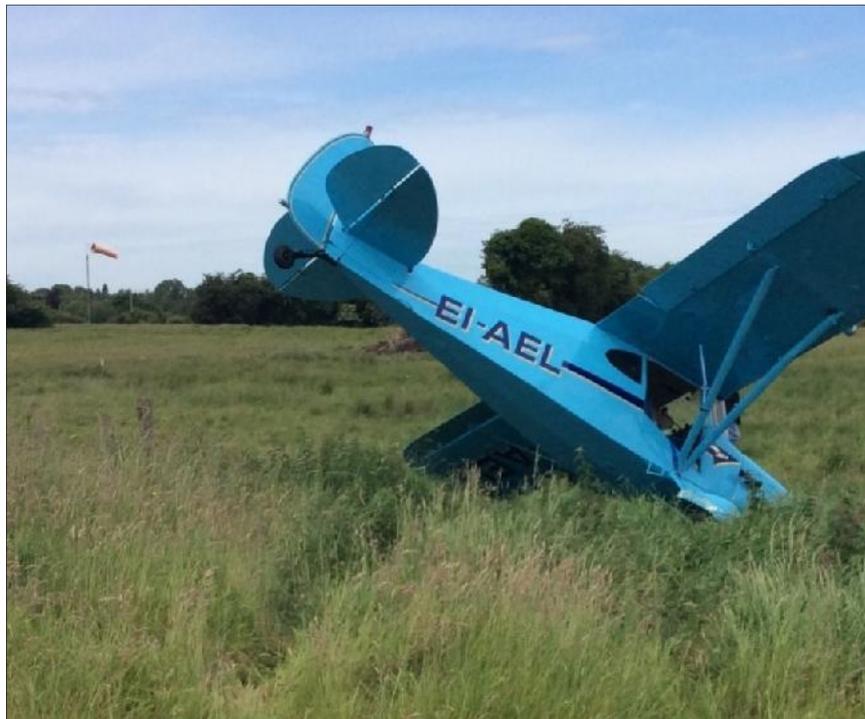
The aircraft, with the Pilot and one passenger on board, was on a private flight from Letterkenny (EILT) to Abbeyshrule (EIAB). On arrival overhead EIAB the Pilot made an advisory call on the airfield frequency. After observing the windsock, the Pilot positioned on a left downwind for RWY 29 before turning left onto final approach. The Pilot reported that his approach and touchdown were normal and that there was a crosswind from the left. Following landing, the Pilot decelerated to taxi speed and continued along the runway. As the aircraft approached the first taxiway intersection on the right, it experienced a '*strong gust of wind*' from the left which resulted in it leaving the paved surface. As the aircraft swerved, the left wingtip struck the runway and the left undercarriage leg collapsed. The aircraft continued through long grass and nosed-down as it entered the adjoining field sustaining substantial damage (**Photo No. 1**).

Photo No. 1: Final position of aircraft facing southwest (windsock in background).

The adjoining field, which lies parallel to the northern side of the runway, is bounded by a wire fence and lies lower than the runway surface and grass flight-strip area. Neither occupant was injured and both exited the aircraft without assistance.

The aircraft had landed and was subsequently taxiing along the runway towards the apron turn-off. The Pilot stated that the aircraft was caught by a 'strong gust of wind'. As the wind was from the left, this upset would have tended to swing the aircraft to the left; subsequent application of right rudder possibly contributed to the aircraft swinging in the opposite direction which, due to the nature of tail-wheel geometry, caused the aircraft to deviate off the paved surface.

Due to their geometry, tail-wheel aircraft are prone to directional instability on the ground. Landing in a crosswind, particularly a gusting crosswind, produces dynamic conditions which can result in loss of directional control on the ground, even for pilots experienced in tail-wheel operations. In this case, directional control was lost subsequent to an initial gust being experienced. The attempt to counteract the gust led to a swerve in the opposite direction, with the turn tightening sufficiently for the left wingtip to strike the runway. The forces were such that the left undercarriage leg collapsed during the excursion. The long grass of the overrun area beside the runway and the significant drop into the adjacent field caused the aircraft to nose-over, resulting in the subsequent damage.

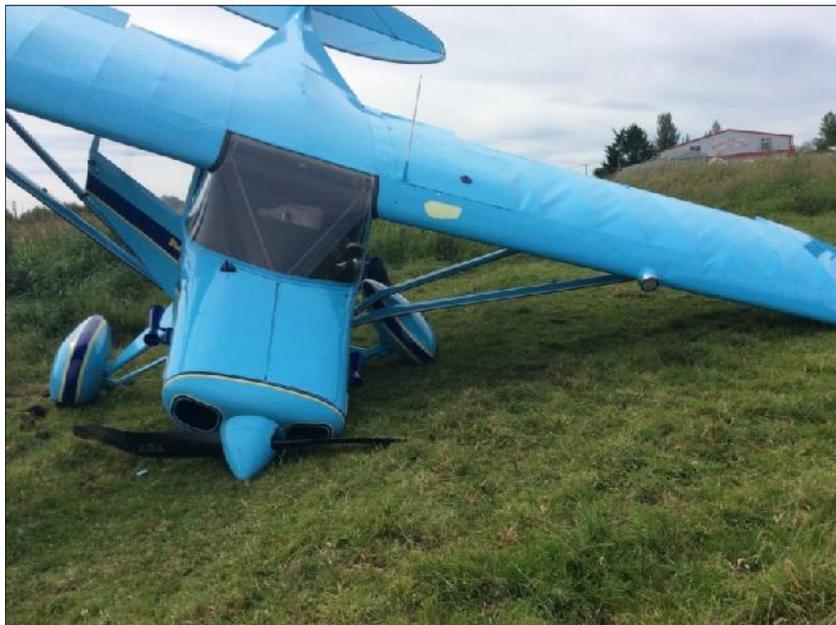
The aircraft sustained substantial damage. As the aircraft swerved, the left wingtip struck the runway and the left undercarriage leg collapsed. The aircraft nosed-down, causing damage to the propeller, engine bearer and cowling (**Photo No. 2**).

Photo No. 2: Damage to undercarriage, wing, cowling and propeller.

As the propeller was rotating under engine power at the time, the engine likely sustained shock-loading. The right wing strut was buckled and the left wing showed rippling on the upper surface. A section of fabric on the left wing was damaged as a result of fuel spillage.
