Air Accident Investigation Unit Ireland

FACTUAL REPORT

SERIOUS INCIDENT

**Bellanca Decathlon, 8KCAB, EI-BIV
Cork Airport Controlled Traffic Region
29 October 2017**

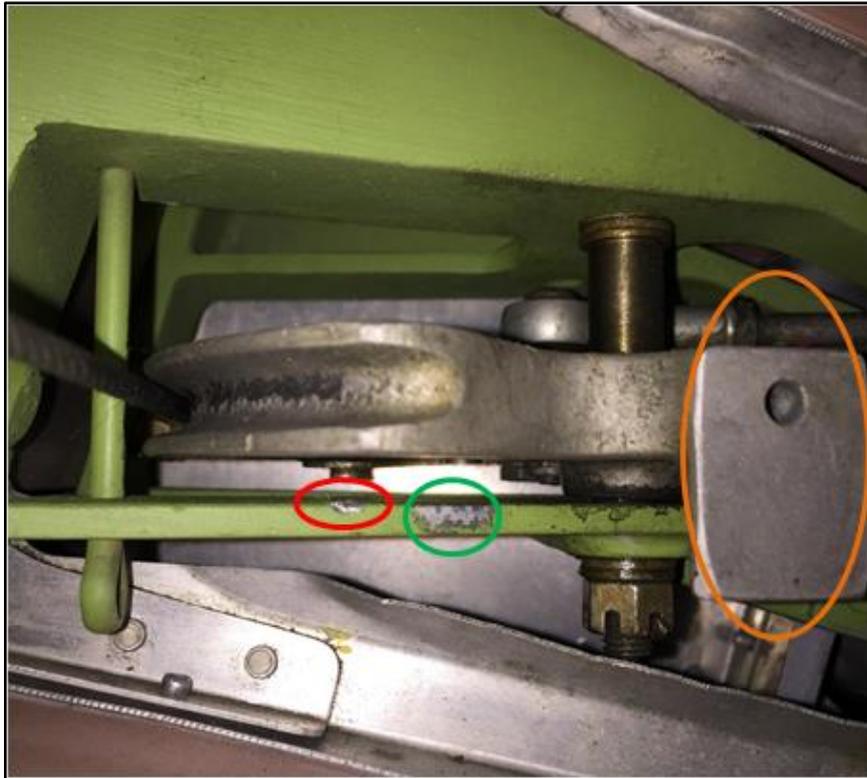
During inspection of the starboard wing, two areas of primer damage were observed on the aileron bell-crank mechanism (**Photo No. 1**). The larger of these (ringed in green) was dull in colour and consistent with normal wear and tear from contact with the control stop (ringed in orange).

The smaller area (ringed in red) was bright in appearance and did not correspond to any normally-expected wear and tear. Tapping on the adjacent fabric wing surface revealed the presence of a large bolt. Positioning the bolt within the aileron bell-crank mechanism (**Photo No. 2**) showed that, with the bolt contacting the bright area of primer damage, it could produce a restriction of the aileron control consistent with that reported by the Pilot.

Photo No. 1: Starboard aileron bell-crank mechanism (*The Pilot*)

This was a serious incident which was handled well by the experienced Pilot, and facilitated by ATC. The circumstances serve to highlight the importance of thorough maintenance practices; loose article checks prior to closing up an area; and part and tool control discipline.

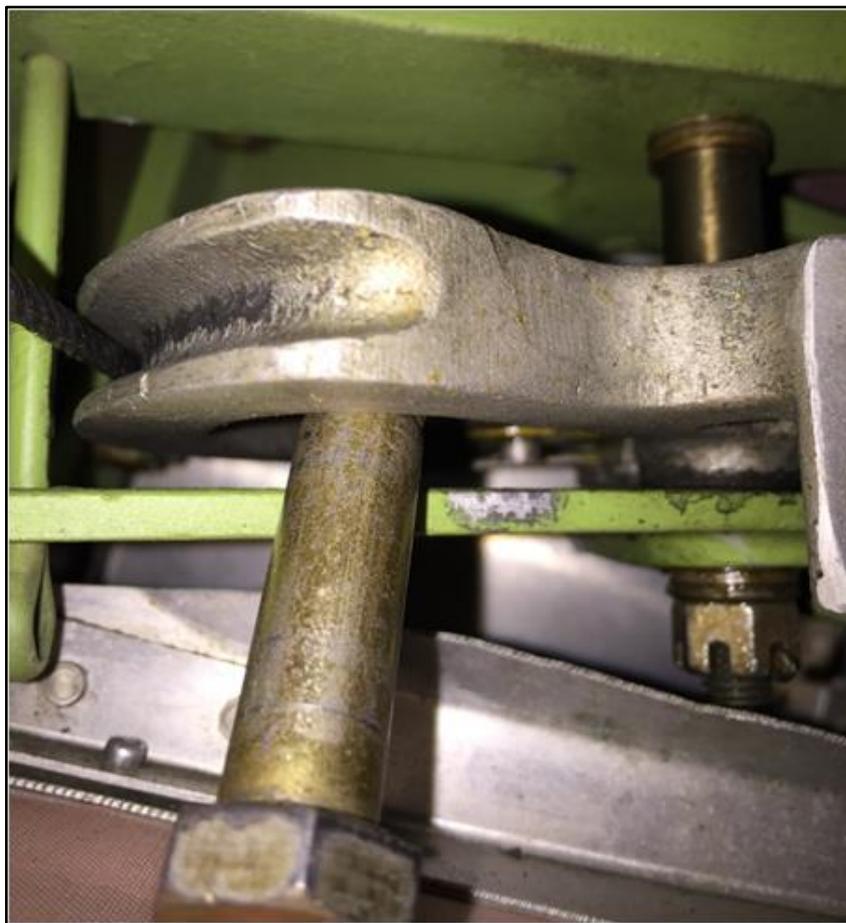
Photo No. 2: Bolt positioned within aileron bell-crank mechanism (*The Pilot*)

Measurement of the bolt identified it as an 'AN7-17A'. Examination of the aircraft Illustrated Parts Catalogue showed that only two 'AN7-17A' bolts were fitted on the aircraft; these bolts attach the wing front spars to the fuselage at the forward wing root area. Inspection of the aircraft showed that both bolts were in their correct positions.

The bolt was neither a serial numbered nor a batch numbered item and accordingly it was not possible to definitively determine its provenance. Maintenance records showed that the aircraft wings had been removed three times (by two different organisations) since 2012, most recently in 2015. It was noted that there is a sill/channel with a high vertical face in the fuselage area adjacent to the forward wing root. If during one of the wing removal operations a bolt had been left behind in this sill it could, over time, have migrated via the wing root area and opening in the trailing edge wing root, to the area of the outboard aileron bell-crank mechanism. The exact circumstances by which the bolt could then become entangled within the aileron bell-crank would then be a matter of chance and circumstance i.e. the bolt could have been in the area for some time without causing any adverse effects, but the aircraft attitudes on this particular flight allowed it to cause the restriction which the Pilot experienced.
