Air Accident Investigation Unit Ireland

FACTUAL REPORT

HATZ CB1, G-BRSY

Coonagh Airfield (EICN)

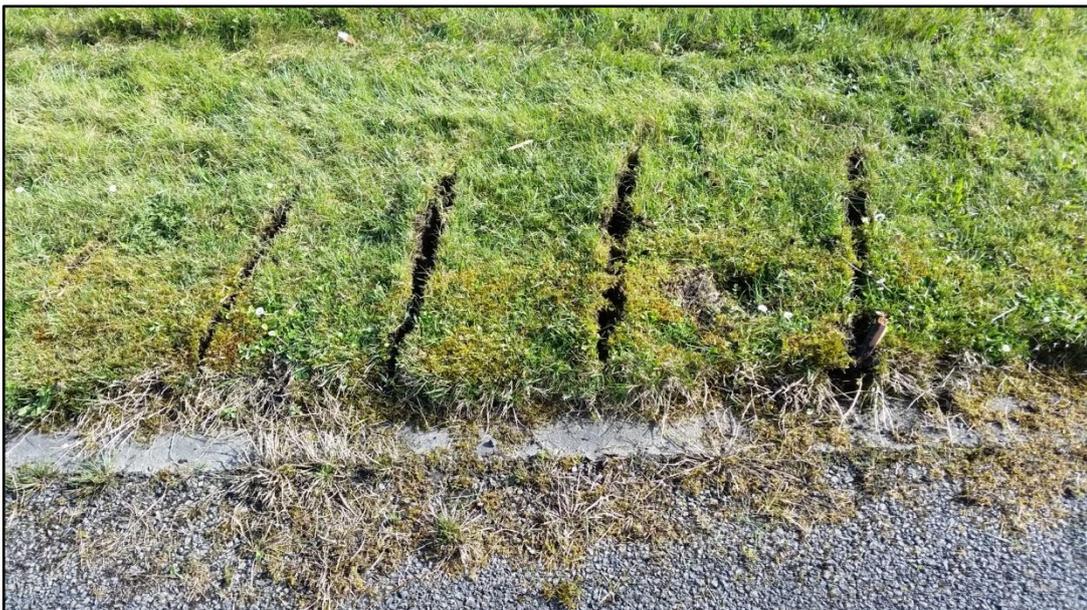
Photo No. 1: Propeller strike marks

The aircraft suffered substantial damage during the occurrence. The tips of both propeller blades were broken when the propeller struck the ground and it is likely that the aircraft engine was shock-loaded as a result. The front cowling of the engine sustained impact damage when the aircraft tipped forward. Also, the tip of the starboard upper wing was bent (**Photo No. 3**), and the strut connecting the port-side upper and lower wing buckled (**Photo No. 4**).

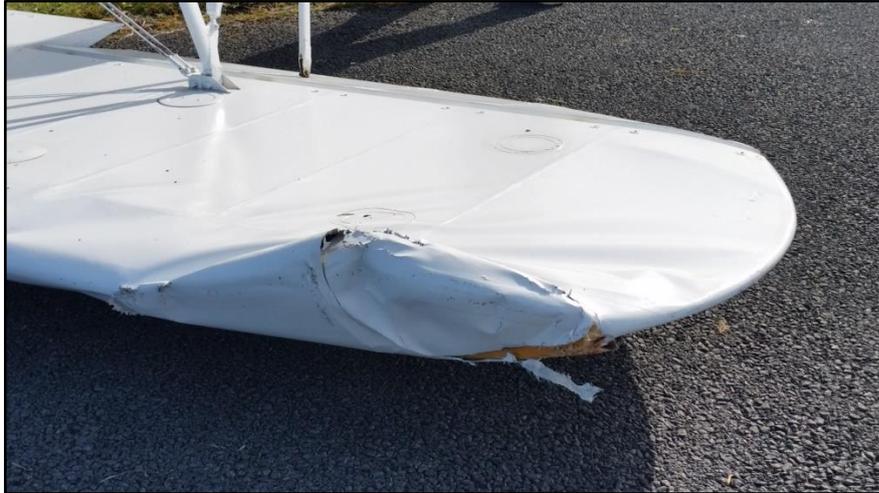
Photo No. 3: Damage to starboard wing tip

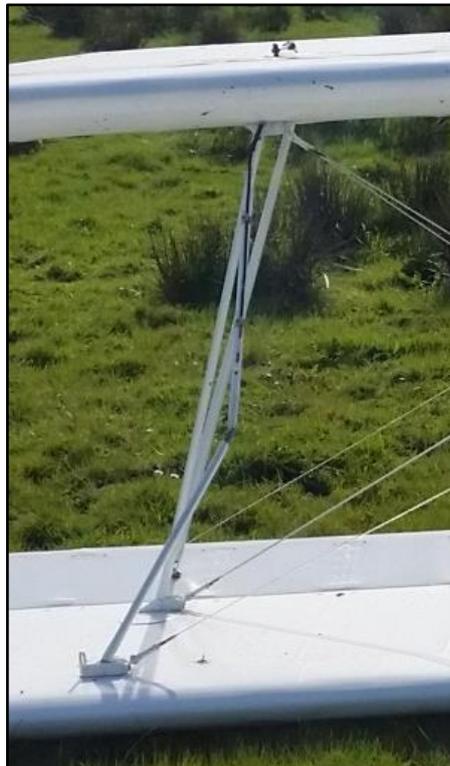
Photo No. 4: Damage to starboard wing strut
