Air Accident Investigation Unit Ireland

FACTUAL REPORT

Ozone Delta 3 (Paraglider)

AAIU Report No: 2019-010
State File No: IRL00919020
Report Format: Factual Report
Published: 25 October 2019

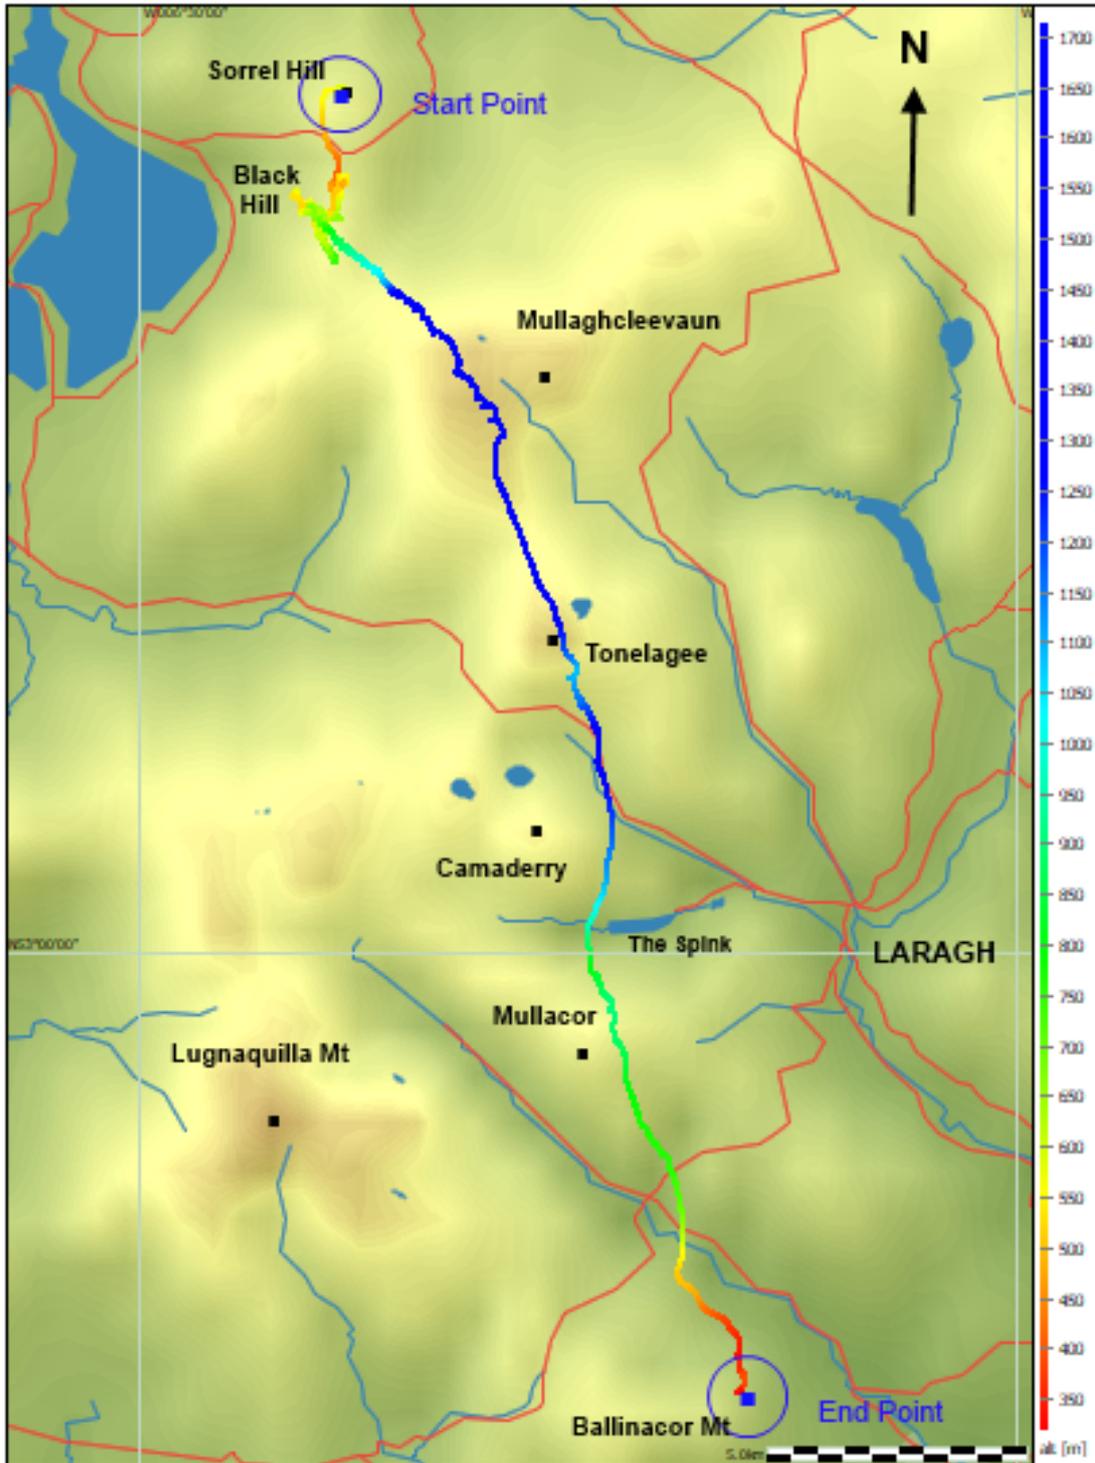
Recorded data shows that the Paraglider commenced a slow descent at the Vale of Glendalough and continued along the Glenmalur Valley towards Ballinacor Mt. The acute myocardial infarction probably occurred while the Pilot was still airborne, and the Paraglider descended until it reached the ground on the north slope of Ballinacor Mt.

Photo No. 2: Recorded Route with Altitude Data in metres (m), start and end points indicated
