# Air Accident Investigation Unit Ireland

**SYNOPTIC REPORT**

**Airbus A330-202, EI-LAX**

**On Take-Off, Dublin Airport**

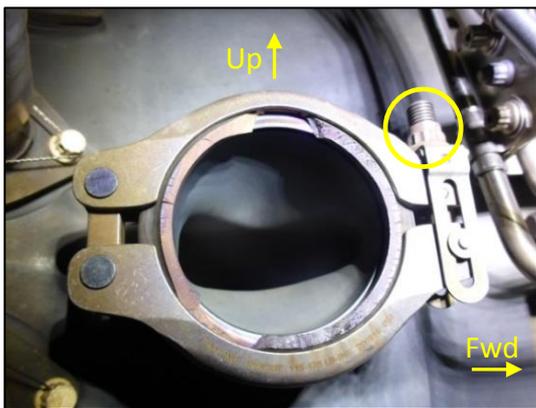
The AAIU inspected the aircraft at EINN. The spacer, which links the upper port of the No. 2 engine's 14<sup>th</sup> stage bleed air outlet to the 14<sup>th</sup> stage bleed manifold, was found to be fractured at the recessed flange close to the clamp which secured the spacer to the bleed air outlet (**Photo No. 3**). This resulted in the engine compartment being exposed to high temperature (646° C)/high pressure (496 PSI) bleed air from the No. 2 engine's 14<sup>th</sup> stage bleed air outlet, which caused heat damage to adjacent wiring looms.

**Photo No. 3:** Fractured spacer flange at coupling which secured spacer to 14<sup>th</sup> stage bleed air outlet (self-locking nut circled)

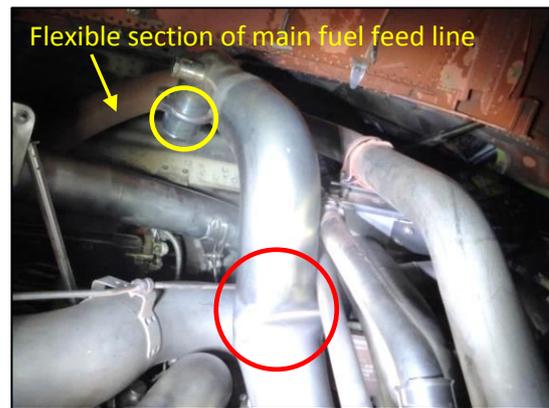
The flange and coupling remained attached to the engine's 14<sup>th</sup> stage bleed air outlet. However, the 14<sup>th</sup> stage manifold buckled, resulting in the coupling, which secured the other (main) portion of the fractured spacer to the manifold, becoming partially embedded in a flexible section of the engine's main fuel feed line (**Photo No. 4** and **Photo No. 5**). This caused damage to the fuel line (**Photo No. 6** below and **Section 1.7.8**); however, the fuel line did not rupture and there was no fuel leak. Impact and heat damage to the engine cowlings were also evident. The pressure relief door on the right-hand aft engine cowling was found in the open position.

**Photo No. 4:** Looking up at buckled 14<sup>th</sup> stage bleed manifold (circled in red). Main portion of fractured spacer (circled in yellow). Fuel line also highlighted

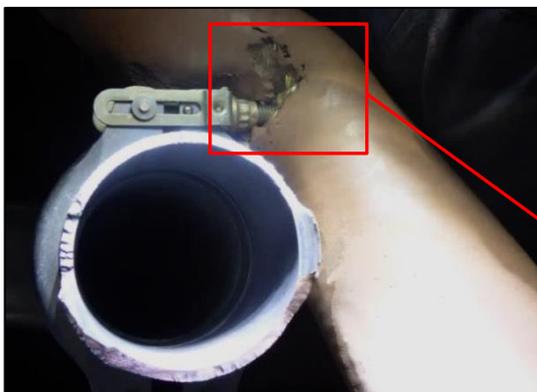
**Photo No. 5:** Coupling securing main portion of fractured spacer to the manifold partially embedded in flexible section of main fuel feed line

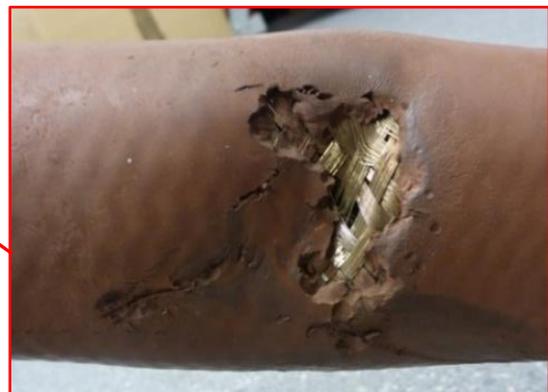
**Photo No. 6:** Damage to flexible section of main fuel feed line

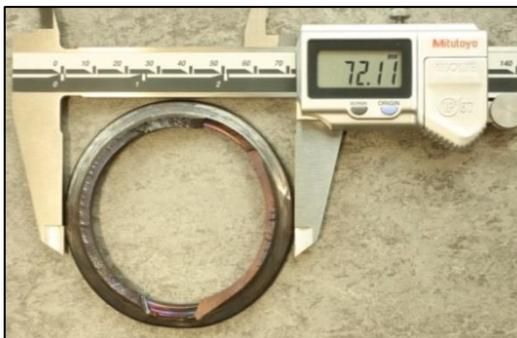
The Investigation examined the minimum and maximum dimensions of the outside diameter of the flange of the fractured spacer to determine if any distortion (out-of-roundness) was evident (**Photo No. 7** and **Photo No. 8**). The maximum out-of-roundness was found to be 0.25 mm (72.11 mm - 71.86 mm). The out-of-roundness of the flange of an exemplar spacer was also evaluated (**Photo No. 9** and **Photo No. 10**). The maximum value was 0.19 mm (72.43 mm - 72.24 mm). The Engine Manufacturer’s component specifications did not contain a tolerance for out-of-roundness. However, the specifications included a manufacturing tolerance for the spacer’s outside diameter of +/- 0.010 inch (0.25 mm) and a maximum *“run-out”* between one diameter and another diameter concentric to the same axis of 0.005 inch (0.127 mm).

**Photo No. 7:** Maximum diameter of fractured spacer flange (72.11 mm)

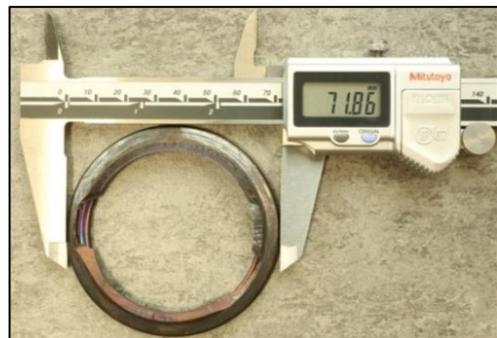
**Photo No. 8:** Minimum diameter of fractured spacer flange (71.86 mm)

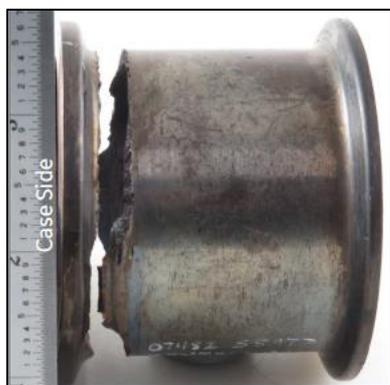
**Photo No. 11:** Fractured Spacer (GE)

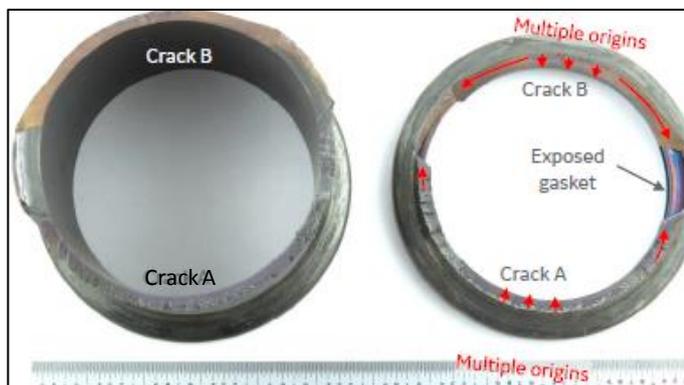
**Photo No. 12:** Fractured Spacer – location of main cracks: Crack A and Crack B (GE)

The subsequent examination identified two main cracks (A and B in **Photo No. 12**). Metallurgical analysis of Crack A identified fatigue striations<sup>17</sup> with a striation density of between 27,000 and 100,000 striations per inch, which the associated report deemed to be consistent with high alternating stress, High Amplitude Fatigue (HAF) crack propagation.

Analysis of Crack B revealed features consistent with lower alternating stress, High Cycle Fatigue (HCF<sup>18</sup>) crack propagation. The metallurgical analysis report deemed Crack A to be the primary origin of the failure. The report summarised that:

The Investigation determined that Crack A originated close to where the T-bolt side of the coupling had been located. Crack B was situated diametrically opposite to Crack A and was determined to be located close to where the coupling's dual hinge point had been located. The cracks were therefore situated adjacent to locations on the spacer flange that were not completely in contact with the clamping surfaces of the coupling. Crack A was forward of Crack B, with reference to the engine's longitudinal axis.

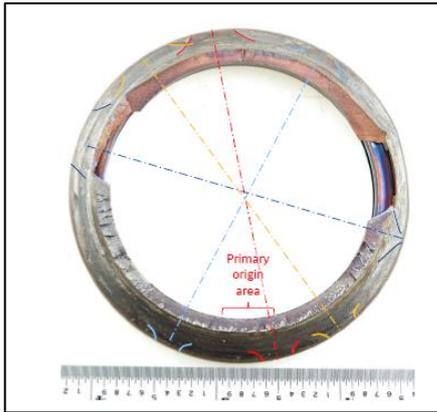
The examination found indentations on the surface of the broken flange at eight locations, which the Engine Manufacturer attributed to be due to where the spacer retention coupling had been tightened onto the spacer at four separate locations (indicated by the coloured dashed lines in **Photo No. 13**). The position of the coupling at the time of the event is shown in **Photo No. 3** in **Section 1.6**. The metallurgical examination noted that the indentation of the flange due to the coupling impression at this clamping position (dashed red line in **Photo No. 13**), was approximately 4.9 thousandths of an inch deep (0.124 mm). Crack A, which was found to have multiples origins, was located close to where the coupling latch was situated (**Photo No. 14**).

**Photo No. 13:** Indentations on flange attributed to be due to locations where coupling had been previously tightened onto the spacer (indicated by the coloured dashed lines) (GE)

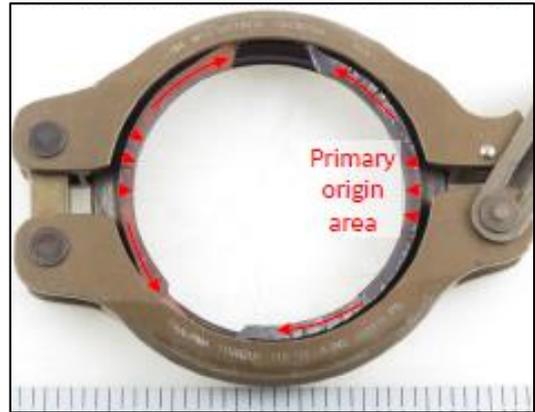
**Photo No. 14:** Location of primary origin of failure adjacent to where coupling latch was located (GE)

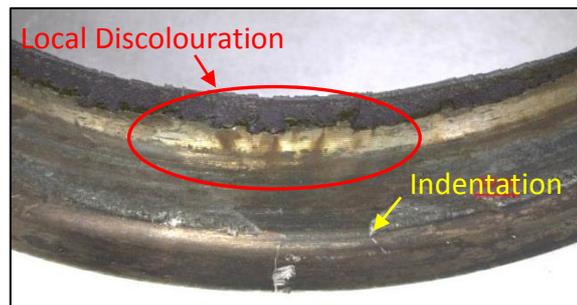
Metallurgical analysis of Crack A also identified local discolouration below the fracture surface, consistent with bleed air leakage (**Photo No. 15**).

**Photo No. 15:** Local discolouration and indentation on flange adjacent to Crack A (GE)

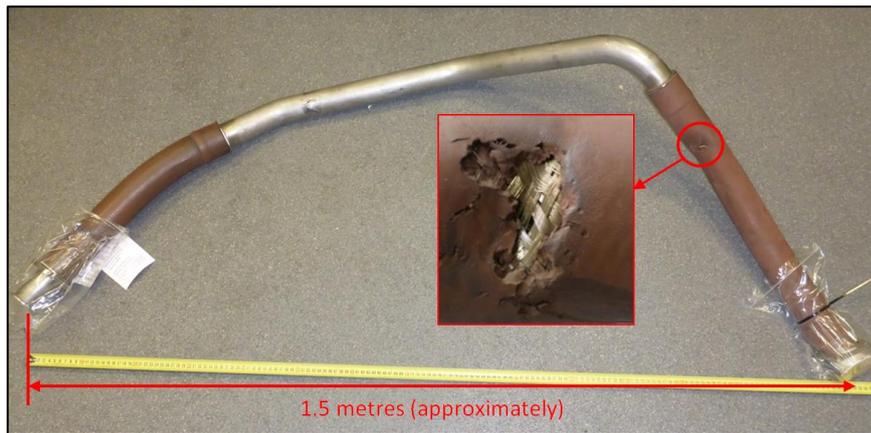
In addition to the damage sustained to the exterior of the flexible hose as shown in **Figure No. 4**, the Component Manufacturer found that the internal support coil had also sustained significant damage at the site of the external impact, with approximately five spiral wraps of the support coil indented toward the centre of the assembly (**Photo No. 16**). Following visual examination, the hose was "*proof tested with water at 500 PSIG [twice its design maximum operational pressure] for 2 minutes with no signs of leakage*".

**Figure No. 4:** Damage to exterior of flexible section of No. 2 engine's main fuel feed line

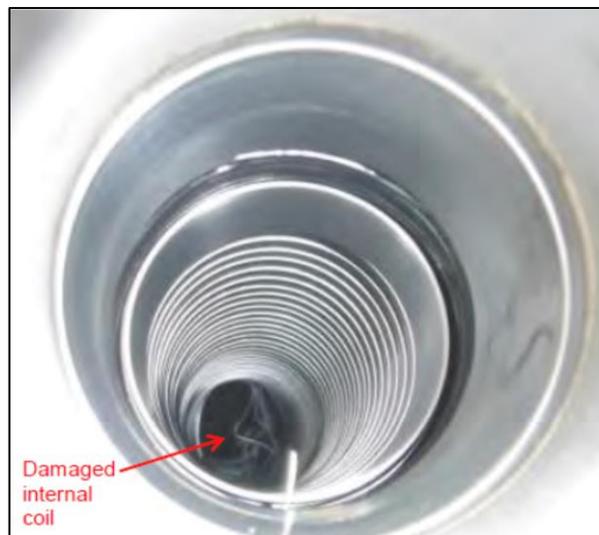
**Photo No. 16:** Damage to interior of flexible section of No. 2 engine's main fuel feed line
