Air Accident Investigation Unit Ireland

SYNOPTIC REPORT

Airbus, A320-214, EI-GAL

2 November 2017

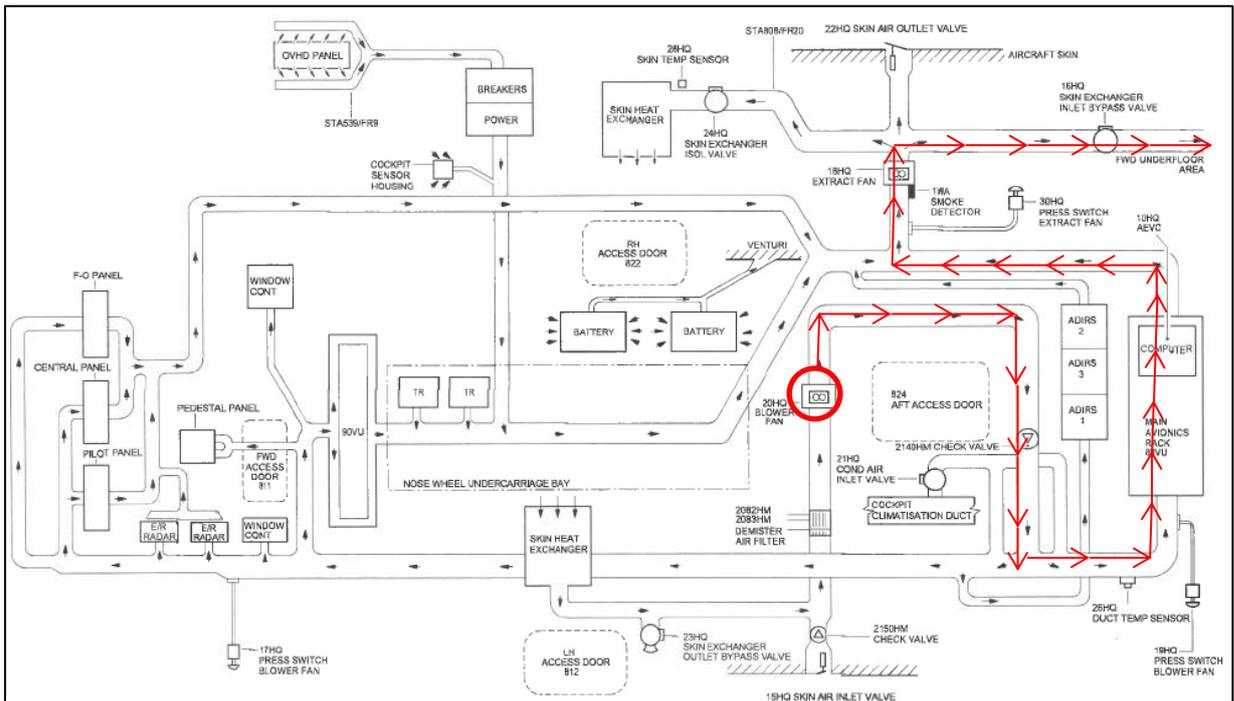
Maintenance personnel in EICK identified the avionics bay blower fan as the source of the fumes. This fan provides cooling air to the avionics bay. **Figure No. 1** shows the location of the blower fan in the avionics bay ventilation system and the route the air takes from the fan through the ventilation system to the forward, underfloor area of the aircraft. Once removed from the aircraft, the fan was examined by an approved maintenance organisation and an investigation report was produced. The report concluded that the root cause of the fan failure was wear of the rear bearing. The report noted that this failure mode was not unusual.

Figure No. 1: Avionics Ventilation System (blower fan circled) (Airbus A320 Maintenance Manual)

During subsequent inspection by maintenance personnel, the source of the fumes in the cockpit was found to have originated from rear bearing wear in the avionics bay blower fan.

26. Subsequent investigation of the removed avionics bay vent fan by an approved maintenance organisation determined that the cause of the fan failure was wear of the rear bearing.

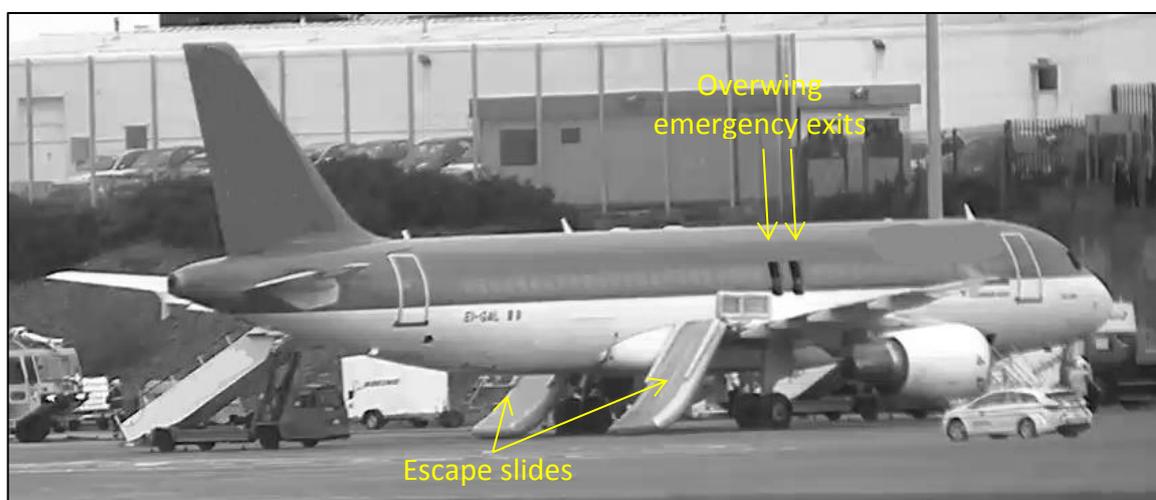
The CCTV footage shows that when the overwing emergency exits were opened both escape slides deployed and inflated correctly, maintaining inflation levels throughout the disembarkation process. **Photo No. 1** is a screenshot taken from the CCTV footage after all of the passengers had disembarked.

Photo No. 1: EI-GAL following the disembarkation of passengers (Operator's logo removed)
