# Air Accident Investigation Unit Ireland

**FACTUAL REPORT**

**Diamond DA42 Twin Star, G-SERE**

**18 May 2019**

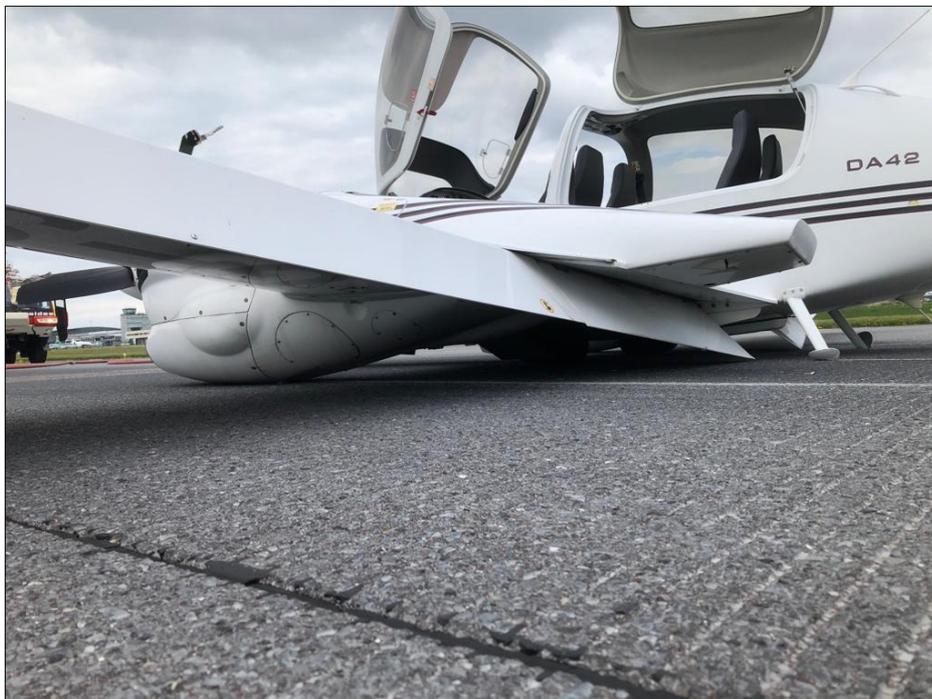
Aircraft damage was restricted in general to the propeller assemblies, lower engine cowlings and boarding steps (**Photo No. 1**). The runway surface had minor scoring damage.

**Photo No. 1:** Damage to aircraft
