Air Accident Investigation Unit Ireland

INTERIM STATEMENT

**ACCIDENT
BRM Aero, Bristell NG5, G-OJCS
Near Belan, Co. Kildare**

Report No: 2020-008

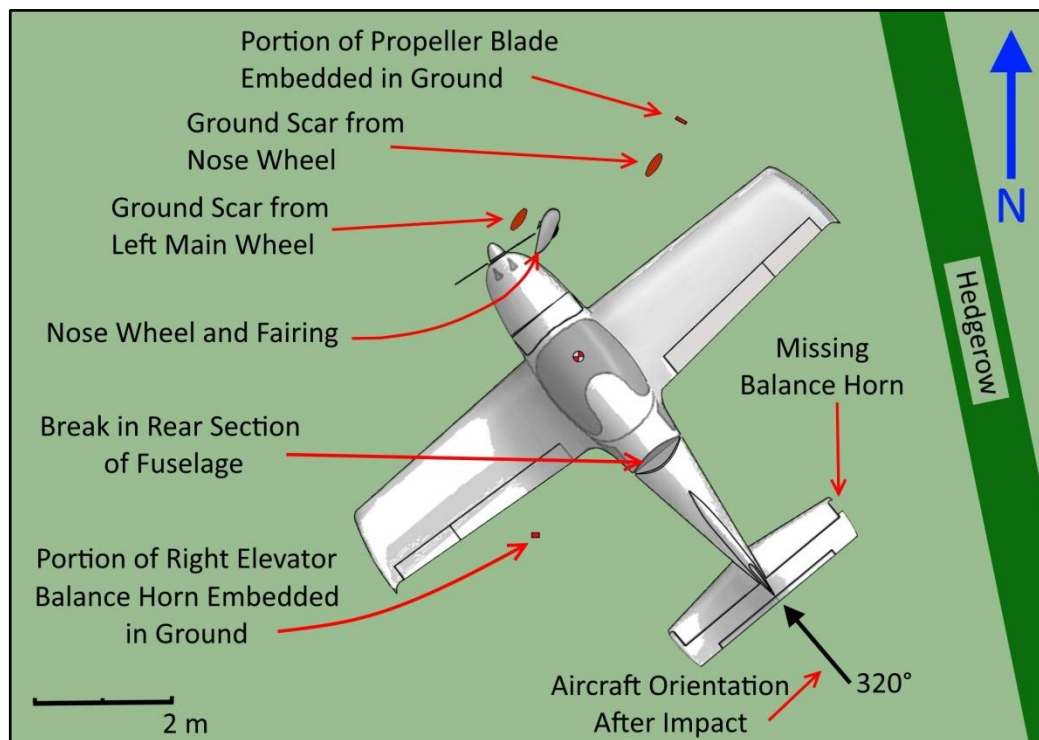
Figure No. 1: Final resting position of Aircraft

The initial impact was on a heading of 033° magnetic. The aircraft then bounced, continued the left rotation through 73°, and came to rest on a heading of 320° magnetic, approximately 2 m south of the initial impact point (**Figure No. 1**). The aircraft exhibited significant distortion due to large deceleration forces.
