# Air Accident Investigation Unit Ireland

**INTERIM STATEMENT**

**ACCIDENT  
BRM Aero, Bristell NG5, G-OJCS  
Near Belan, Co. Kildare**

**13 June 2019**

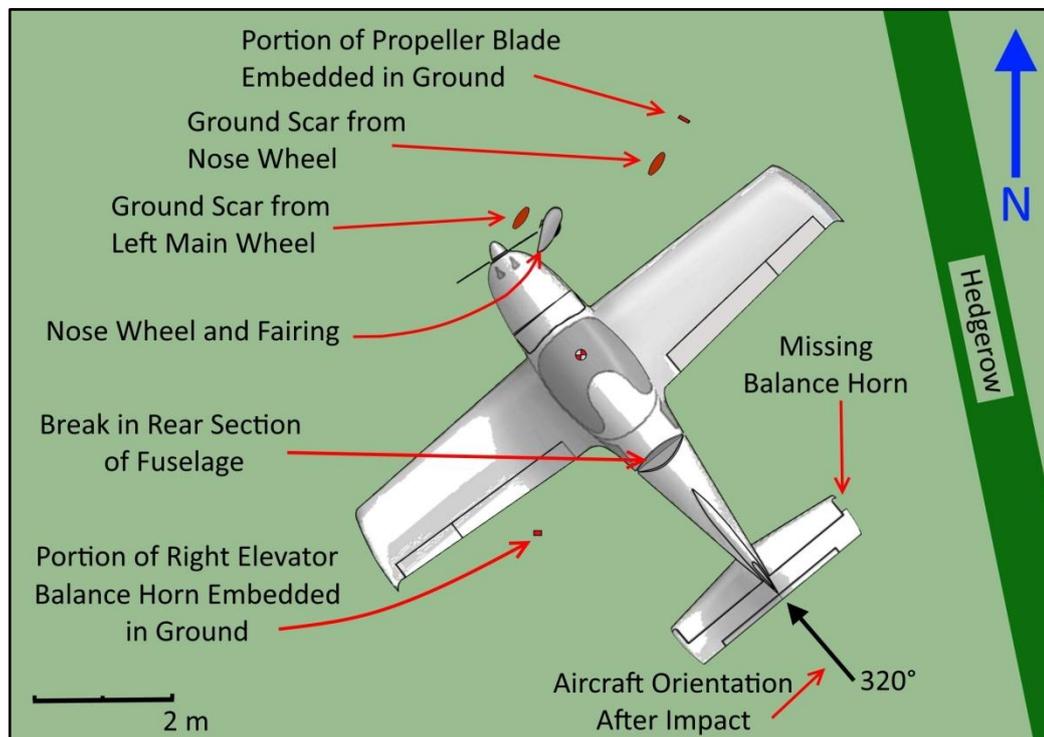
Examination of the aircraft at the accident site showed that all aircraft components were present. All flight control surfaces and their associated linkages were located on the aircraft, and control continuity was confirmed during examination. Engine control continuity was also confirmed. Initial examination of the wreckage at the accident site, and subsequently at the AAIU wreckage facility, at Gormanston, Co. Meath, indicates that the aircraft impacted the ground whilst rotating in a left-hand flat spin<sup>6</sup>.

The initial impact was on a heading of 033° magnetic. The aircraft then bounced, continued the left rotation through 73°, and came to rest on a heading of 320° magnetic, approximately 2 m south of the initial impact point (**Figure No. 1**). The aircraft exhibited significant distortion due to large deceleration forces.

**Figure No. 1:** Final resting position of Aircraft
