Air Accident Investigation Unit Ireland

SERIOUS INCIDENT REPORT **Airbus A330-301, EI-ORD** **Over Iceland** **11 May 2010**

AAIU Report No: 2012-015

Report Format: Synoptic Report

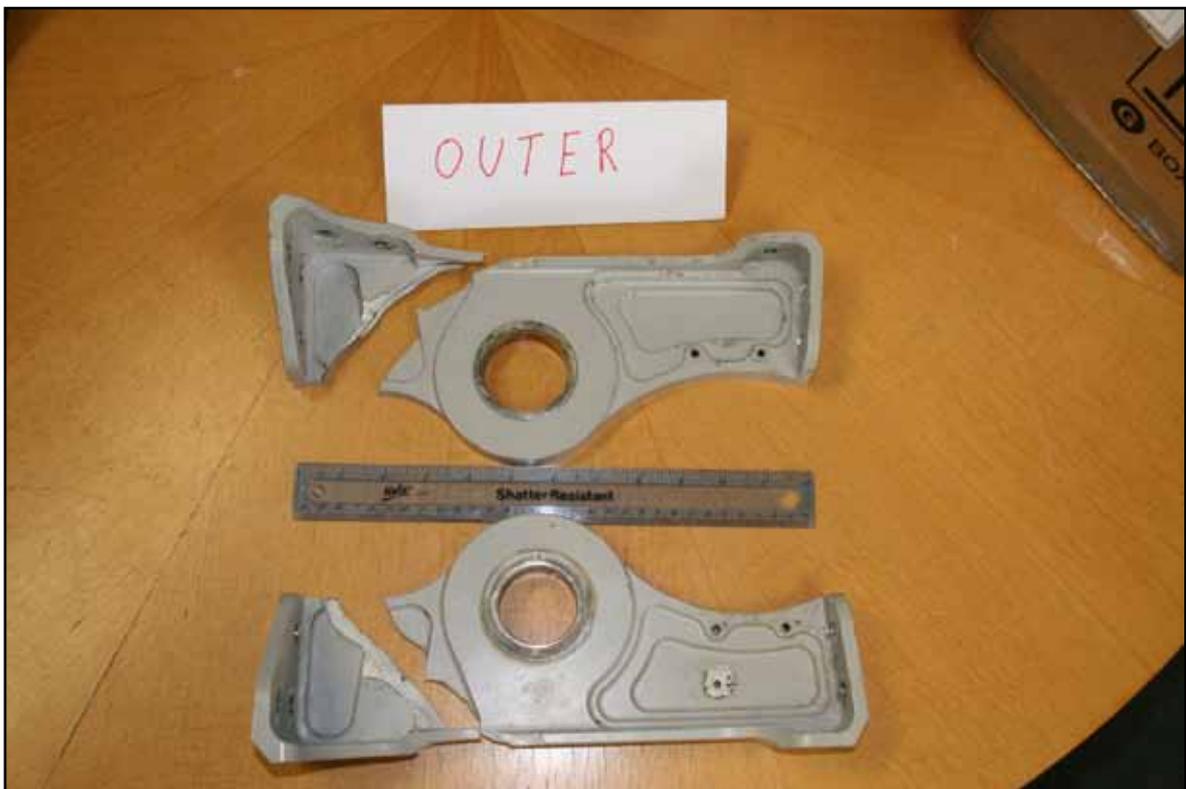
On arrival at KORD the aircraft was inspected by maintenance personnel. The brackets (Part Number F575-50986) attaching the outside (active) servo-control, of the RH inboard aileron, to the RH wing rear spar, were found to be fractured (**Photo No. 1**), and the lower wing skin directly beneath the brackets' attachment points was deflected. Further inspection revealed that the corresponding outer bracket on the other (LH) side of the aircraft was cracked in the same area where the RH outer bracket had failed.

Photo No. 1: The fractured brackets

The Manufacturer's examination revealed that the primary failure was of the outer bracket. The failure was caused by fatigue cracking which originated from a pit in the bracket surface. The pit, which was approximately 50 microns in depth, was believed to have been present in the bracket since it was manufactured. Following failure of the outer bracket due to fatigue cracking the inner bracket failed due to overload.

At the time of the meeting laboratory tests on six affected brackets had revealed surface pitting to depths of 50 microns; this pitting was the site of the crack initiation. Fatigue striations were in evidence in most of the cracks; cracks with a length up to about 4 mm exhibited a typical striation spacing of approximately 2 microns.

This event was caused by the failure of the inboard aileron outside servo-control outer bracket (F575-50989) on the RH wing due to fatigue cracking. The outside servo-control inner bracket (F575-50987) failed in overload as a consequence of the failure of the outer bracket. The corresponding bracket pair on the left hand wing was inspected and found to be cracked. The triggering event for this failure was an aircraft encounter with turbulence over Iceland.

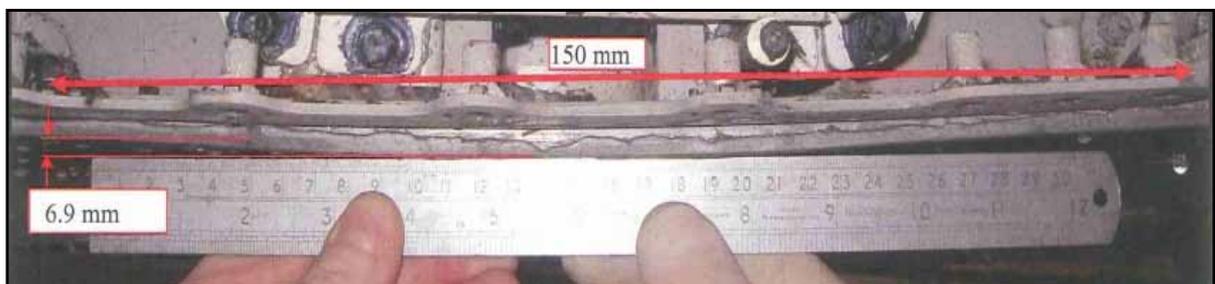
Detailed examination of the wing lower skin in the area directly below the failed bracket revealed an area of deformation between ribs 28 and 29. The deformation started at the aft spar fastener line and continued aft reaching a maximum value of 6.9 mm. **(Photo No. 2)**

Photo No. 2: Deformation of lower wing skin, RH wing

There was no deformation of the bottom skin directly under the rear spar, nor was there any deformation of the rear spar flange fasteners, nor elongation of associated holes. The lower fastener holes in the rear spar web for attaching the brackets to the rear spar web were found to be elongated; the holes had an initial diameter of 7.94 mm but were found to be elongated to 8.6 mm approximately.

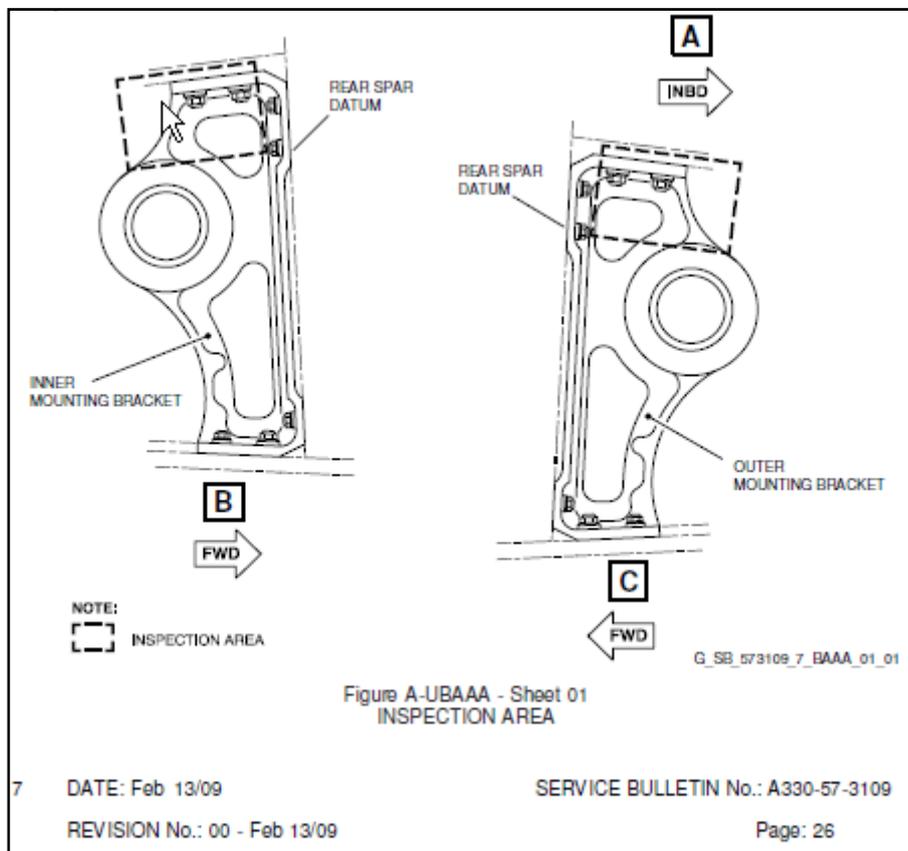
- The diagram in the SB showed the bracket pair for the inside servo-control instead of the bracket pair for the outside servo-control. **(Figure No. 3)**

Figure No. 3: Original SB Diagram showing incorrect bracket pair

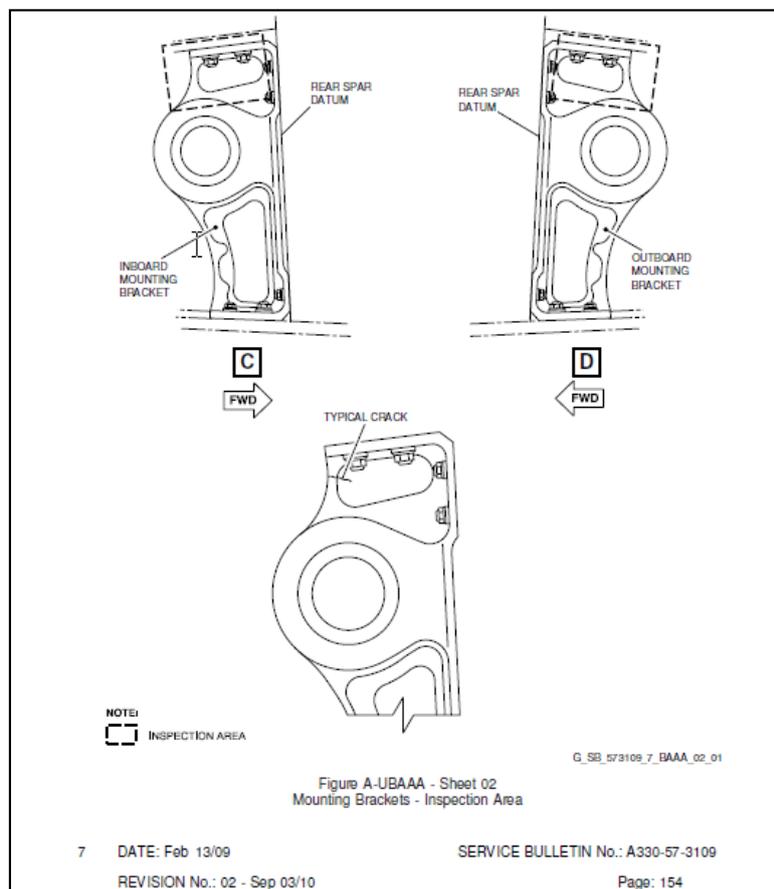
Figure No. 4: Revised SB diagram showing correct bracket pair

In relation to the SB, the Aircraft Manufacturer advised that it was re-issued (Version 02, 08 September 2010) with a new title "WINGS - INNER AILERONS REAR SPAR ATTACHMENTS - INSPECTION OF OUTBOARD ACTUATOR BRACKETS". Service Bulletin A330-57-3109 Version 02 increased the recommended number of operators required to accomplish the inspection from one to two. The reason for the SB was changed from "An operator reported cracks on both brackets attaching the L/H Active Servo Control 8CS1(inner ailerons at the rear spar ..." to "An operator reported a rupture of both the pair of attachment brackets for the outboard L/H Servo Control *8CS1) of the inner aileron ..." Service Bulletin A330-57-3109 Version 02 also pictures the correct bracket pair (**Figure No. 4**), includes notes on non-destructive testing, graphics depicting the typical crack location and details for a locally manufactured plastic guide to address the problems with the probe slipping off the bracket edge. On the question of repetitive intervals the Manufacturer subsequently informed the Investigation that the following intervals were published in the Service Bulletin A330-57-3109 Revision 03 on 31 May 2011:
