Air Accident Investigation Unit Ireland

SERIOUS INCIDENT REPORT
Steen Skybolt, EI-SAT
Foynes, Co. Limerick
5 June 2011

AAIU Report No: 2012-016

Report Format: Synoptic Report

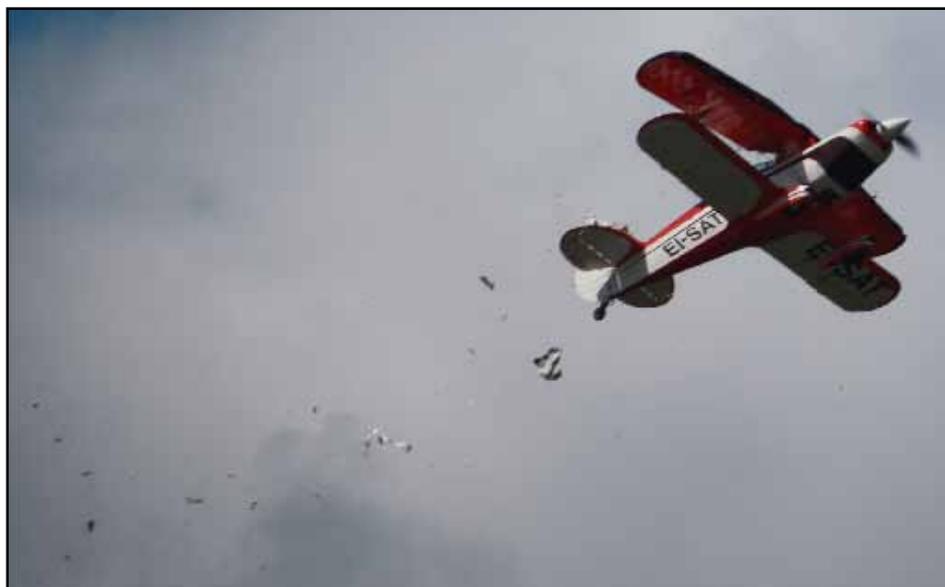
The Pilot was engaged in an aerobatic display as part of a local weekend festival at Foynes on the southern bank of the River Shannon. Approximately 4 minutes into the display routine, sections of fabric tore loose from the top surface of the upper left wing and across its centre section resulting in serious control difficulties for the Pilot. He carried out a successful forced landing to the best available field, with no additional damage to the aircraft.

The Owner of EI-SAT gave permission for his aircraft to be used by the Pilot for the scheduled aerobatic display. On the day of this occurrence, the aircraft positioned from a private airfield in east Co. Limerick to the display area. The aircraft was one of several performing on the last afternoon of a festival. Weather on the day was good, with little cloud and a moderate westerly wind. The Pilot commenced his display and performed a prepared sequence of aerobatic manoeuvres. Approximately 4 minutes into the routine, as it passed from left to right along the display line, in near level flight with a slight left bank, sections of fabric detached from the upper surface of the top left wing. The Pilot was observed to make a shallow left turn, followed by a further shallow right turn as he descended to carry out a forced landing in a field. The aircraft was being observed by spectators at the Festival, several of whom made photographs and video of the flight available to the Investigation (**Photo No. 1**).

Photo No. 1: Sections of fabric separating from the upper wing (Peter Diffley)

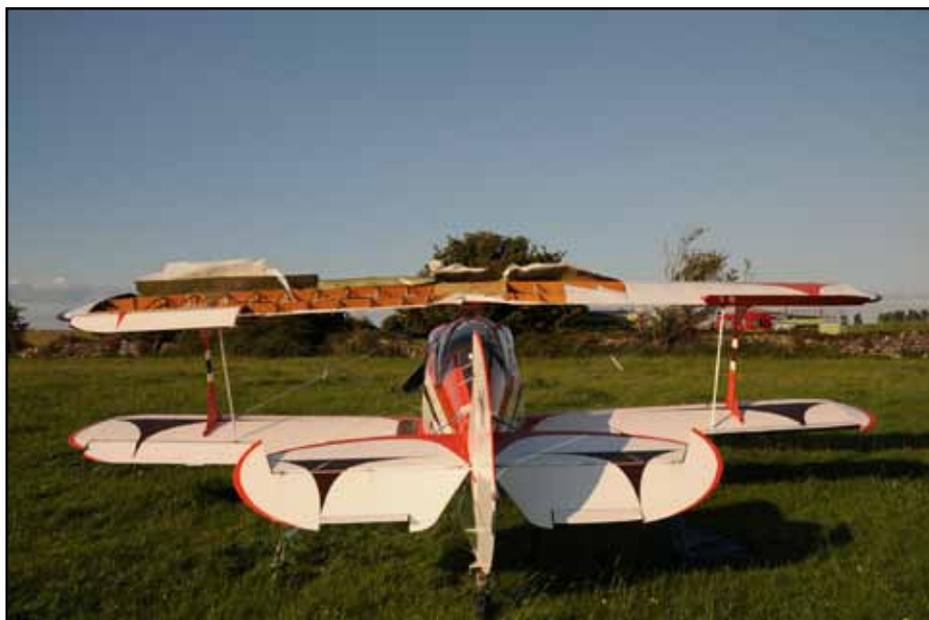
Several sections of fabric were recovered from an island in the River Shannon and were made available to the AAIU Inspector on arrival. The aircraft was initially inspected in the field where it had been secured and it was found that almost 2/3 of the fabric on the upper surface of the upper wing was missing (**Photo No. 2**).

Photo No. 2: Fabric damage to the upper wing.

Sections of the detached fabric were inspected. These sections of fabric revealed that the fabric sections tore free due to the pulling of the fabric away from the rib, with the lacing cords pulling through the covering tapes.

3. The detachment of the fabric from the upper wing surface initiated in the area of the second (No. 2) rib.
4. Remaining sections of fabric then detached due to airflow and non-standard loads being exerted as a result of the initial fabric failure.

5. Remaining sections of fabric tore loose due to the rib lacing cords pulling through the rib reinforcing tapes.
6. Control of the aircraft was severely compromised due to the spoiled airflow over the wing and associated buffeting following the loss of the wing fabric. In addition the aluminium leading edge had detached from the upper wing spar, further disrupting the airflow.

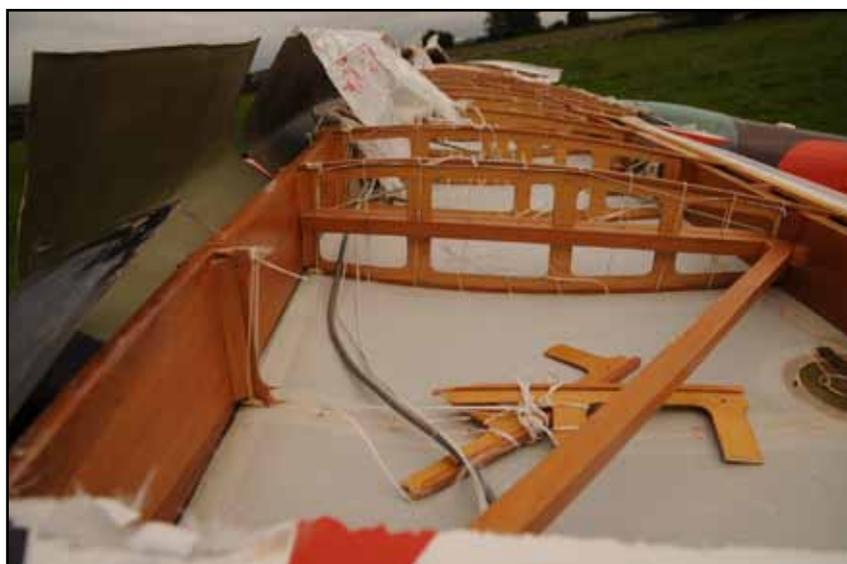
Three ribs on the left upper wing were damaged; most damage occurred to the second (No. 2) rib, numbered sequentially from the left wingtip. This rib had shattered into fragments between the main spars and some fragments remained attached only by lacing cord (**Photo No. 3**). The first (No. 1) rib was broken but components were still in-situ. The seventh (No.7) rib was missing its trailing edge section.

Photo No. 3: Damaged No. 2 rib with associated fragments.

The Investigation was fortunate in sourcing many photographs and video recording of the aircraft during the display sequence. The disruption of the fabric from the top surface of the upper wing was sudden and stripped the upper surface in a rapid sequence. The fragmentation of the No. 2 rib is evidence of an impact on the upper surface, probably by a small bird, which resulted in its disintegration; pulling an initial section of fabric from the area. Following this failure, the remainder of the fabric came away in two large sections probably as a result of non-standard aerodynamic loads on the upper wing, creating a force on the fabric that it was not designed to withstand. The No. 2 rib pieces situated between the main upper wing spars and the attached fabric were not recovered.

1. The aircraft was airworthy prior to the occurrence flight. It had a valid Permit to Fly and Air Display Permission, issued by the IAA.
2. The second (No. 2) left-upper wing rib was completely destroyed, indicating that it may have been struck by an object in flight, probably a small bird.

The fabric from the upper wing detached probably due to impact with a small bird during flight, resulting in the break up and local tearing of fabric in the vicinity of the left wingtip.
