# Air Accident Investigation Unit Ireland

**ACCIDENT REPORT**  
**Mainair Sports Ltd**  
**Gemini Flash IIA, G-MYKH**  
**Renairee, Macroom, Co. Cork**  
**2 July 2011**

AAIU Final Report No: 2012-012

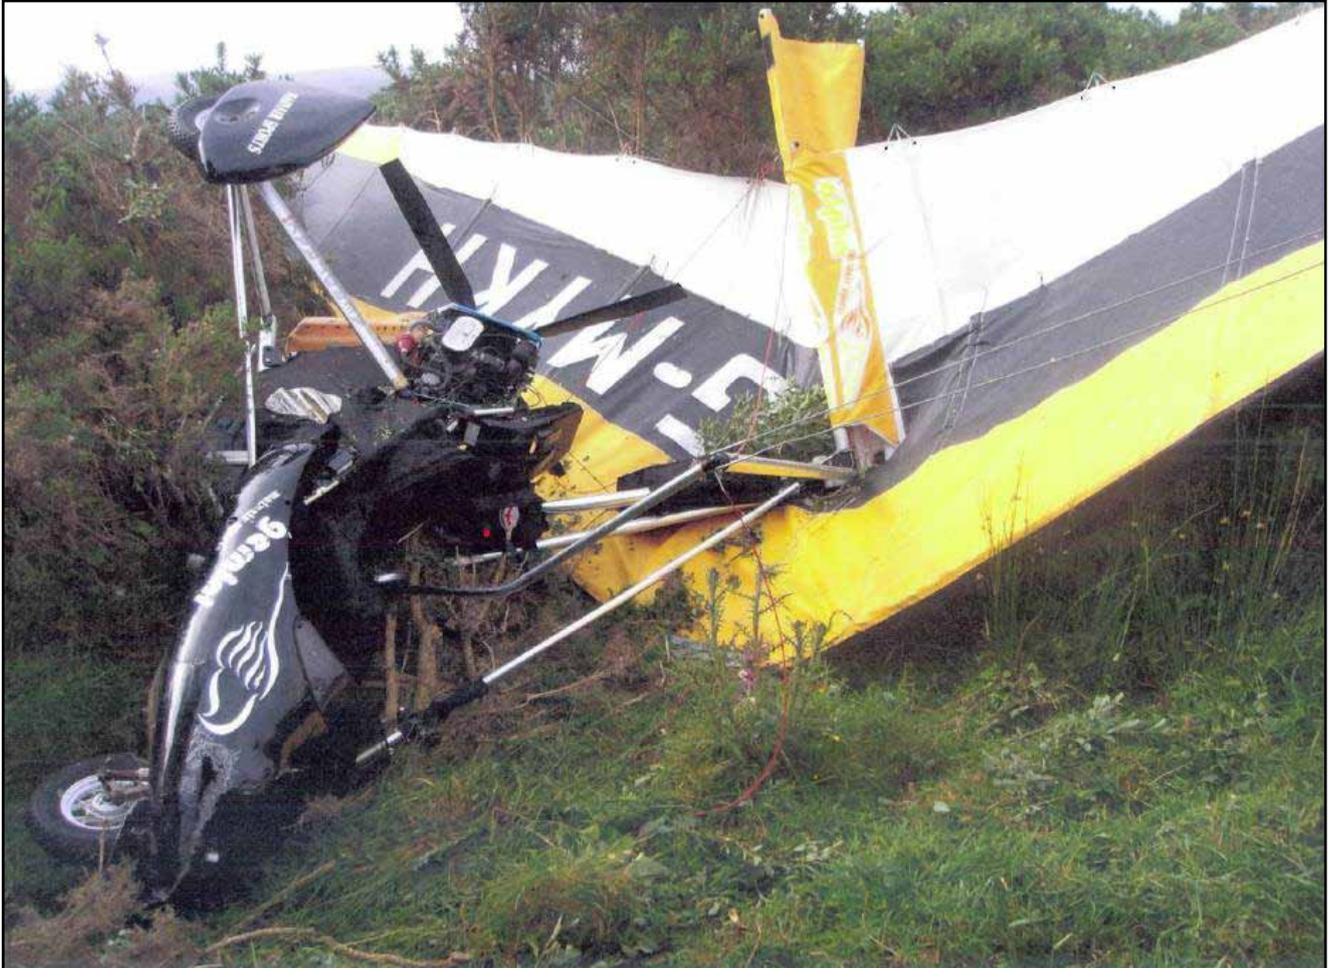
The aircraft suffered substantial damage in the forced landing. The forward crew pod section (**Photo No.1**) was substantially damaged and had split. The monopole had snapped, the wing sail was punctured and the wing frame destroyed. The trike frame was also bent.

Photo No. 1: Final resting position of G-MYKH (Pilot's Photo)
