Air Accident Investigation Unit Ireland

SYNOPTIC REPORT

**Bolkow Bo-209 Monsun, D-EFJG
Navan Airfield, Co. Meath**

14 May 2019

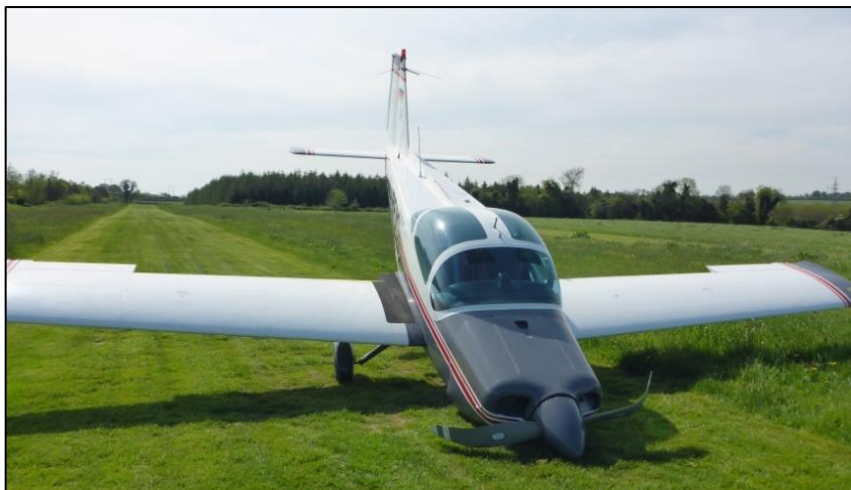
After take-off from Runway (RWY) 09 at EIHH, the Pilot (in command), who was seated in the left-hand seat, selected the nose landing gear to the up position and the aircraft's retractable nose landing gear retracted as commanded. Following the completion of one circuit of the airfield, the Pilot extended the aircraft's trailing edge flaps in preparation for landing back on RWY 09. During the landing roll, the propeller and the lower engine cowling came into contact with the runway surface, as the nose landing gear had not been extended prior to landing. The aircraft came to rest on the runway (**Photo No. 1**). The two occupants were uninjured and exited the aircraft unaided. There was no fire.

Photo No. 1: Final resting position of aircraft

The propeller’s two blades sustained bending damage and the engine was shock-loaded. The engine’s left and right cowlings and the lower air intake sustained minor damage. Repairs to the aircraft were on going at the time of writing.

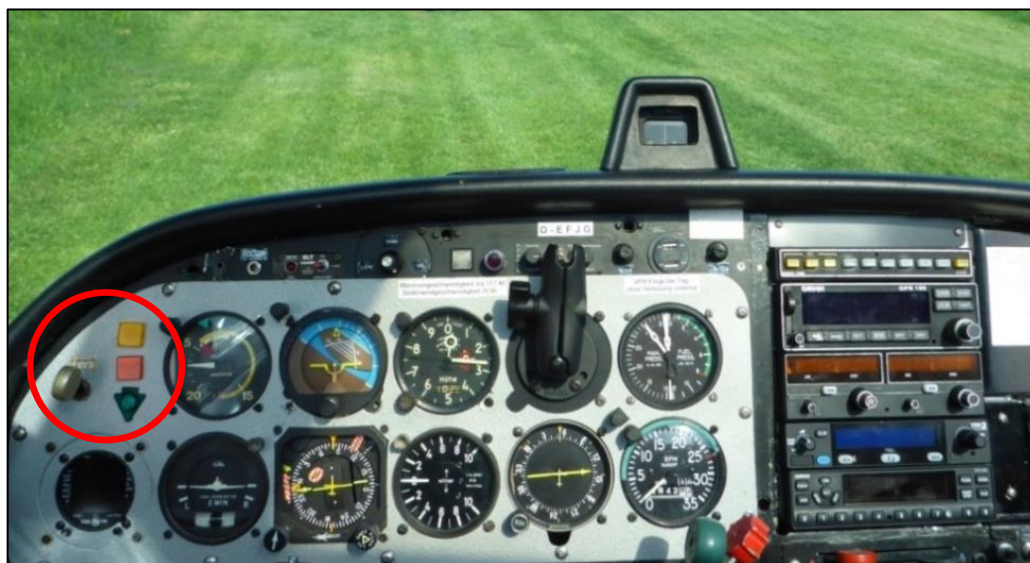
The aircraft's nose landing gear is selected to retract or extend by a wheel-shaped two-position switch located on the left-hand side of the aircraft's main instrument panel. Amber, red and green indication lights are fitted adjacent to the switch (**Photo No. 2**). The nose landing gear is retracted and extended by an electrically powered actuator. It can also be extended manually using a hand crank. According to the Aircraft Manufacturer's 'Technical Description' document, all three indication lights will be off when the nose gear is retracted; the amber light will flash on the approach to warn the pilot to extend the nose landing gear, and will flash on the ground with the gear extended if the switch is placed in the up position; the green light will illuminate when the gear is down and locked; and the red light will illuminate when the gear is in transit.

Photo No. 2: Nose landing gear extension/retraction switch and indication lights (circled)

According to the 'Technical Description' document, the amber light is activated by a throttle position switch, which should operate 'as soon as the throttle lever is pulled back to about 1/3 of its travel'. The 'Technical Description' document also states that commencing with aircraft serial number (S/N) 131 an aural alert horn is installed in parallel with the amber light. The S/N of the subject aircraft is 129 and the horn was not installed.

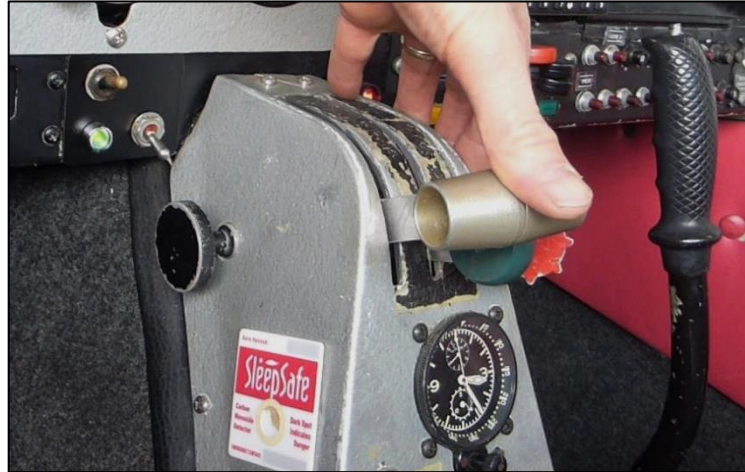
Photo No. 3: Throttle position required to actuate nose landing gear warning switch

The Pilot advised the Investigation that during examination of the landing gear warning system in Germany, it was found that the actuation mechanism for the throttle position switch was worn. This resulted in it not being possible to adjust the warning system to activate earlier than the position shown in **Photo No. 3**. The Pilot said that the subsequent examination also found that a wire had been directly soldered to one of the indication bulbs and that an additional resistor was installed in the circuit. The resistor was secured to the wiring with plastic tape. The Pilot said that this arrangement resulted in a burning smell during system testing. It was also found that a flasher unit was fitted, which was of a different part number to that listed in the Aircraft Manufacturer's parts list obtained by the Investigation. It was not possible to determine when this work was carried out.

According to the aircraft's 'Technical Description' document, the amber light should flash when the throttle is retarded to about 1/3 of its travel and the nose landing gear is in the retracted position. However, the Investigation's post-occurrence examination of the aircraft found that the light did not activate until the throttle was closer to the idle position. It was also found that once the amber light began to flash, the red light (normally only illuminated when the gear is in transit) also flashed. This may have been due to the condition of the electrical circuit as observed during further examination of the aircraft. In addition, a flap position switch was not installed on the aircraft.

8. Post-occurrence examination by the Investigation also found that the nose landing gear warning system activated at a throttle position that was closer to the idle position than the '*1/3 of its travel*' position described in the aircraft's '*Technical Description*' document.
