Air Accident Investigation Unit Ireland

SYNOPTIC REPORT

**TrikeBuggy Bullet V3.2 (unregistered)
Near Bellharbour, Co. Clare**

AAIU Report No: 2020-012
 State File No: IRL00919028
 Report Format: Synoptic Report
 Published: 21 July 2020

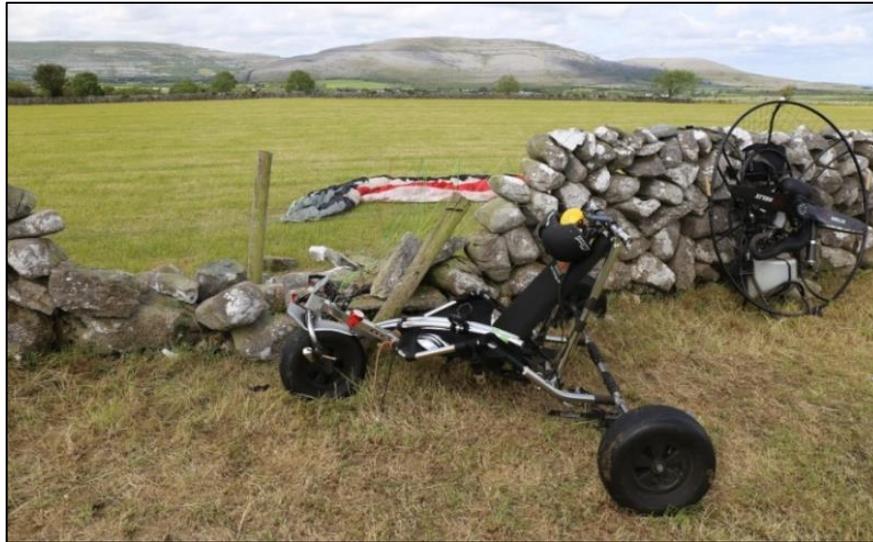
The trike and the impact site are shown in **Photo No. 1**, which was taken on the day following the accident. The rear-mounted engine/propeller assembly had been separated from the trike to facilitate recovery of the Pilot, as had two of the trike’s tubular steel side members. The canopy is visible on the other side of the wall.

Photo No. 1: Trike, engine/propeller and canopy at accident site (on the following day)

The trike's nose wheel support assembly sustained bending damage.

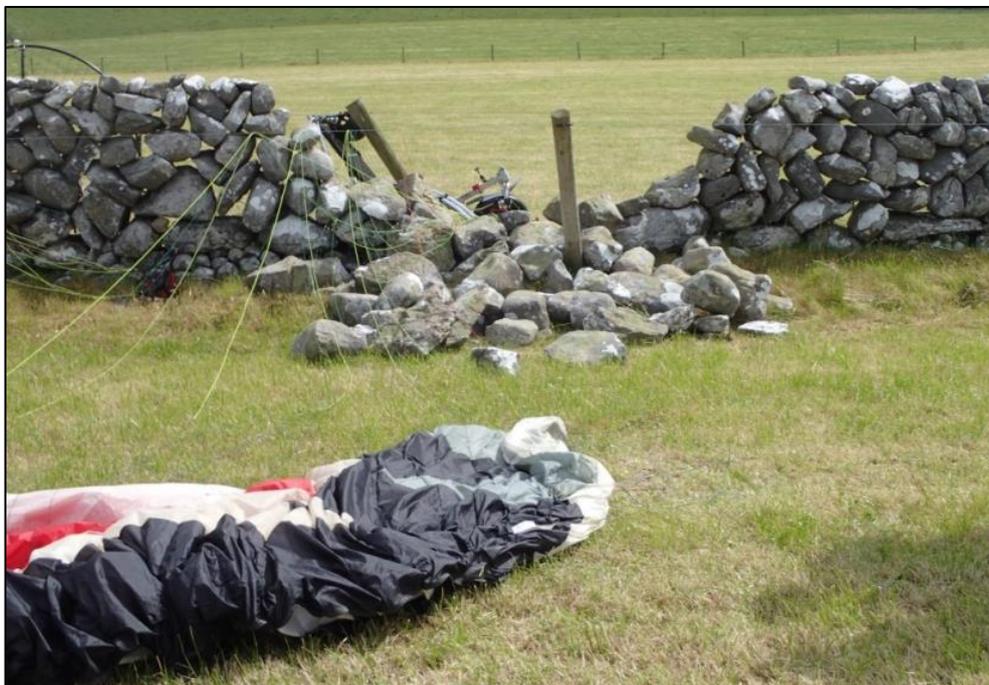
A portion of a dry stone wall at the field's south-western perimeter was knocked down due to the impact (**Photo No. 2**). The trike had been travelling parallel to the wall from right to left in the field on the other side of the wall, before it turned left and was almost perpendicular to the wall at impact.

Photo No. 2: Damage to dry stone wall (photo taken the following day)

The trike impacted a wall which was of dry stone construction, causing a portion of it to be knocked down. This would have absorbed some of the trike's energy. Notwithstanding that the only restraint harness fitted to the trike was of a two-point design (lap-belt), the Pilot remained restrained within the trike during the impact sequence. The frame of the trike, members of which extended to shoulder height at either side of the trike's seat, would have assisted in restraining the Pilot. He was also wearing a helmet. These factors, combined with the nature of the wall's dry stone construction, likely lessened the severity of the Pilot's injuries.
