Air Accident Investigation Unit Ireland

SYNOPTIC REPORT

**Cessna F172P Skyhawk, EI-ING
Near Craughwell Airfield, Co. Galway**

4 August 2018

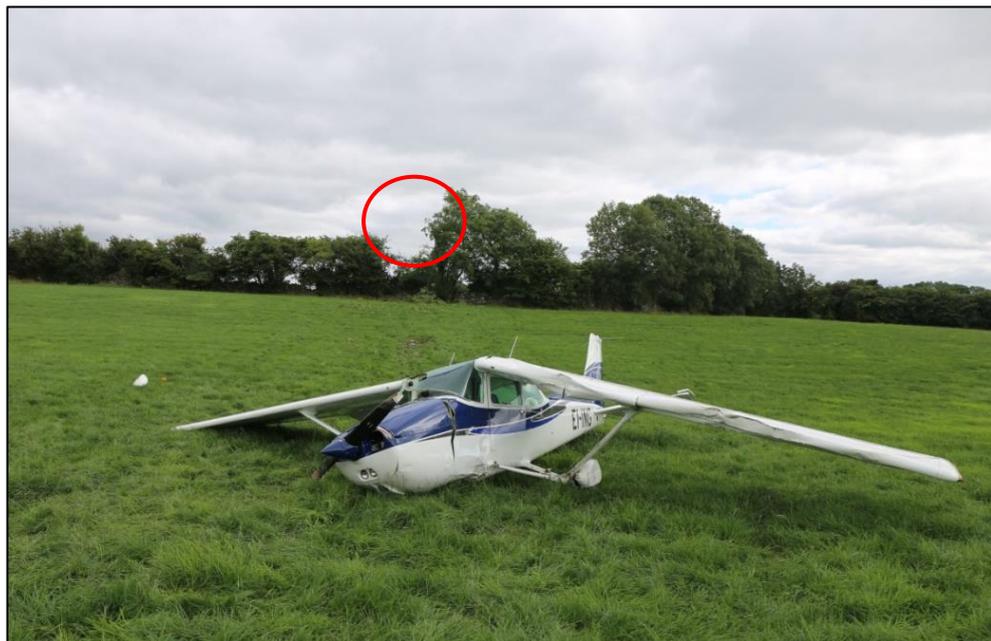
The aircraft landed long and bounced before touching down again. The Pilot noticed a stone wall just beyond the end of the runway at the airfield boundary and realised that the aircraft was not going to stop safely in the distance remaining. He immediately applied full power and the aircraft took-off again, marginally clearing the 1.7 m high stone wall. The aircraft climbed briefly and travelled over the field immediately beyond the boundary wall, but then sank, drifted left, and struck a tree situated in a line of trees at the far boundary of the field. The aircraft impacted the ground in the next field, and travelled for approximately 30 m before coming to rest (**Photo No. 1**). The three occupants evacuated the aircraft with some difficulty and were brought to hospital by the emergency services, for assessment. There was no fire.

Photo No. 1: Final resting position of EI-ING (area of impact with tree circled)

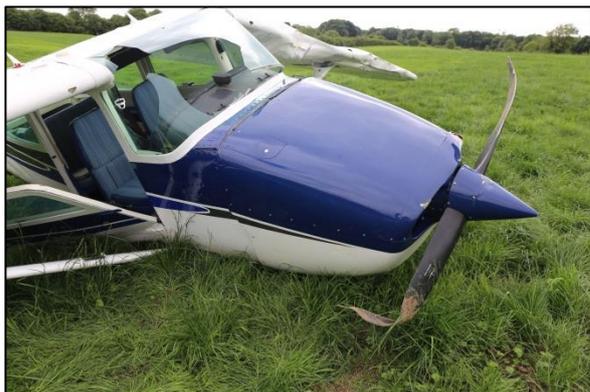
The aircraft was damaged beyond economic repair. The aircraft wreckage remained upright, lying on its fuselage, left main wheel and right wingtip. No significant deformation of the aircraft cabin was evident. The left wing was angled downwards from the root and exhibited impact damage to its leading edge. Both propeller blades sustained bending damage, there was damage to the engine cowlings and engine mounting points, the forward windscreen was broken at its right-hand side, and the upper hinge of the access door on the right side of the fuselage was found broken away from its hinges (**Photo No. 2**). The right horizontal stabiliser sustained substantial impact damage to the inboard section of its leading edge (**Photo No. 3**).

Photo No. 2: Damage to propeller blades; engine cowling and mounting points; windscreen; and right-hand access door

The damage to the aircraft's windscreen and to the leading edge of the left wing and right horizontal stabiliser is consistent with impact with a tree. The Pilot said that following the impact with the tree, he tried to keep the wings of the aircraft level and make a landing. The aircraft made contact with the ground but continued to travel on the grass surface. These factors likely resulted in the aircraft's energy being absorbed gradually, and notwithstanding that Passenger No. 2, who was seated in the rear reported that his feet were initially trapped, no significant deformation of the aircraft cabin was evident. The two cockpit seats were fitted with three-point restraint harnesses and lap belts were installed in the rear seats. The Pilot ensured that the harnesses were fastened before the flight and the Pilot and passengers remained restrained in their seats throughout the impact sequence. There was no post-crash fire and all occupants were able to evacuate the aircraft, albeit with some difficulty; the door on the Pilot's side of the aircraft was jammed and the passenger door required to be kicked open to allow egress, which likely resulted in the detachment of the door's upper hinge.

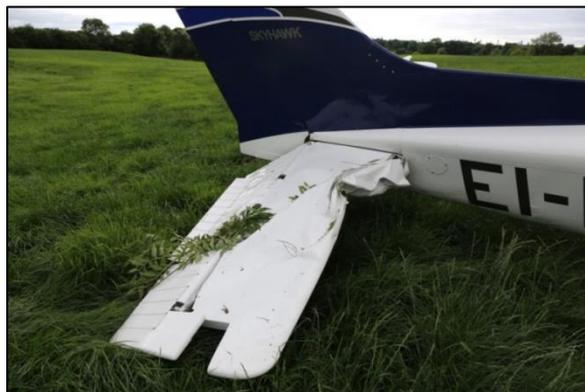
Photo No. 3: Impact damage to right horizontal stabiliser

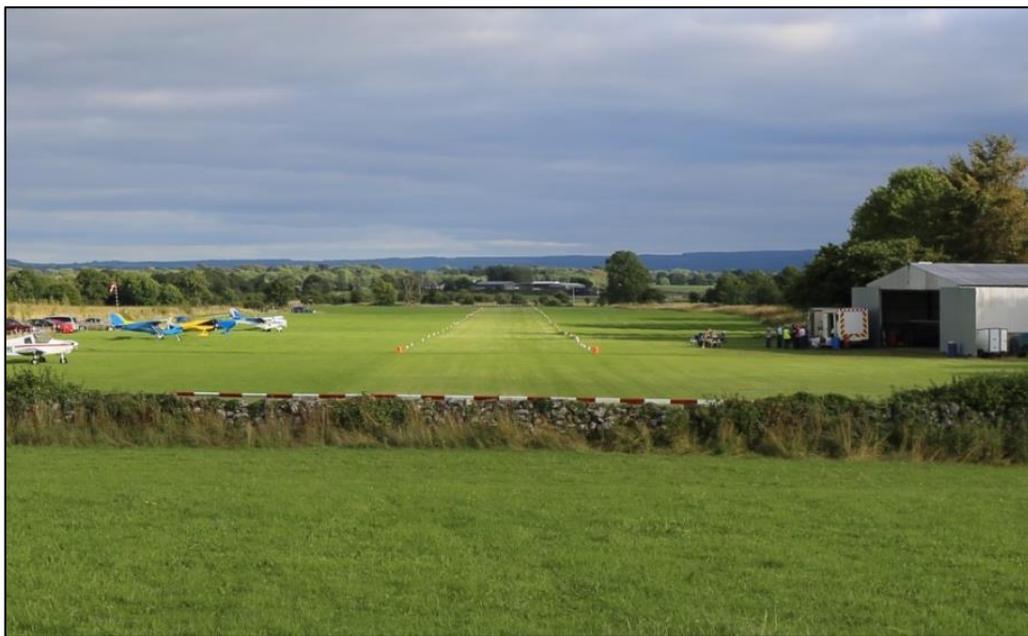
The runway surface was level and the grass was short and dry. The distance from the boundary wall at the threshold of RWY 34 to the red markers placed adjacent the end of the runway, was 530 m. There was approximately a further 90 m of runway surface between the red markers and the boundary wall at the end of RWY 34.

Photo No. 4: View of the runway at Craughwell Airfield opposite to direction of landing (boundary wall approximately 90 m from marked end of RWY 34 is visible in the foreground)

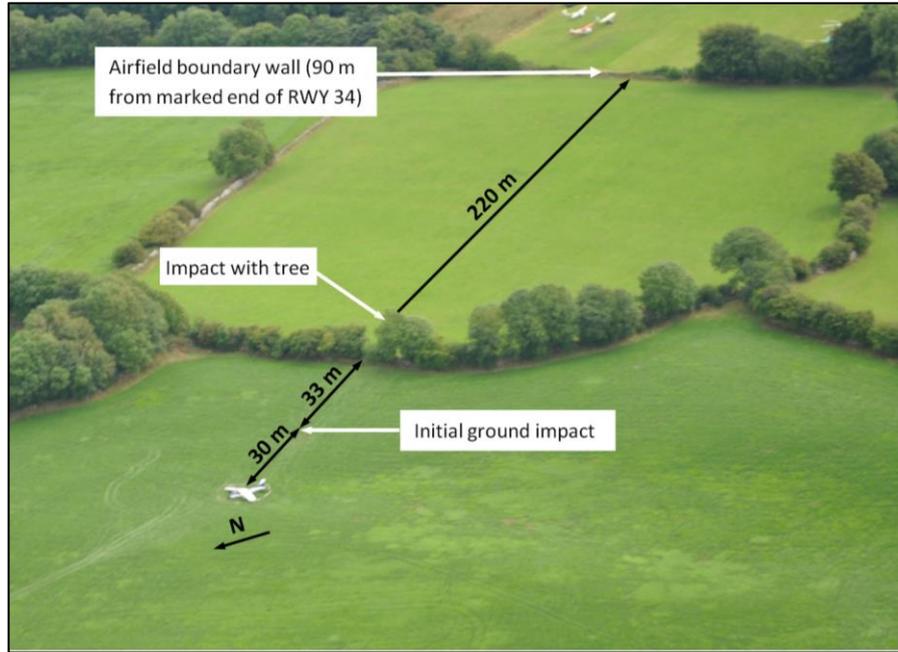
The Investigation's site survey indicated that following the rejected landing¹³, the aircraft struck a tree situated in a line of trees at the far boundary of the 220 m-long field that was immediately beyond the airfield boundary (**Photo No. 5**). The tree that was struck was located slightly to the left of the extended centreline of the runway. Debris from the tree extended for 20 m into the next field. The aircraft impacted the ground at a distance of approximately 33 m from the line of trees. Ground marks show that the aircraft then continued along the grass surface for a further 30 m approximately, resulting in the detachment of the nose landing gear and the right main undercarriage assembly, before the aircraft came to rest on a heading of 360° (N). Acrylic window fragments were also present in the wreckage trail.

Photo No. 5: Aerial image showing location of impact points and aircraft's final resting position (image used with permission of photographer)
