Air Accident Investigation Unit Ireland

FACTUAL REPORT

**BRM, Land Africa (Citius), EI-FBY
Ballyheelan, Co. Cavan**

21 April 2021

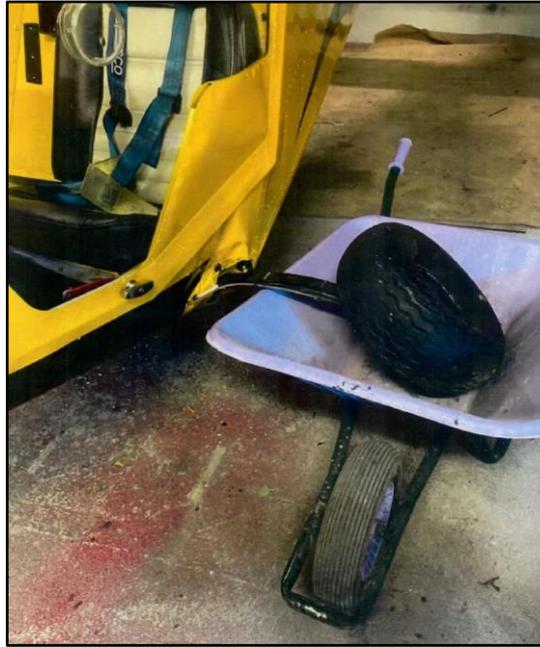
No photographs were available of the aircraft prior to its removal from the airfield following the occurrence. When the Investigation inspected the aircraft, it was found that the left undercarriage leg was distorted and had rotated upwards about a point on the undercarriage crossbeam inboard of the left leg attachment point. This rotation of the leg had caused bending and cracking of the crossbeam and buckling of the fuselage skin in the vicinity of the attachment point (**Photo No. 2** and **Photo No. 3**).

Photo No. 2: Damage to left landing gear

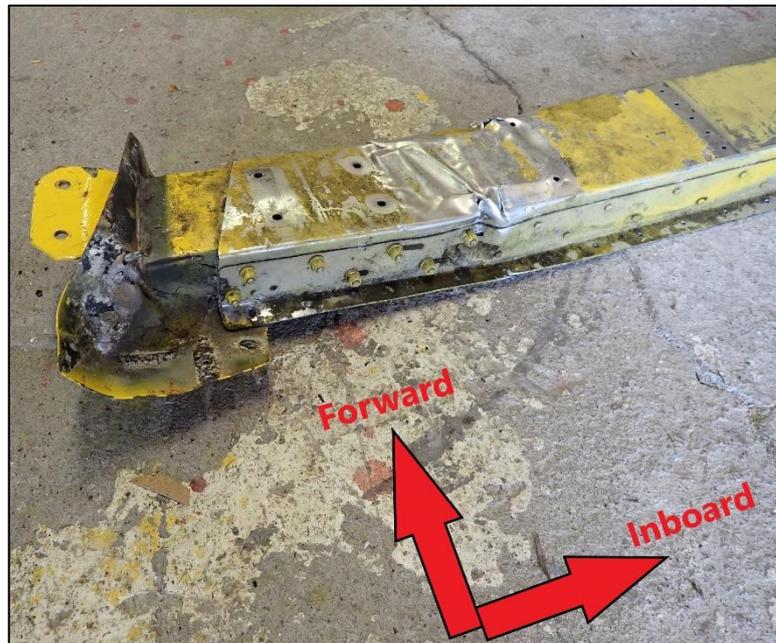
Photo No. 3: Damage to undercarriage crossbeam

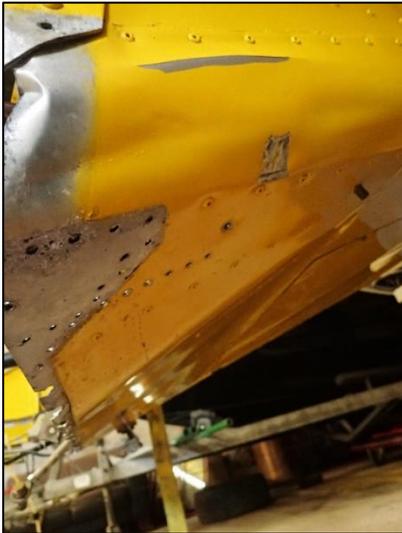
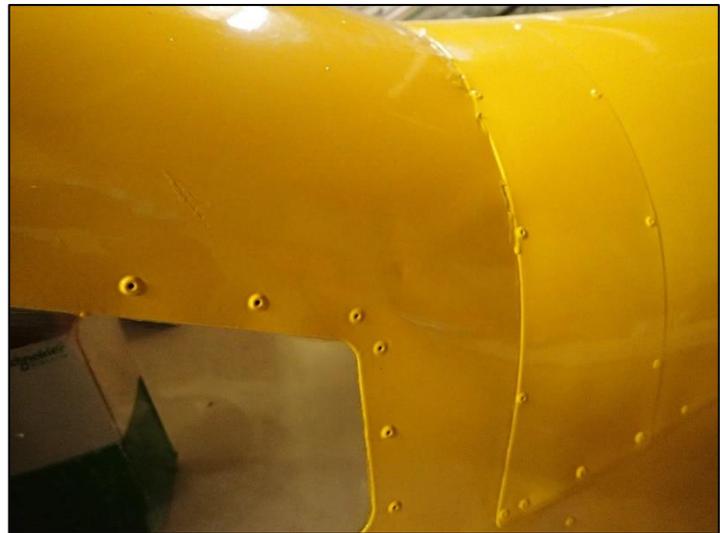
In addition to the buckling of the fuselage in the vicinity of the left undercarriage attachment point, further wrinkling of the skin was also identified, which extended along the left side of the fuselage (**Photo No. 4** and **Photo No. 5**).

Photo No. 4 and **Photo No. 5**: Wrinkling of aircraft skin

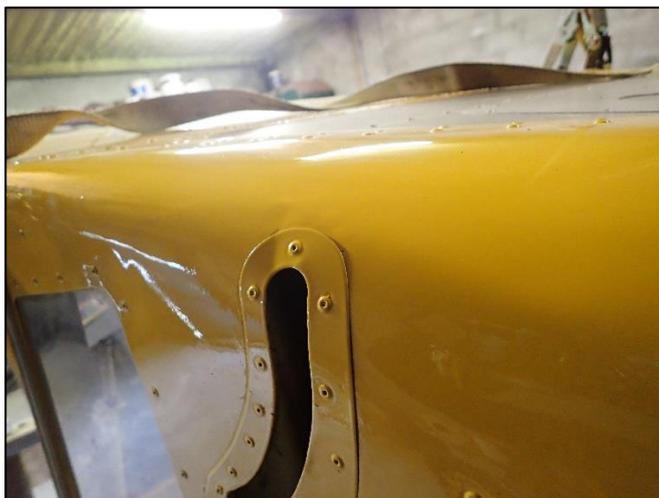
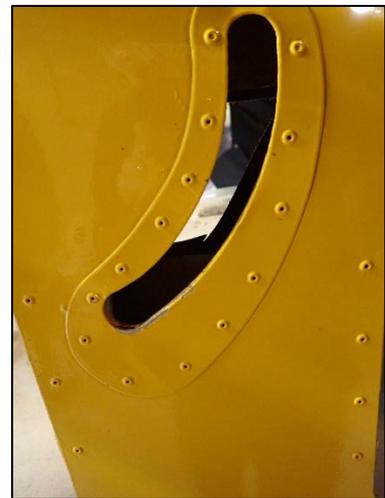
The reinforced slot on the left side of the fuselage behind the cockpit, that accommodated the actuating mechanism for the aircraft's flaperons⁹, had wrinkle damage at the top and impact damage to the paintwork at the bottom of the slot (**Photo No. 6** and **Photo No. 7**).

Photo No. 6 and **Photo No. 7**: Damage to reinforced slot for flaperon mechanism

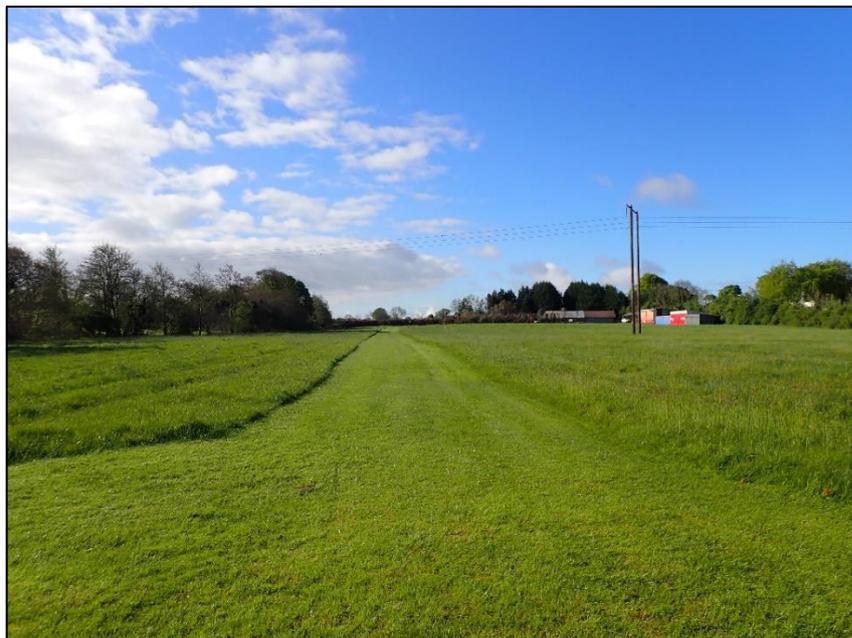
Ballyheelan is a private, unlicensed airfield located approximately 6.5 nautical miles west of Ballyjamesduff, Co Cavan at an approximate elevation of 279 feet (ft) AMSL¹¹. The runway in use was RWY 17, which had a grass surface approximately 325 metres (m) long, on a magnetic bearing of 171°. A view from the threshold along RWY 17 is shown in **Photo No. 8**.

Photo No. 8: RWY 17 at Ballyheelan Airfield

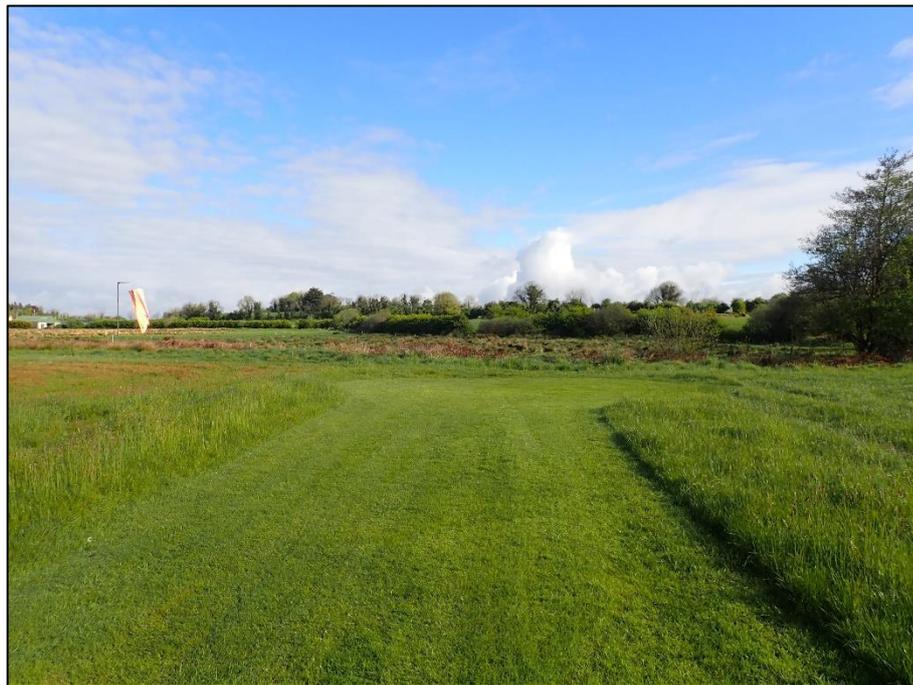
The threshold and approach area of RWY 17 are shown in **Photo No. 9**. The area immediately prior to the threshold of RWY 17 consisted of hedgerows and scrubland. More substantial trees were situated to the east of the approach and threshold. A wind direction indicator (windsock) was situated to the west of the threshold. The hedgerow defining the eastern boundary of the airfield was approximately 30 m east of the RWY 17 centre line in the vicinity of the threshold.

Photo No. 9: The approach area for RWY 17

During the approach to land on RWY 17 at Ballyheelan Airfield, the Pilot experienced a gusting crosswind from the east. The terrain in the general vicinity of the airfield was undulating and a hedgerow with trees lay to the east of the approach and runway. The conditions were conducive to wind shear. Microlight aircraft, due to their low mass and low operating speeds, have low momentum and therefore are more easily affected by strong winds (especially crosswinds), turbulence and terrain influences. The Pilot's description of the occurrence indicates a probable windshear encounter at a low height above the runway from which he was unable to prevent a hard landing.
