# **Air Accident Investigation Unit Ireland**

**FACTUAL REPORT**

**ROBIN HR200-100, D-EIIL**

**Dowth Hall Airstrip, Co. Meath**

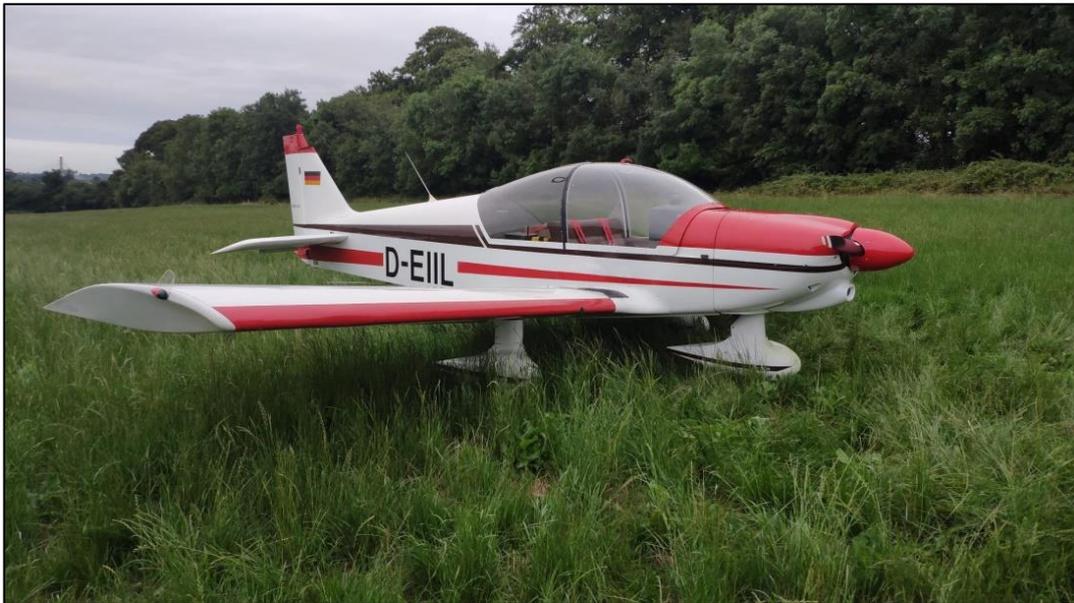
During a landing at a private airstrip at Dowth Hall, the aircraft touched down hard and bounced, before touching down again. The nose landing gear was damaged during the landing, which caused the aircraft to veer to the left, and depart the side of the runway. The two occupants were uninjured and exited the aircraft normally. There was no fire.

**Photo No. 1:** Final position of the aircraft (*courtesy of the Pilot*)

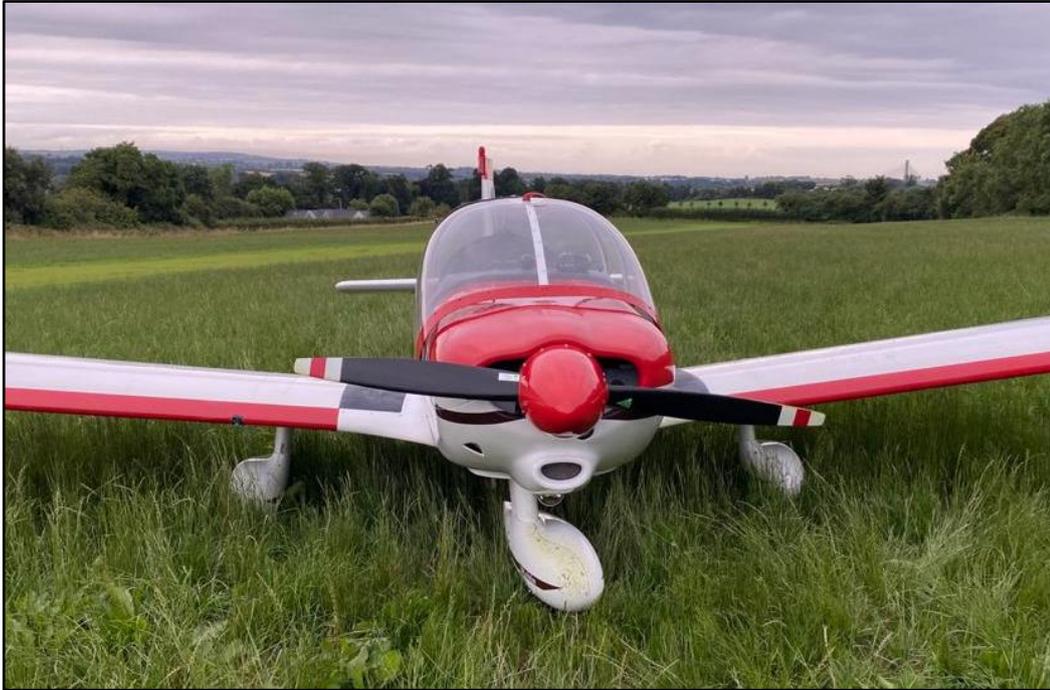
The aircraft's nose landing gear sustained substantial damage. Damage to the nose landing gear steering linkage resulted in the nose landing gear pointing approximately 25° left of the longitudinal axis of the aircraft (**Photo No. 2**).

**Photo No. 2:** Photo showing distortion to nose landing gear (*courtesy of the Pilot*)

The nose landing gear leg was distorted approximately 6° to the left of its normal vertical orientation. In addition, the throttle linkage to the engine carburettor is routed close to parts of the nose landing gear assembly.

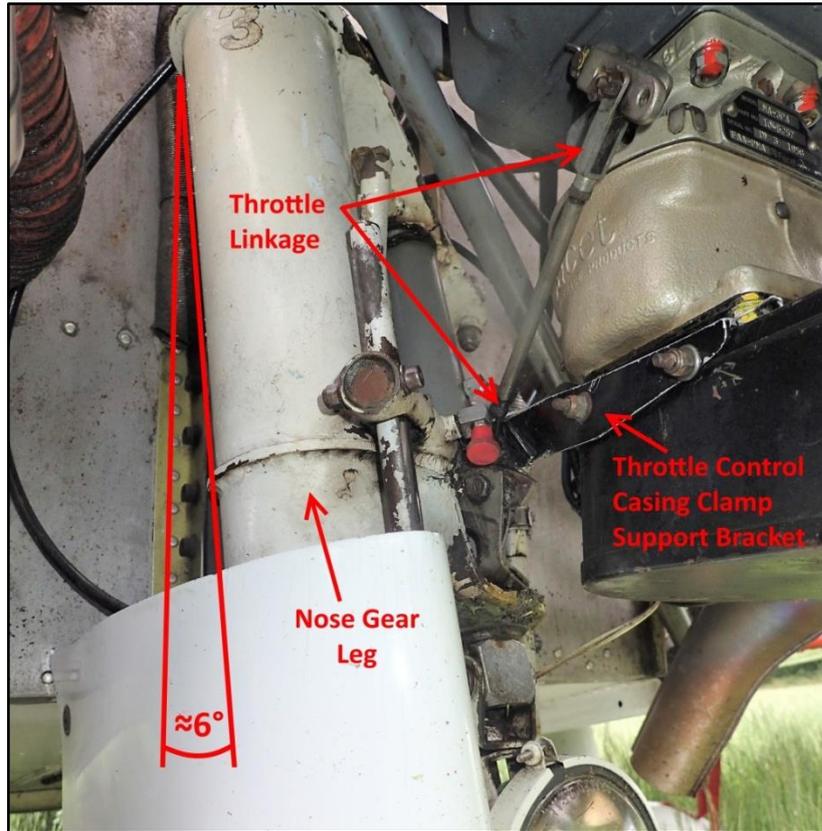
Due to the distortion of the nose landing gear leg, the throttle linkage became damaged and partially trapped against the throttle control casing clamp support bracket, **Photo No. 3**.

Photo No. 3: View showing distortion of nose landing gear assembly

The damage to the nose landing gear, and the ground impact marks where the aircraft made its initial contact during landing at Dowth Hall, indicate that the aircraft touched down hard, with a pronounced nose-down attitude. The Pilot noted that he '*probably commenced the flare too early*'. Although the Instructor called for a go-around, it was likely that there was insufficient height above the runway for the Pilot to react. The Instructor considered that a stall occurred once the engine power was removed and the aircraft was pitched up. Following the hard impact, damage to the nose-gear caused the aircraft to turn left as it continued the landing roll. In addition, the throttle became jammed in a partially open position due to distortion of the nose-gear leg against the throttle control casing clamp support bracket, both of which contributed to the aircraft departing the side of the runway.

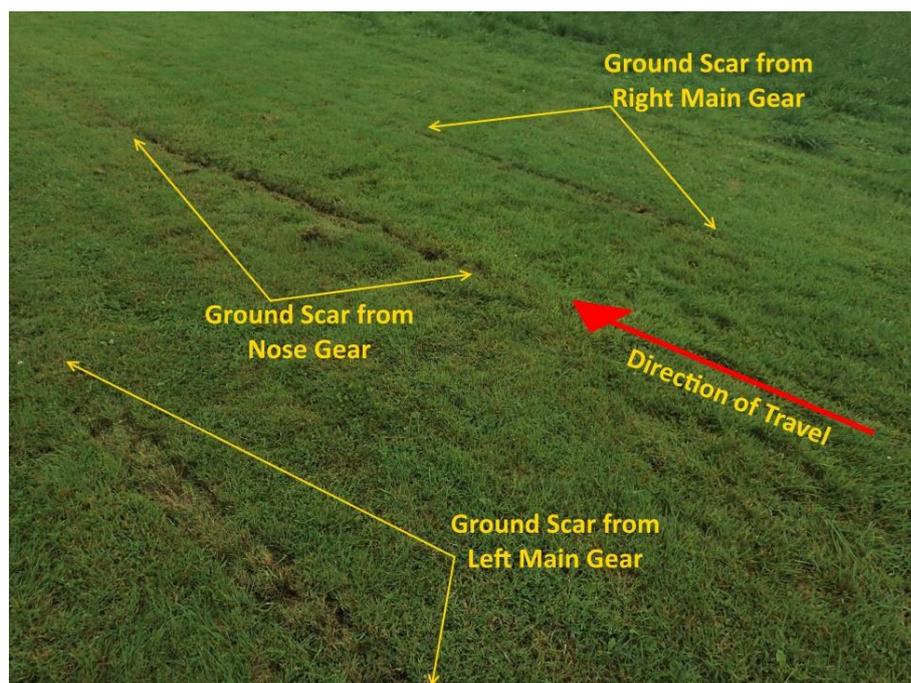
The Investigation carried out an inspection of the runway surface from the start of RWY 25, to the point at which the aircraft came to rest. Ground scars on the grass runway surface, 86 m from the boundary hedge at the beginning of RWY 25, indicated where the aircraft first touched down during the landing (**Photo No. 4**).

Photo No. 4: Ground Scars at Initial Touch-down Point on RWY 25

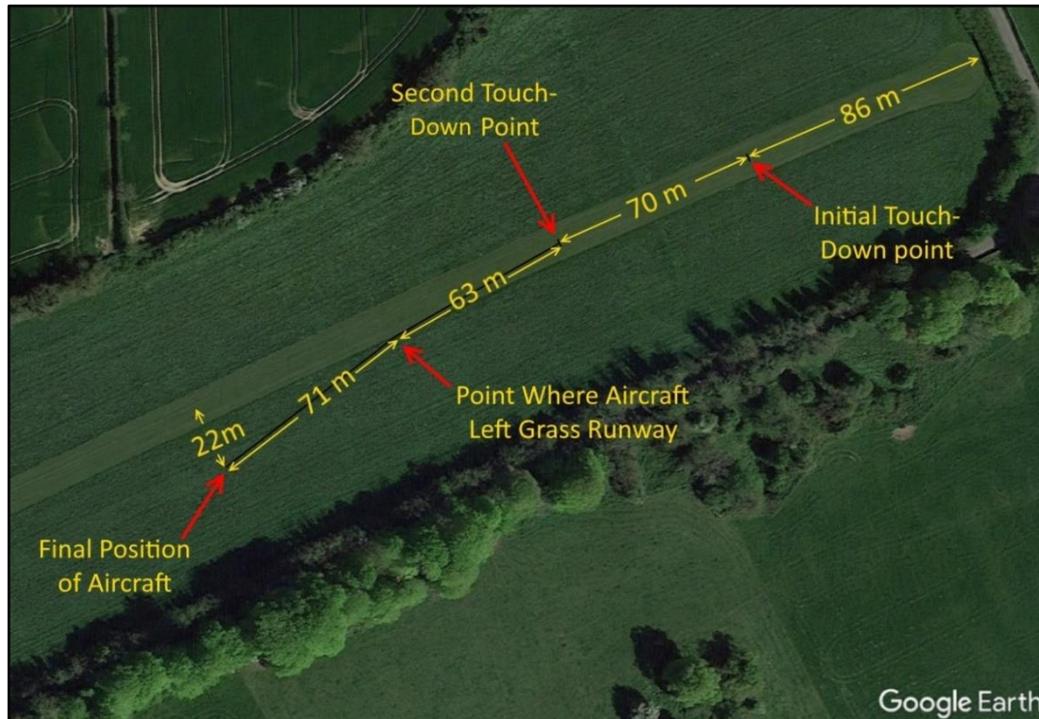
Following the initial touch-down, there were no marks or tracks on the runway until approximately 70 m further along the runway, where there was a second set of wheel marks from all three of the aircraft's wheels. From this point, the wheel marks continue until the final resting position of the aircraft, approximately 290 m from the beginning of the runway, and 204 m from the initial touchdown point (**Figure No. 2**).

**Figure No. 2:** Plot of site survey measurements

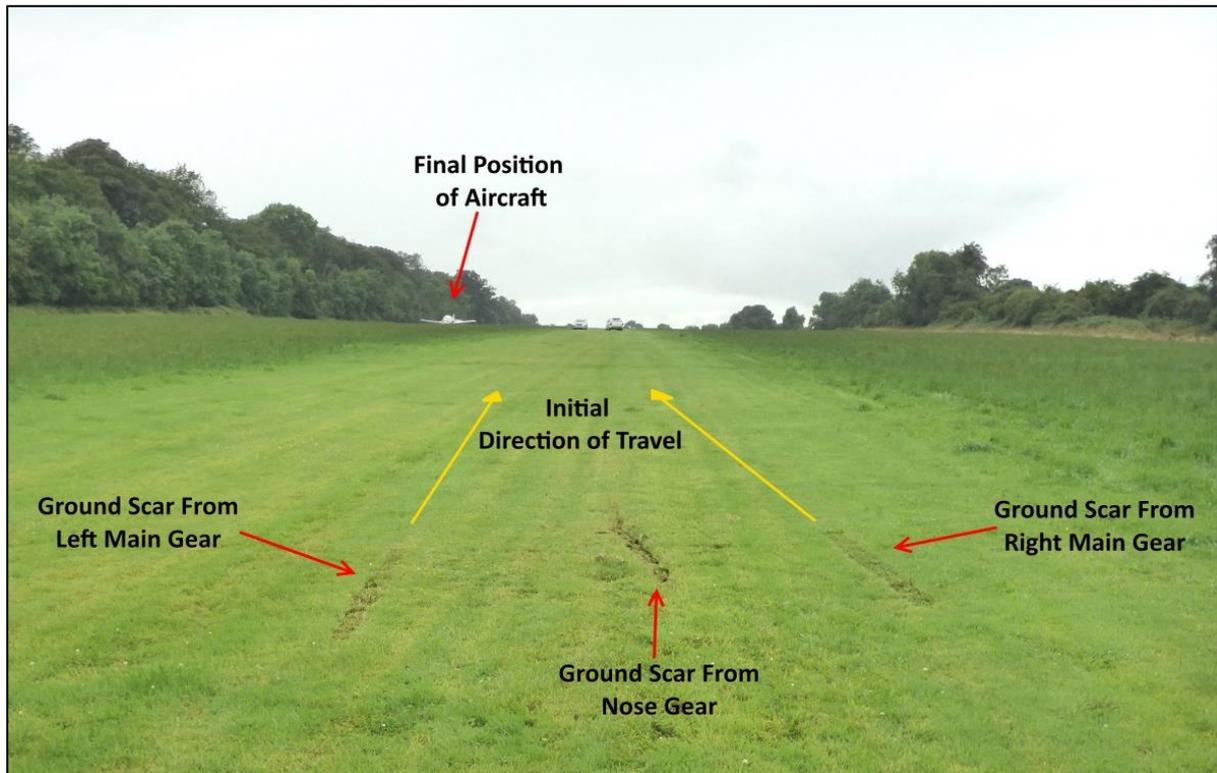
Dowth Hall is a private airstrip located in county Meath. It has one grass runway – RWY 07/25 (**Photo No. 5**). The runway length is approximately 1,000 m long. The runway width was measured and found to be approximately 12 m.

**Photo No. 5:** View along RWY 25 at Dowth Hall airstrip showing Ground Scars from Aircraft Landing Gear at Initial Touchdown point

RWY 25 at Dowth Hall has an upslope which varies along its length. Using survey data for the area, including the runway, the Investigation determined the runway slope to be as follows:

- First third 3.7% (2.1° upslope)
- Mid third 2.0%
- Last third 0.7%
