Air Accident Investigation Unit Ireland

FACTUAL REPORT

**ATEC v.o.s., Zephyr 2000, EI-DGV
Near Athenry, Co. Galway**

AAIU Report No: 2022-005

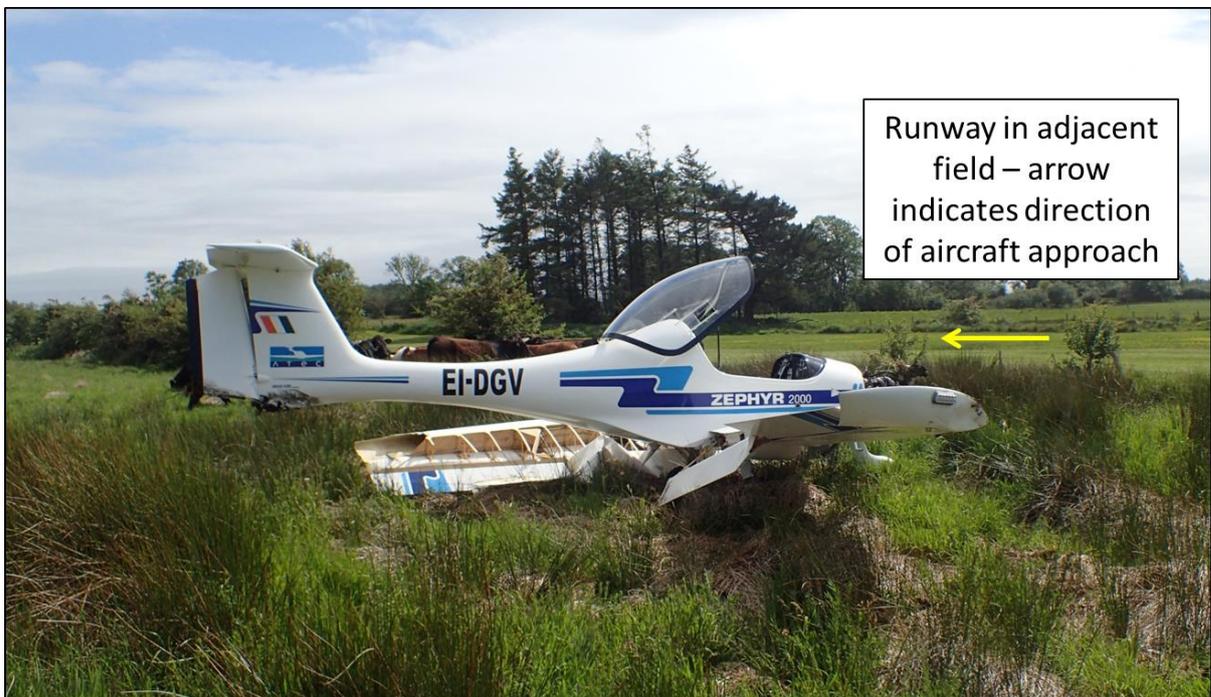
The left wing of the aircraft was broken at approximately one third of its span. The inboard flap of the right wing had partially separated from the wing and the wing tip was cracked. The lower section of the rudder sustained buckling and tearing damage. The engine casing was cracked and the engine mounting frame was broken. The engine firewall was ruptured. One propeller blade was broken at approximately one third of its length from the blade hub.

Photo No. 1: Final position of aircraft
