Air Accident Investigation Unit Ireland

SYNOPTIC REPORT

**Thruster, T600N-450, EI-GOE
Woolengrange, Co. Kilkenny**

AAIU Report No: 2022 - 007

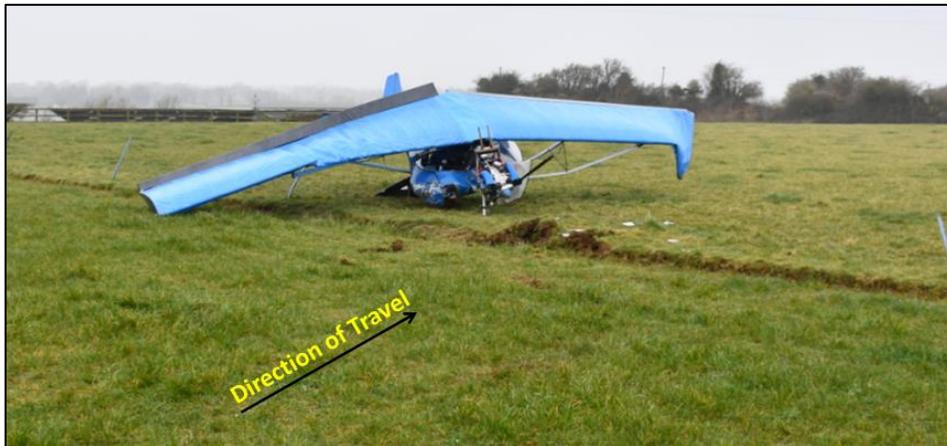
Photo No. 1: Final position of EI-GOE

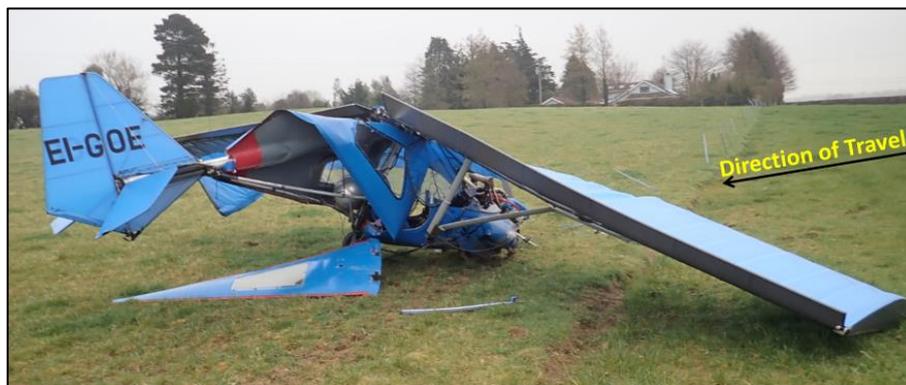
The aircraft sustained significant damage during the impact sequence and was destroyed. There was significant structural damage to the cockpit and main fuselage area. Both doors remained attached to their respective hinges but were unlatched due to the distortion of the fuselage. The nose undercarriage had collapsed.

The engine and propeller nosecone displayed impact marks, one of the propeller blades was broken, and the engine was likely shock loaded. The left wing was buckled and broken rearwards and displayed evidence of ground impact at the wing tip area. The right wing leading edge tube was broken at the midpoint area. The wing struts and associated jury struts⁷ on both wings were found buckled. The main undercarriage, which is of tubular steel construction, was fractured in a number of areas and exhibited significant splaying on both sides. **Photo No. 2** shows the final position of the aircraft adjacent to the line of raised ground where it came to rest.

Photo No. 2: Final resting position of EI-GOE and damage sustained

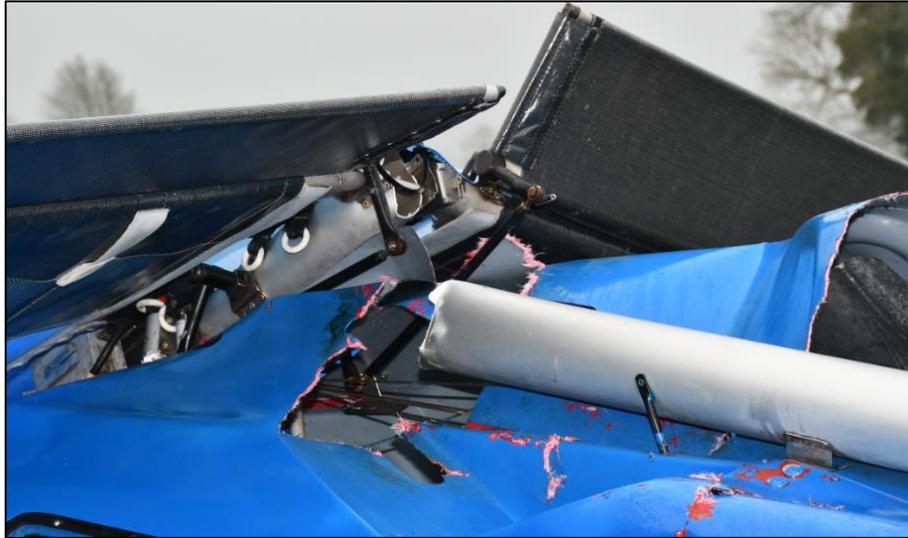
The aircraft's central keel tube, which forms the central spine of the aircraft, was fractured at the junction of the wing rear attachment point as shown in **Photo No. 3**.

Photo No. 3: Fractured central keel tube
