# **Air Accident Investigation Unit Ireland**

**SYNOPTIC REPORT**

**Piper PA23-250F, EI-WMN  
Shannon Airport**

**2 December 2019**

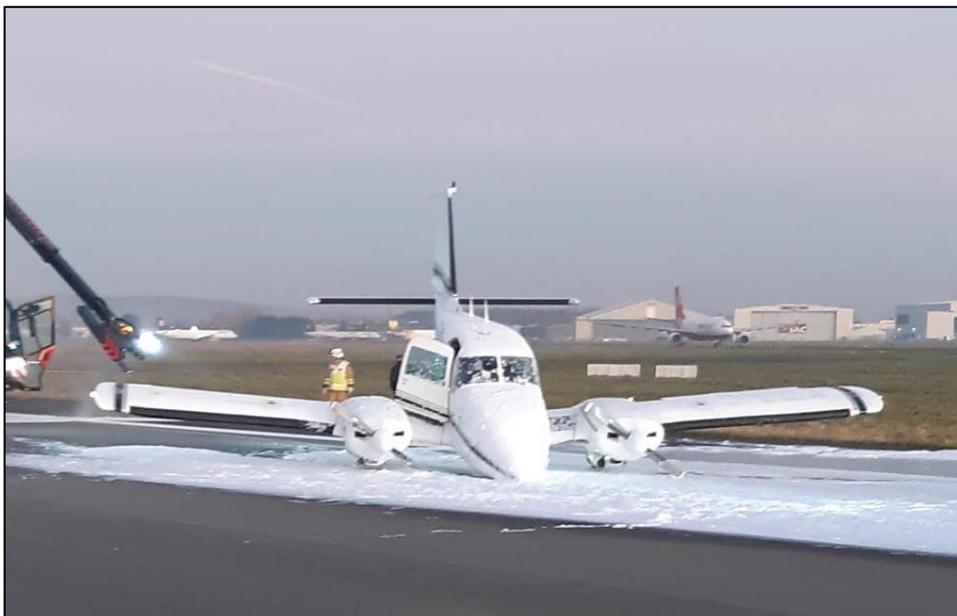
The Pilot stated that as the aircraft was crossing the runway threshold, at a speed of approximately 95 knots (kts) and with the flaps extended, he reduced the engine power for landing. He said the aircraft's red landing gear warning light illuminated and the aural alert sounded, indicating that all landing gears were not down and correctly locked. The Pilot reported that at that stage the aircraft's main wheels were on the runway and that it was 'too late to go around' (i.e. abort the landing). The Pilot said that he felt the nose landing gear collapsing and that he tried to keep the nose up by pulling back on the aircraft's control column. The nose of the aircraft dropped and the propellers struck the runway. The aircraft came to rest on the left side of the runway at approximately 16.24 hrs (**Photo No. 1**). The Pilot, who was the sole occupant, was uninjured and exited the aircraft normally. There was no fire. The Airport Fire and Rescue Service attended the scene, and as a precaution, covered the aircraft and the adjacent runway surface in a blanket of fire-retardant foam.

**Photo No. 1:** Final resting position of aircraft (*Shannon Airport Fire and Rescue Service*)

The tips of both propellers were bent rearwards and the lower surface of the aircraft's nose section sustained abrasion damage. In addition, both engines sustained shock loading. The subsequent repairs to the aircraft were delayed due to the Covid-19 pandemic, and the aircraft did not return to service following the occurrence until November 2021.

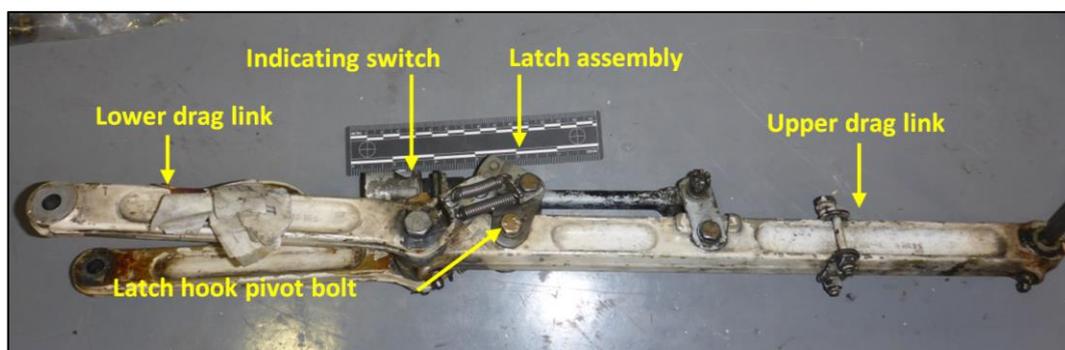
The nose landing gear drag link assembly, to which the down-lock latch assembly and nose landing gear down indicating switch are fitted, was removed from the aircraft for further examination (**Photo No. 2**).

**Photo No. 2:** Nose landing gear down-lock latch and drag link assembly

During further examination of the drag links and down-lock latch assembly, significant free play was found in the latch hook pivot. In addition, damage was noted on the upper drag link, which appeared to have been caused by contact with the latch assembly when it was in the unlatched position. When the pivot bolt (circled in red in **Figure No. 5**) was removed to identify the cause of the free play, it was noted that the machined hole in the upper drag link was larger than the diameter of the bolt. The Investigation notes that it would be difficult to identify this free play when the drag link assembly, down-lock latch assembly, and associated springs are installed on the aircraft.

During the Investigation's post-occurrence examination of the aircraft, it was identified that the machined hole in the upper drag link was larger than the diameter of the latch hook pivot bolt. This resulted in significant free play in the latch hook pivot. Subsequent investigation found that the upper drag link fitted was for an older serial number aircraft, and had a larger diameter hole than the correct drag link. Maintenance records indicate that the drag link assembly was not removed during the maintenance visit conducted prior to the flight from EINN to EIKY. The Operator reviewed the technical records for the aircraft but it could not be determined when the incorrect assembly had been installed.

The damage noted on the upper drag link was likely as a result of the free play, which may have permitted the latch hook to move beyond its designed limit when unlocked, allowing it to make contact with the upper drag link.

11. Significant free play was found in the nose landing gear down-lock latch hook pivot.
12. System testing identified that when the landing gear selector lever was selected to the DOWN (extend) position, the pressure in the down line was not maintained in accordance with Service Manual limits.

Subsequent investigation found that the upper drag link fitted was for an older serial number aircraft, and had a larger diameter hole than the correct drag link. Maintenance records indicate that the drag link assembly was not removed during the maintenance visit conducted prior to the flight from EINN to EIKY. The Operator reviewed the technical records for the aircraft but it could not be determined when the incorrect assembly had been installed. Subsequent to the occurrence, the entire nose landing gear drag link assembly and the down-lock latch assembly were replaced.

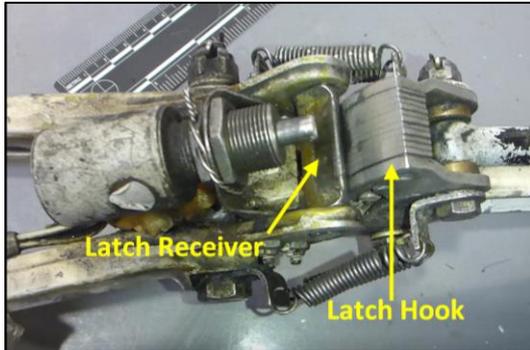
**Photo No. 3:** Latch assembly with latch receiver in contact with latch hook, prior to locking

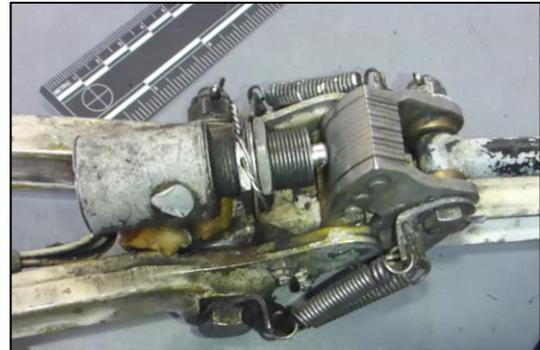
**Photo No. 4:** Latch assembly in fully locked position

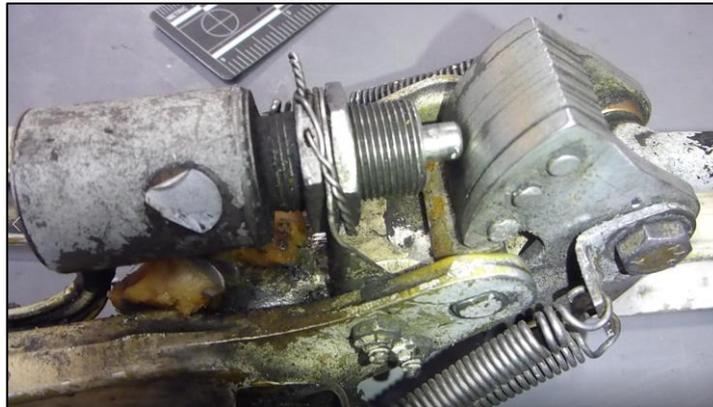
During examination of the switch operation, with the drag link assembly removed from the aircraft, it was found that when the latch hook was manually pulled back towards the unlocked position, the indicating switch could be heard to open before the latch was fully unlocked and could be heard to close before the latch was in the fully locked position (**Photo No. 5**).

**Photo No. 5:** Latch at switch actuation position

It is also possible that during the extend cycle, the nose landing gear down-lock latch reached a position where it was just actuating the switch but had not yet reached the fully locked position (**Photo No. 5**). Such a position could cause the indication light to be on, off or to flicker. During the approach to EIKY, the latch appears to have eventually reached a position whereby it caused the indication light to come on steady and the nose landing gear to lock in the DOWN (extend) position, as evidenced by the normal landing. However, the collapse of the nose landing gear on landing at EINN indicates that the latch must have been unlocked.

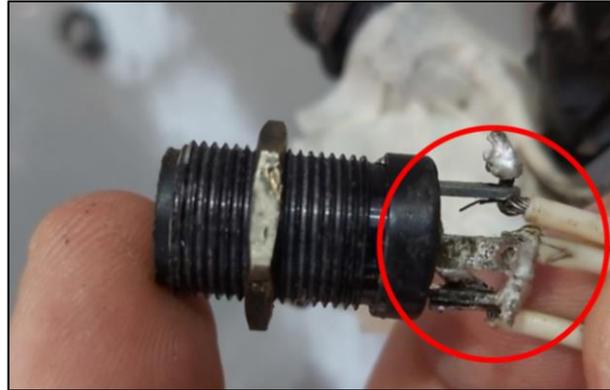
The Operator's maintenance personnel also removed the nose landing gear down indication light assembly from the panel in the cockpit pedestal and noted that the soldered joints between the electrical wiring and the bulb fitting were in poor condition (**Photo No. 6**). It could not be established when these connections had been soldered/repared.

**Photo No. 6:** Condition of soldered joints (circled) at nose landing gear indication light fitting

In addition, the soldered joints between the electrical wiring and the nose landing gear down indication light fitting were found to be in poor condition during post-occurrence inspection. This could result in the nose landing gear down indication light flickering when the light is powered, i.e. when the nose landing gear is down. Therefore, the Investigation considered if this could also have been a factor in the occurrence.

The condition of the soldered joints at the nose landing gear down indication fitting was not in keeping with normal aviation standards and had the potential to cause the indication light to flicker when the light was powered, i.e. when the nose landing gear latch assembly had actuated the switch. Therefore, the possibility that the reported flickering of the nose landing gear down indication light on the previous flight (to EIKY) being solely due to a poor electrical connection at the light fitting cannot be ruled out. However, unlike the landing at EIKY, the nose landing gear was not locked in the down position prior to the landing at EINN on the occurrence flight, as evidenced by the collapse of the gear. Nevertheless, while the Investigation considers the condition of the soldered joints not to have been causal in the actual collapse of the gear, any erosion of the Pilot's confidence in the indication system could lead to appropriate responses following a flickering gear indication light, such as a go-around or a re-selection of the landing gear, not being carried out.

10. The soldered joints between the electrical wiring and the bulb fitting were found to be in poor condition when the nose landing gear down indication light assembly was removed from the aircraft following the occurrence.
