# Air Accident Investigation Unit Ireland

PRELIMINARY REPORT

Airwave Hang Glider/Mosquito Motor Harness  
Near Miltown Malbay, Co. Clare

18 September 2022

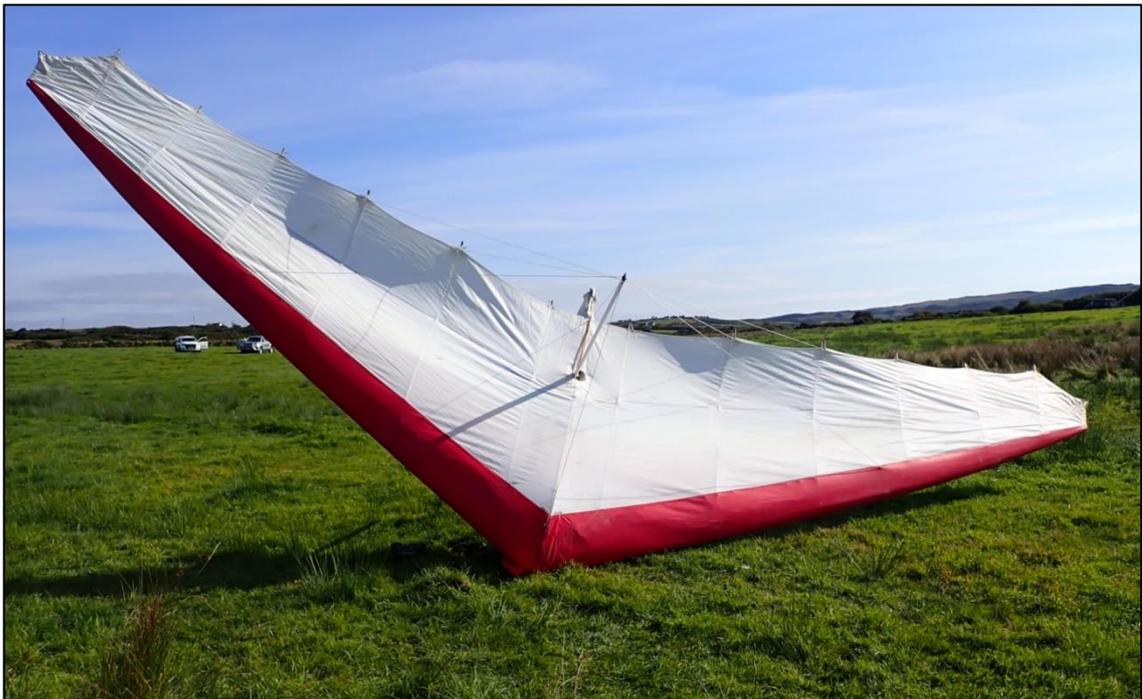
**Photo No. 1:** Accident site

The hang glider impacted terrain in an agricultural field close to Miltown Malbay, County Clare (**Photo No. 1**).
