Air Accident Investigation Unit Ireland

FACTUAL REPORT

**Reims Aviation SA, Cessna F172M, EI-DDC
Navan Airfield, Co. Meath**

4 March 2022

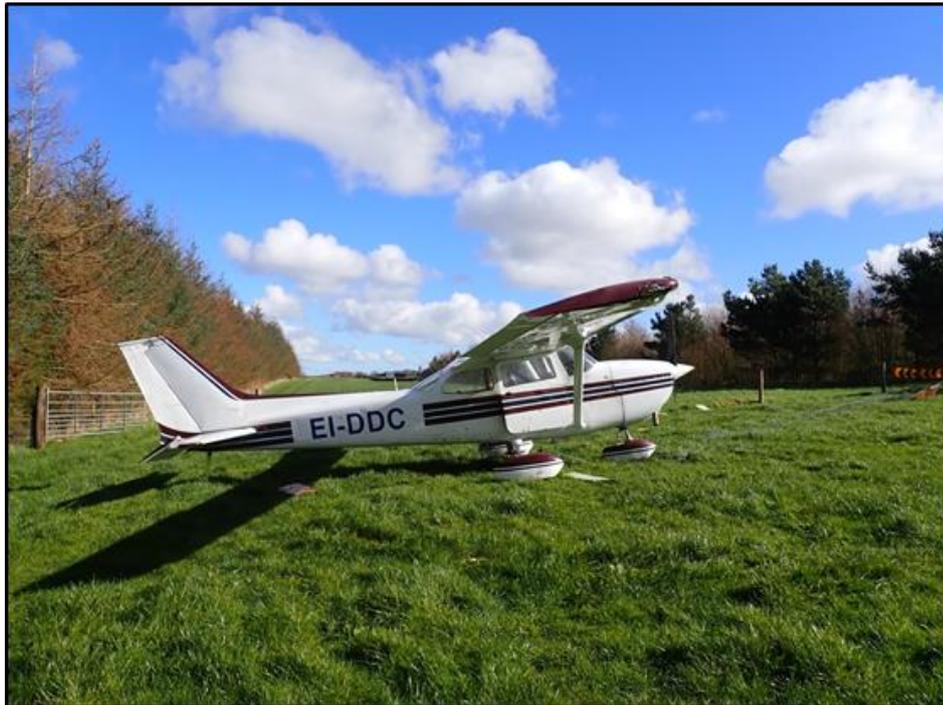
The Pilot reported that he advanced the throttle for take-off and as the airspeed increased, the aircraft eventually became airborne, but he felt that it was struggling to stay aloft, so he lowered the nose to *'get into ground effect'*⁵. The Pilot noticed that his airspeed was indicating only 40 knots and decided to land again. The Pilot stated that he *'pulled the throttle and put the plane back on the ground'*. The aircraft touched down and bounced before touching down again. The Pilot braked hard and the aircraft veered to the right and impacted with a perimeter fence at the end of the runway. The aircraft then slewed left before coming to rest in an adjacent field, on a magnetic heading of 180° (**Photo No. 1**). The Pilot who was the sole occupant of the aircraft, was uninjured. There was no fire.

Photo No. 1: Final position of EI-DDC

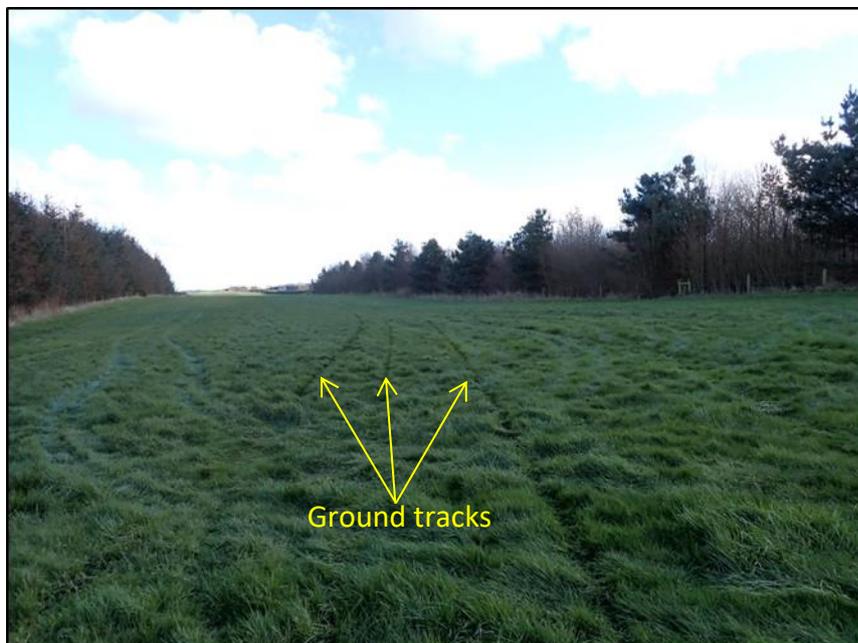
Photo No. 2: Ground tracks on RWY 27 (looking in the opposite direction to flight)

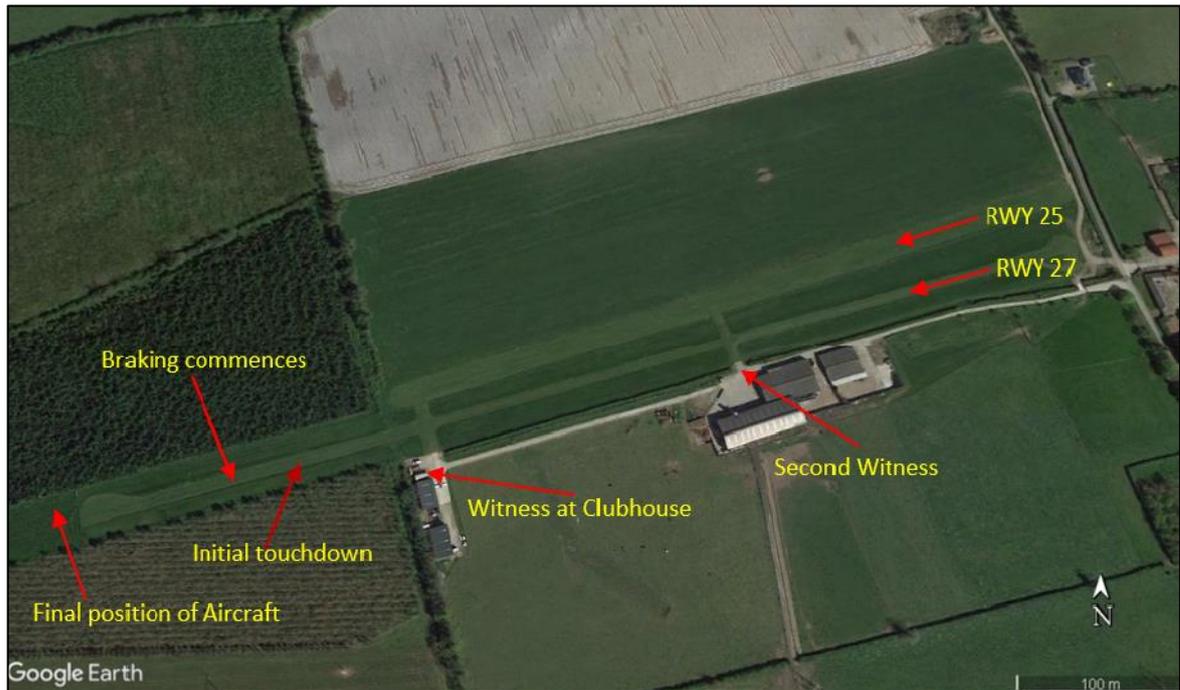
Figure No. 1: Witness locations

The Investigation interviewed two individuals who witnessed the event. The first witness, who was a qualified pilot, was in the club house (**Figure No. 1**) and observed the aircraft, stating that *'it was airborne far too early; the [aircraft] was hanging on the verge of the stall'*. This witness made the radio transmission described by the Pilot in his interview.

The second witness, also a qualified pilot, was located near some farm buildings. This witness informed the Investigation that he *'heard the aircraft developing full power ready for take-off'*. The witness then walked to an access point at the edge of RWY 27 because it took a little bit longer than usual for the aircraft to come into view.

This second witness stated that the aircraft passed him with a pronounced nose high attitude and at a reduced engine rpm. The witness estimated the height achieved by the aircraft during the flight was between 30 and 40 feet above ground before it touched down, became airborne and touched down again prior to impact with the perimeter fence.

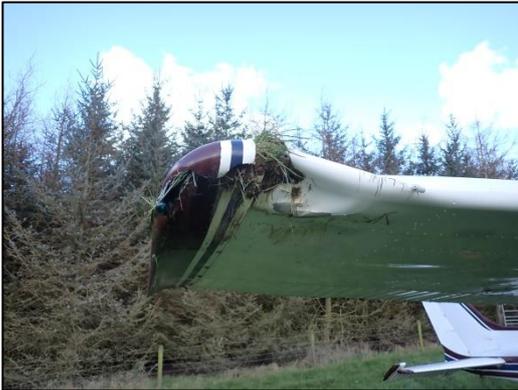
The right wingtip fairing was cracked, and mud and grass were present (**Photo No. 3**). A section of the wing's leading edge adjacent to the wing tip was deformed. Scratch marks were observed on one propeller blade and on the engine exhaust pipe (**Photo No. 4**). Wire from the perimeter fence had become entangled around the nose and left main landing gear with impact damage and scuff marks visible on the propeller spinner (**Photo No. 5**).

Photo No. 3 (left) and **Photo No. 4** (right): Damage to right wing tip and propeller blade

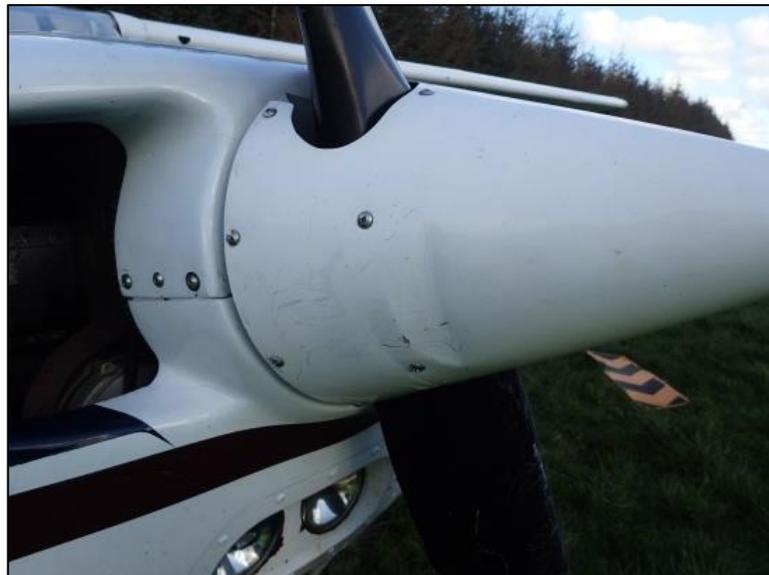
Photo No. 5: Damage to the propeller spinner

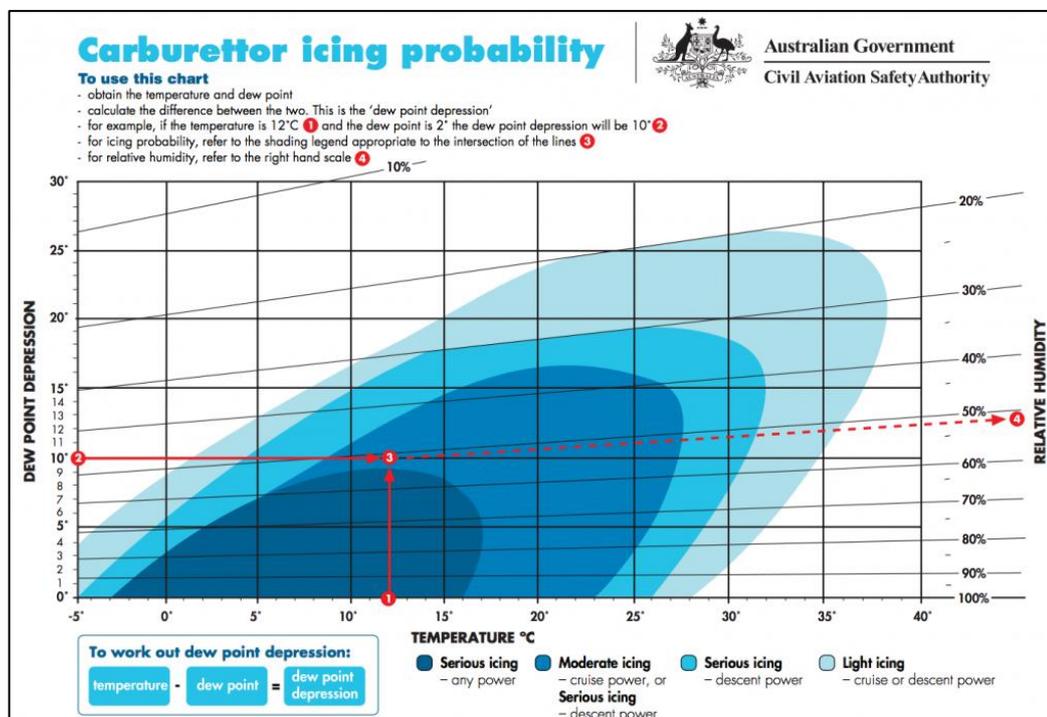
Figure No. 3: Icing chart (CASA)

Numerous charts have been produced indicating the probability of carburettor ice forming, depending on a variety of factors including temperature, dew point, relative humidity, and power settings. The following chart (**Figure No. 3**) was produced by the Australian Government's Civil Aviation Safety Authority (CASA). This chart uses the 'dew point depression', which is the ambient temperature minus the dew point. The estimated meteorological condition for Navan Airfield on the day of the accident gave a temperature of 3°C and a dew point of 1°C giving a dew point depression of 2°C which would give a probability of serious icing at any power setting.
