# **Air Accident Investigation Unit Ireland**

**FACTUAL REPORT**

**ICP Srl Savannah S, EI-GUZ  
Clonbullogue Airfield, Co. Offaly**

**14 August 2022**

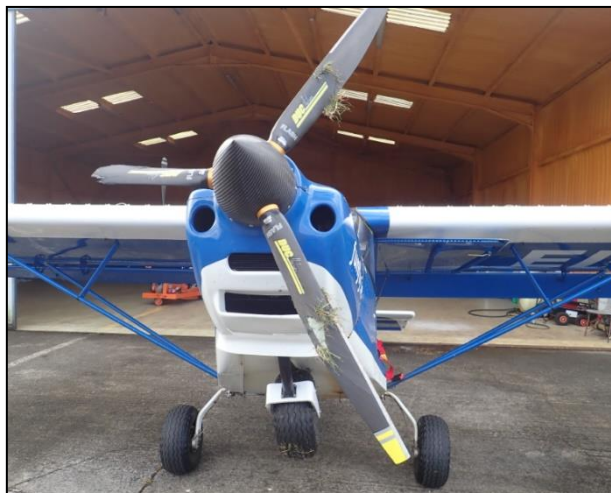
The nose landing gear had collapsed rearwards and all three propeller blades sustained significant damage. The collapsed nose landing gear caused some minor buckling of the lower fuselage panel and attachment fixtures below the cockpit area (**Photo No. 1**).

**Photo No. 1:** Damage sustained by EI-GUZ
