Air Accident Investigation Unit Ireland

SYNOPTIC REPORT

SERIOUS INCIDENT

**Boeing 737-800, EI-EMM
Dublin Airport**

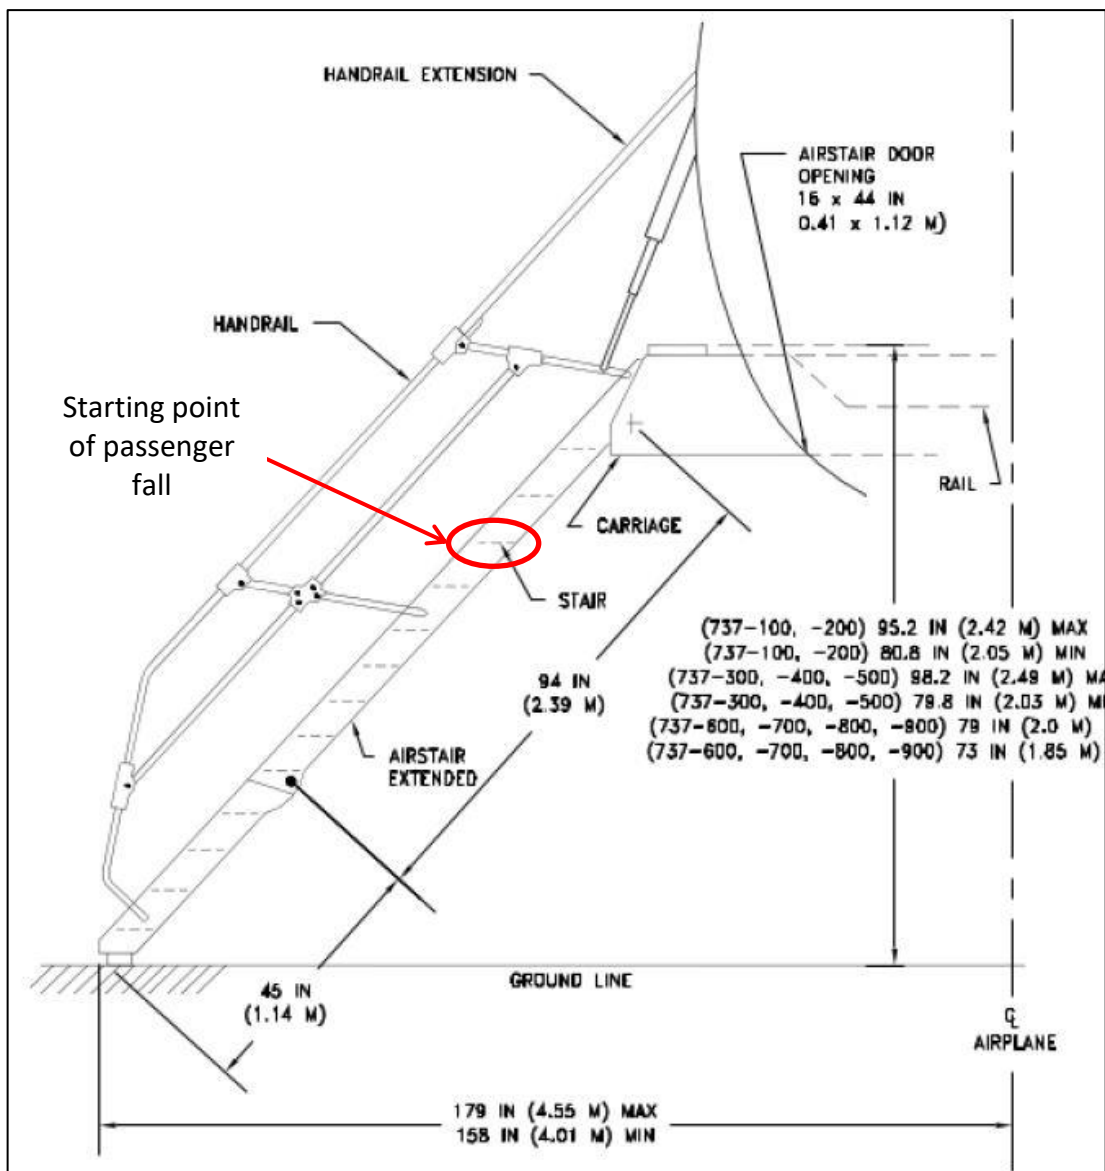
The Boeing 737-800 aircraft type has an integrated, retractable stairs known as an airstair installed at the front left exit (**Figure No. 1**), which was in use by the Operator for embarkation and disembarkation. The airstair is approximately 0.62 m wide and as such is narrower than the mobile stairs provided by ground handling agents at airports.

Figure No. 1: Aircraft Manufacturer's drawing of airstair looking forward (starting point of Passenger fall indicated by Investigation)

The CCTV footage showed that the Passenger stepped onto the top step with their left foot and then placed their right foot beside their left foot on the top step. They repeated this process when moving down to the second step. The Passenger then placed their left foot on to the third step and appeared to fall forwards as they tried to place their right foot onto the fourth step. The Passenger did not appear to stumble prior to falling. The Passenger's clothing did not appear to have caught on the handrails or any other part of the airstair. A second Passenger who was waiting on the ground close to the bottom of the airstair attempted to arrest the first Passenger's fall.

EASA undertakes a safety promotion campaign to highlight to passengers and crew, the behaviours which will minimise their personal risk of falling whilst embarking or disembarking an aircraft.
(IRLD2023001).
