TECHNICAL REPORT

A-013/2022

**Accident occurring on 3 March 2022
during disembarkation of a Boeing 737-
800 aircraft bearing the registration EI-
DHH, operated by RYANAIR, at Ibiza
Airport (Balearic Islands, Spain)**

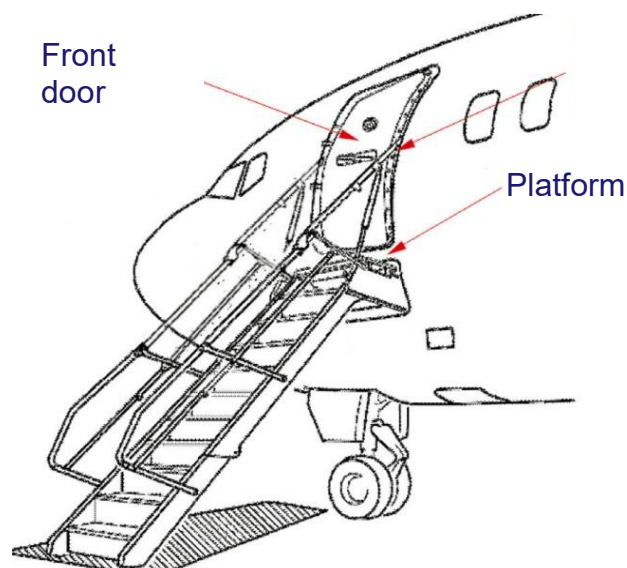
Figure 1. Extendable front stairs on the Boeing 737-8SA

These types of stairs have narrower steps and thinner and lighter handrails than the stairs that are external to the aircraft, which are normally provided by airport handling services³.

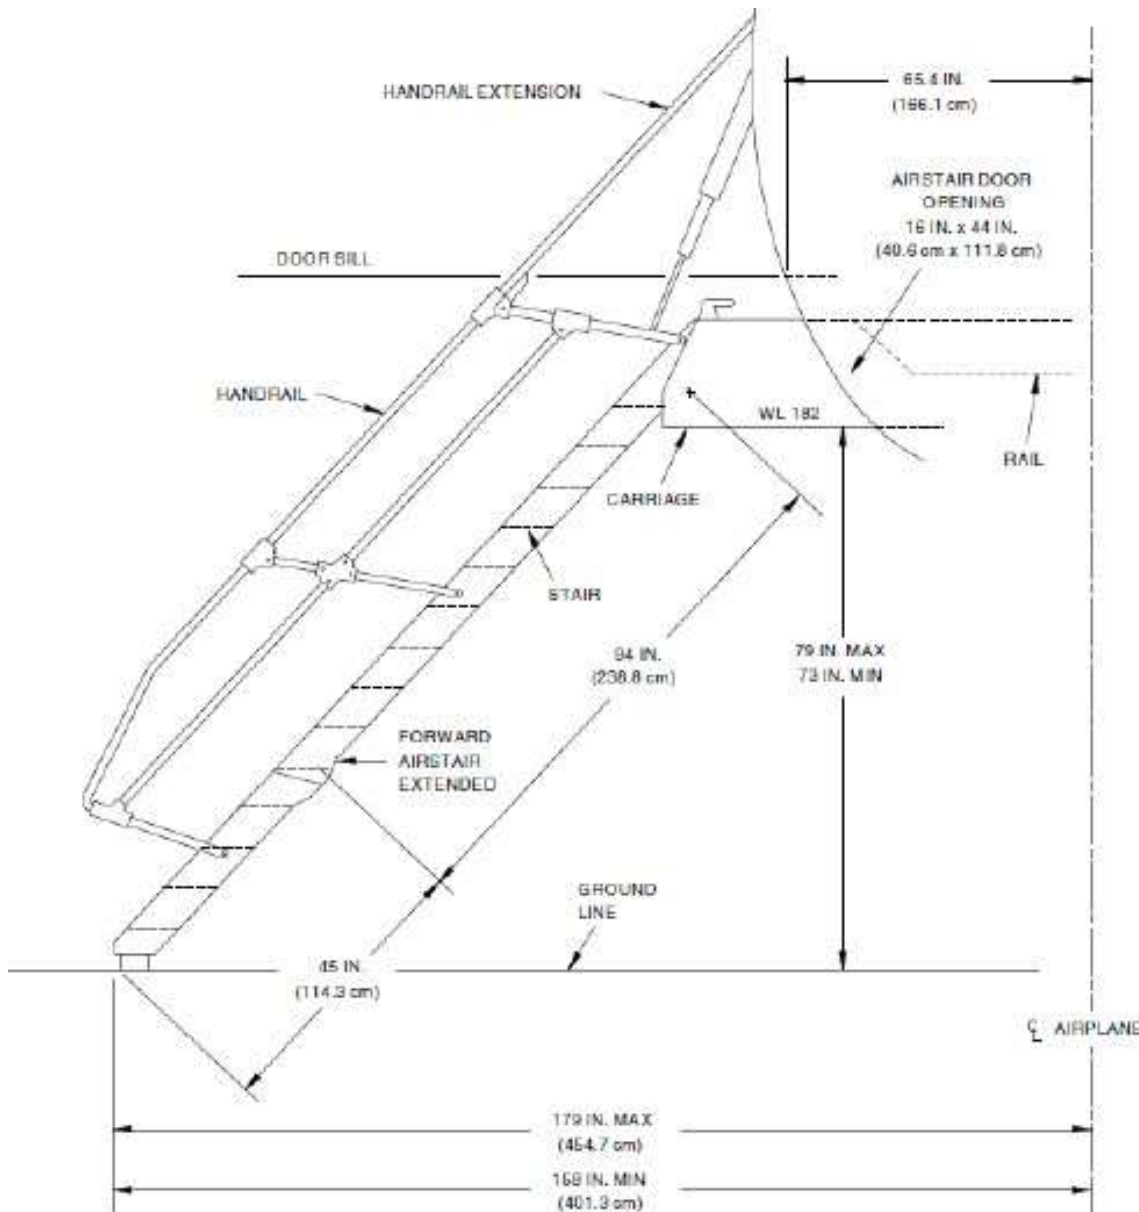
The dimensions of the stairs are defined in the Boeing document titled “Airplane Characteristics for Airport Planning”. The height of the stairs can vary, ranging from 1.85 m to 2 m, with a length of 3.53 m. Consequently, the gradient of the slope ranges from 62 % to 69 %, respectively.

The stairs are 0.62 m wide and have a total of 12 steps, covered with non-slip material in the tread area.

Figure 2. Dimensions of the extendable front stairs on the Boeing 737-8SA
