SERIOUS INCIDENT

Aircraft Type and Registration:	Sikorsky S-92A, EI- ICU	
No & Type of Engines:	2 General Electric CT7-8A turboshaft engines	
Year of Manufacture:	2006	
Date & Time (UTC):	5 February 2023 at 1453 hrs	
Location:	5 nm east-northeast of City of Derry Airport, Eglinton, Londonderry	
Type of Flight:	Training	
Persons on Board:	Crew - 4	Passengers - None
Injuries:	Crew - None	Passengers - N/A
Nature of Damage:	Damage (possibly pre-existing) resulting in replacement of stabilizer strut, aft tail drive shaft bearing support and forward tail drive bearing support	
Commander's Licence:	Airline Transport Pilot's Licence	
Commander's Age:	47 years	
Commander's Flying Experience:	8,080 hours (of which 2,400 were on type) Last 90 days - 45 hours Last 28 days - 13 hours	
Information Source:	Aircraft Accident Report Form submitted by the pilot

Synopsis

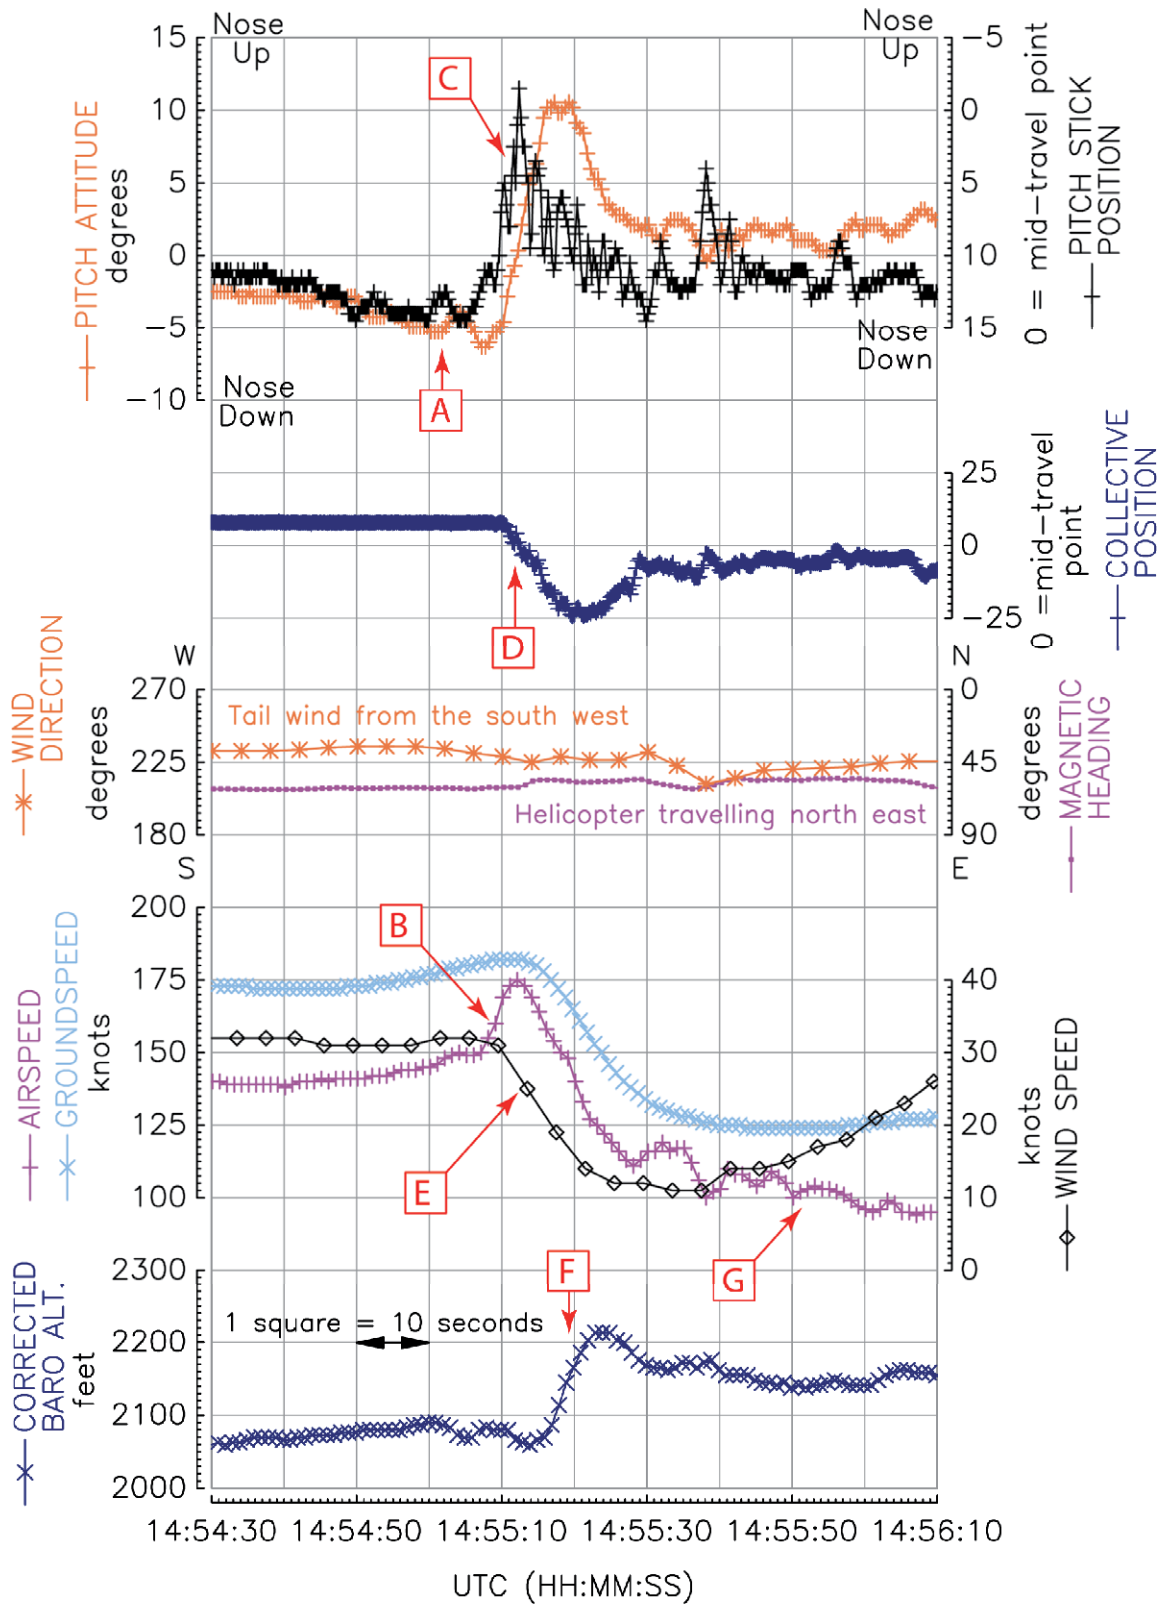
Figure 1
FDR data from EI-ICU at the time of the weather encounter

FDR data showed that at Point A in Figure 1, the aircraft experienced an oscillation in pitch over approximately eight seconds with the cyclic control moving in the opposite sense to the pitch. At the end of this period, at Point B, the airspeed began to increase sharply, and the pilot made a nose-up cyclic input (Point C), which increased the pitch attitude, and lowered the collective control (Point D). During the 10 seconds after the indicated airspeed began to increase, the wind speed dropped significantly (Point E) although there was no change in direction.

Approximately eight seconds after the speed began to increase the altitude began to increase, and the pilot responded by making a nose-down cyclic input while continuing to lower the collective. The airspeed peaked approximately 25 kt above its initial value, and the altitude increased by approximately 150 ft (Point F) as the pilot made these inputs.

The helicopter subsequently slowed to around 100 KIAS (Point G), which was maintained until the pilot later elected to climb to a higher altitude.

As the helicopter approached a point approximately 5 nm east-northeast of the City of Derry Airport it suddenly encountered severe turbulence. FDR parameters indicate that the pitch of the helicopter varied gradually until a sudden change in windspeed was experienced, when the pitch began to oscillate. The built-in time lag and the method of calculation used to generate the FMS wind speed means that although the FMS data indicates that the wind speed reduction occurred after the initial pitch oscillations (Points A and E in Figure 1), it is likely that this change in wind occurred close to or prior to the oscillations beginning.

The crew described the helicopter pitching up momentarily before pitching down and accelerating. The airspeed reached 175 KIAS which exceeded V_{NE} . The commander reduced the collective and increased the pitch attitude to reduce the speed, with the helicopter climbing 150 ft in this time. The relatively constant groundspeed recorded suggests that the change in airspeed was due to a sudden change in wind conditions.

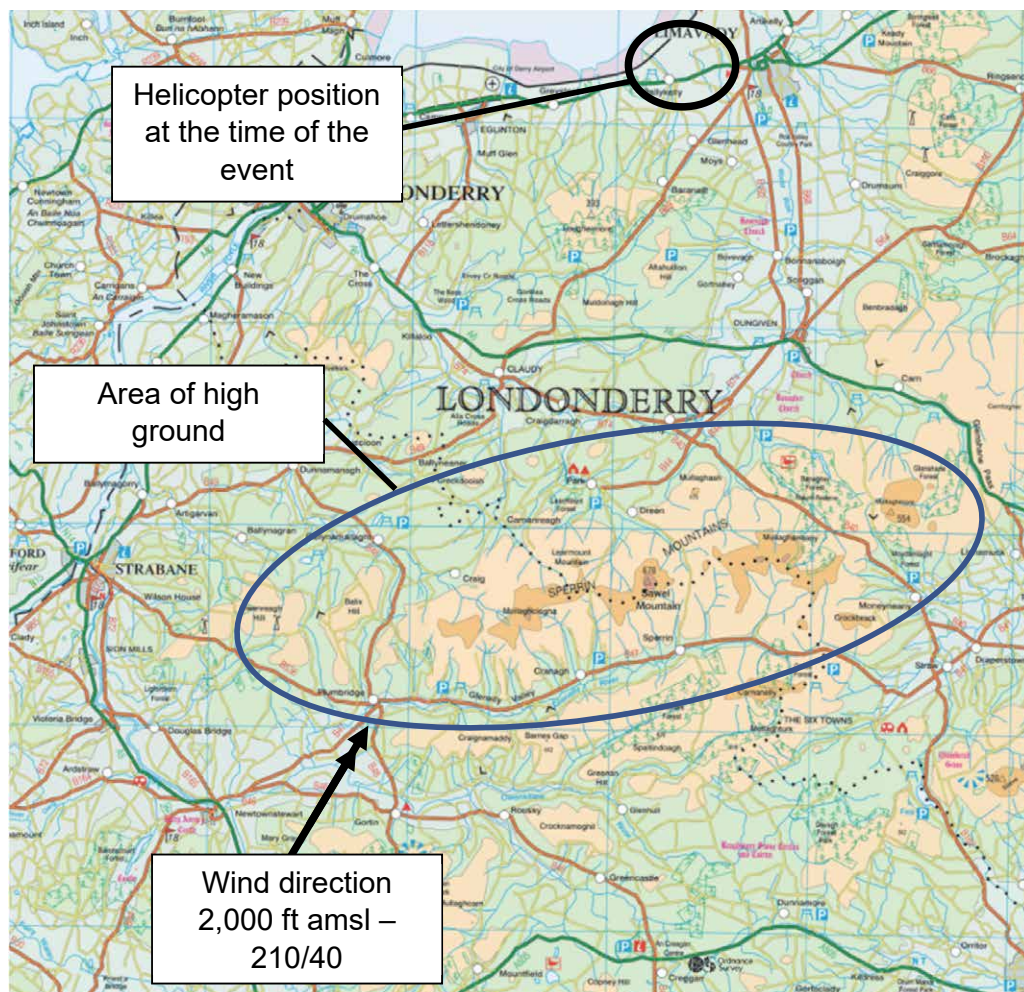
Figure 3

At 2,000 ft amsl in the area where the turbulence encounter occurred, the crew were directly in the lee of the Sperrin Mountains, a range of hills to the east of Strabane. The highest point on these hills is around 2,200 ft amsl. At the height the helicopter was flying, the wind was approximately 210° at 40 kt. This meant that the wind was flowing almost perpendicular to the ridge of hills and the helicopter was approximately 8 nm downwind. The UK Met office concluded from a satellite image taken at 1530 hrs that there were areas of mountain wave activity over western Ireland with some weak activity in the area of the event.

Helicopter position at the time of the event © Ordnance Survey

It is likely that EI-ICU flew through an area of mountain wave activity associated with the Sperrin Mountains. Flying through this activity created the turbulence which affected the helicopter. There were no visual indications for the crew of the presence of mountain wave activity. Moderate turbulence was forecast for the north of the region in the crew briefing but subsequent analysis of forecasts not available to the crew would have suggested that mountain wave activity was a possibility in Northern Ireland. Observations by satellite taken near the time of the event did show weak activity in the area.
