FINAL REPORT

AAIU Synoptic Report No: 2010-013

Aircraft Type and Registration:	Pipistrel Taurus 503, EI-ECS
No. and Type of Engines:	1 x Rotax 503 UL
Aircraft Serial Number:	039
Year of Manufacture:	2008
Date and Time (UTC¹):	06 December 2008 @ 16.04 hrs
Location:	Near Birr Airfield, Co. Offaly, Ireland N53° 04.53', W008° 53.97'
Type of Flight:	General Aviation – Check flight
Persons on Board:	Crew – 1 Passengers – 1
Injuries:	Crew – Nil Passengers – Nil
Nature of Damage:	Damaged beyond economical repair
Commander's Licence:	JAA PPL (M)
Commander's Details:	Male, aged 46 years
Commander's Flying Experience:	974 hours, of which 0 were on type
Notification Source:	Gardaí at Birr
Information Source:	AAIU Field Investigation

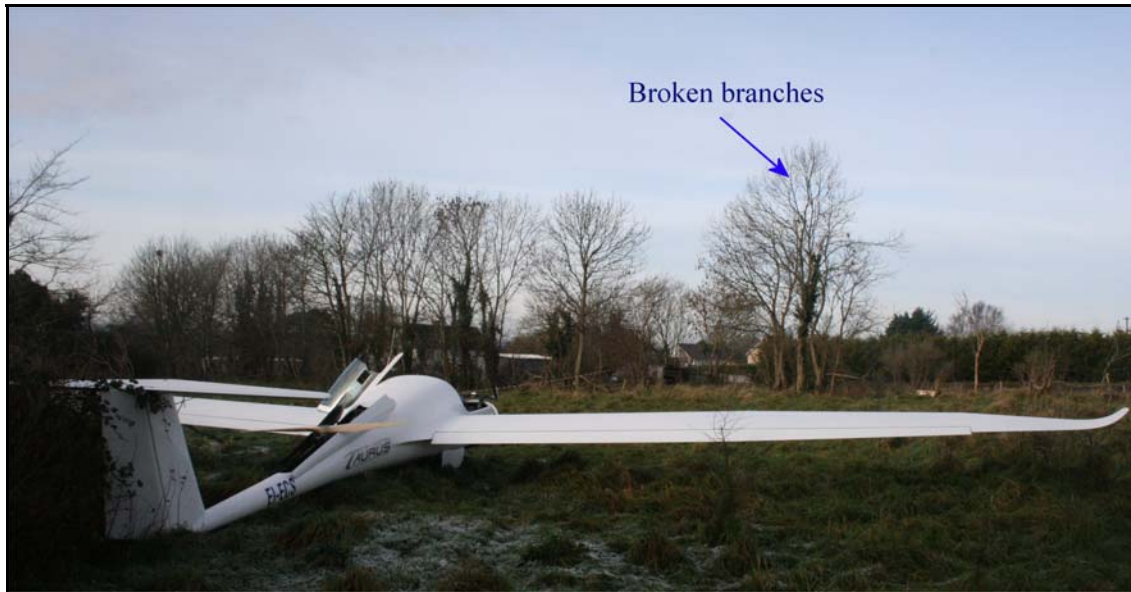
The aircraft was on a heading of 340°M facing the direction from which it had come (**Photo No. 1**). The canopy had shattered and the fuselage underneath the cockpit was distorted and fractured. The landing gear was found extended. The engine was partially extended, the rear actuating support having fractured but not separated thus allowing the propeller to fall from a fully extended position onto the engine bay doors. Witness marks on the engine bay doors show that the propeller was stopped but not aligned at impact. The flaperons⁴ were found near the T or fully extended position. Continuity was established for all controls at the accident site.

Photo No. 1: Accident site

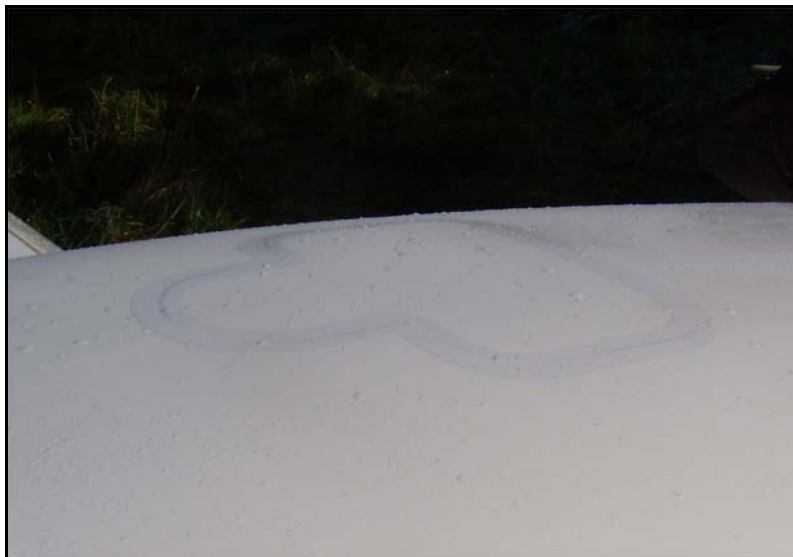
The aircraft bore registration marks and although equipped with a ballistic parachute system, there were no external markings to indicate that this system was installed, or where it was located. However, the egress panel outline could be seen on the hoar frost that covered the aircraft the following morning (**Photo No. 2**).

Photo No. 2: Ballistic parachute egress panel outlined in frost

The Investigation notes that there were no placards on the aircraft to warn that a pyrotechnic and projectile hazard was on board the aircraft. As time progresses, more and more light aircraft are being equipped with these ballistic parachute systems. By their nature, light aircraft accidents such as this often occur away from airports and in isolated places, thus the first responders are often likely to be members of the public.

The Investigation is of the opinion that, for the protection of persons about the aircraft, all aircraft equipped with a ballistic parachute system, should have clear warnings on the outside of the aircraft prior to being allowed to fly. Accordingly, three Safety Recommendations are made to that effect.

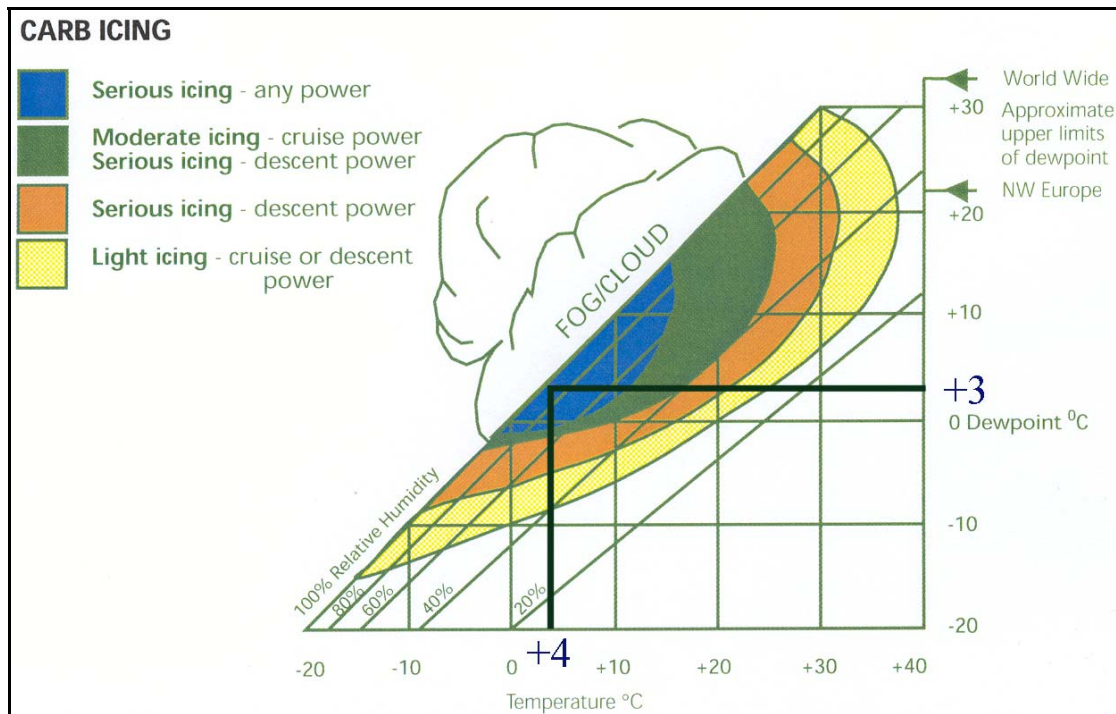
As the temperatures on the day were approximately +4°C with a dew point of +3°C this indicates that the atmospheric conditions were conducive to the formation of serious carburettor icing. Although the graphic in **Figure No. 1** was produced for Avgas⁷, the Mogas used on this aircraft is known to be more susceptible to carburettor icing.

Figure No. 1: Carburettor icing likelihood while using Avgas
