FINAL REPORT

AAIU Report No: 2010-016
State File No: IRL00909071
Published: 13/10/10

Aircraft Type and Registration:	Avid Mk. IV Speedwing, G-BTMS
No. and Type of Engines:	1 x ROTAX 582 UL
Aircraft Serial Number:	PFA 189-12023
Year of Manufacture:	1999
Date and Time (UTC):	11 August 2009 @ 16.55 hrs
Location:	5 nm southwest of Tuskar at position 52° 09.60 N 006° 19.17 W
Type of Flight:	Private
Persons on Board:	Crew – 1 Passengers – Nil
Injuries:	Crew – Nil Passengers – Nil
Nature of Damage:	Damaged beyond economic repair
Commander's Licence:	JAA Private Pilot Licence (UK)
Commander's Details:	Male, aged 53 years
Commander's Flying Experience:	152 hours, of which 4 were on type
Notification Source:	Marine Rescue Coordination Centre (MRCC)
Information Source:	AAIU Field Investigation

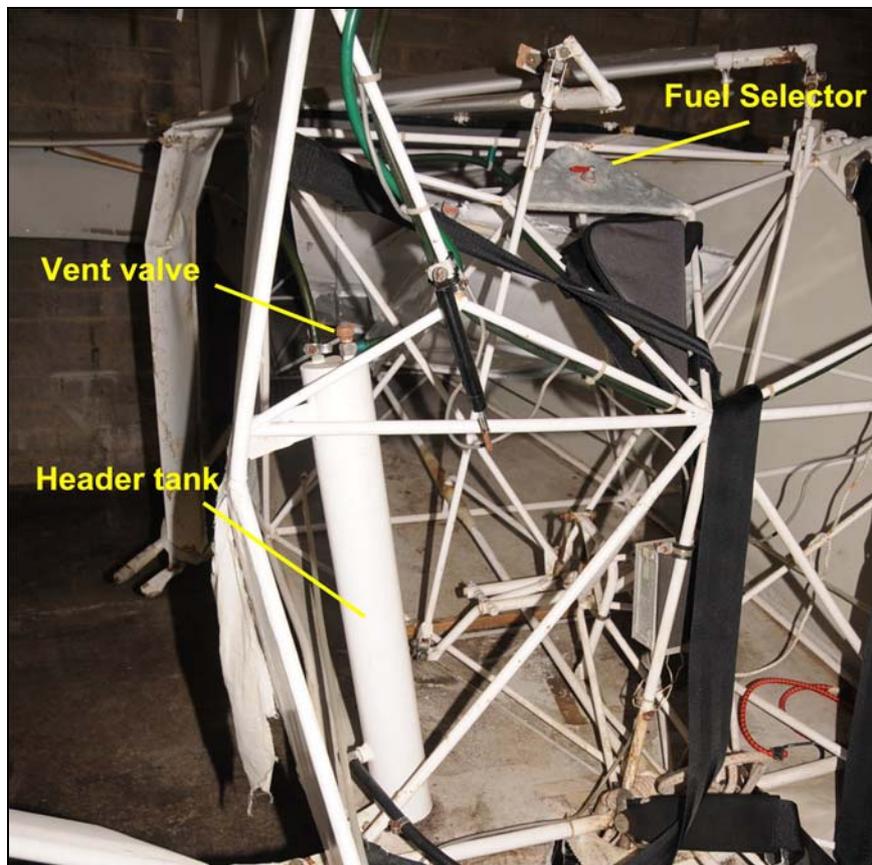
The fuel system installed in G-BTMS consisted of two main wing tanks; a standard Right tank with a capacity of 55 litres, and an optional Left tank with a capacity of 35 litres. The two tanks supplied fuel through 1/4 inch fuel lines to a fuel selector valve situated just above shoulder height behind the pilots seats. Fuel was supplied through this valve to the top of a Header tank, consisting of a metal cylinder, situated behind the passenger seat (the right seat). The Header tank supplies fuel to the engine carburettors via a fuel filter, fuel shutoff and a pneumatically driven fuel pump. The Header tank was fitted with a manually operated vent valve to remove any trapped air in the fuel system (**Photo No. 1**).

Photo No. 1: View of fuselage looking aft showing positions of the Header tank, Vent valve and Fuel Selector.

The fuel system in G-BTMS differs in some respects to the manufacturer's construction manual. The addition of the fuel selector valve and the position of the fuel shutoff valve were non-standard. In particular, the vent line was left open-ended at a point between the pilot seats, inside the cabin. The construction notes refer to the vent line being installed between the Header tank to a section of aluminium vent tubing installed in the butt rib (innermost wing rib) venting above the wing surface. After finishing the vent tube should be bent to the rear and downward.

The tubing to the top of the header tank contained air and was free of blockages. The header tank was found to contain approximately 970 ml of fuel and 330 ml of seawater. The remainder of the header tank capacity (approximately 250 ml) was air under slight negative pressure, which was observed when the vent valve was opened. The fuel line from the side of the header tank contained seawater. The fuel shutoff valve, situated in the floor of the cockpit, was in the open position and functioned correctly. The fuel filter, which could be inspected visually, contained seawater. The two underwing fuel drains, and the fuel drain at the bottom of the header tank, were all found under spring tension in the normal (closed) position.

The fuel system in G-BTMS was not strictly in accordance with the manufacturer's specification. With a selector valve installed enabling either tank to supply fuel, the vent line should have been routed above the wing rib to provide positive pressure to the system in accordance with the installation drawings. Adequate venting is essential to proper fuel system operation. The pneumatically driven fuel pump will be unable to continue to draw fuel if there is not adequate venting in the system. Also, operation using MOGAS, or a fuel mixture which is predominantly MOGAS, poses increased risk of vapour-related problems. The storage of fuel in the aircraft tanks for at least 5 months would have reduced the volatility of the fuel, which was then topped off with a quantity of AVGAS. Taken all the above into account it seems probable that the engine in G-BTMS stopped due to a fuel supply problem. The Investigation is of the opinion that a fuel vapour-related problem, in probability a vapour-lock in the fuel supply line, occurred during flight. It is not possible to say if inadequate venting of the Header tank contributed to the loss of fuel flow.

Possible inadequate venting of the fuel system due to the Header tank vent valve being closed.

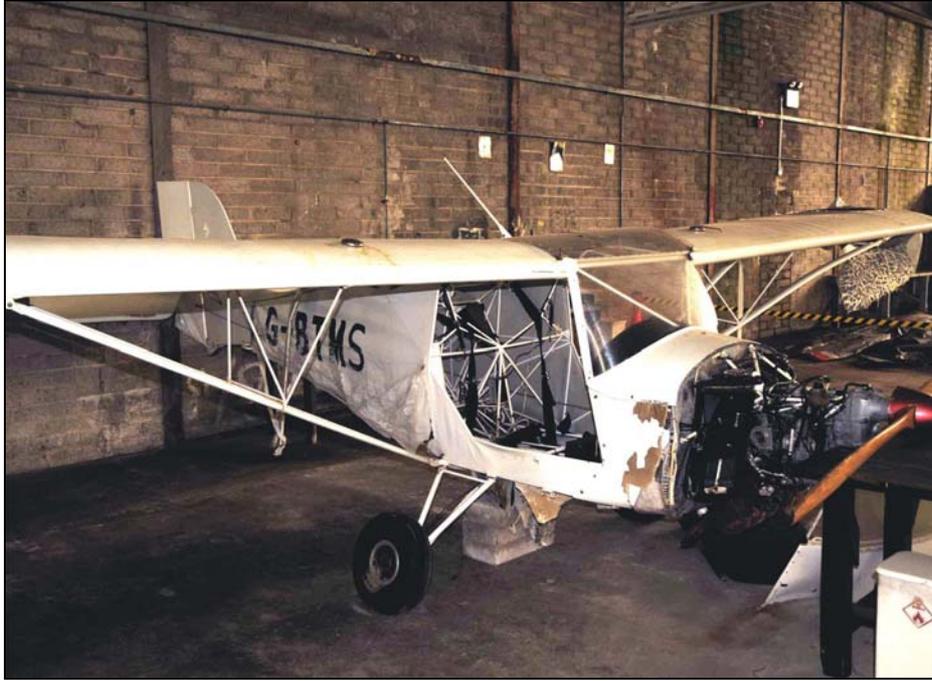
The flight controls were examined for full and free operation. This inspection revealed no pre-accident defects with the installed flight control systems or linkages. Inspection of the cockpit however, revealed that the right stick was held in a forward position by a red removable bungee cord, the ends of which were attached to the nose-steering mechanism. As the two control sticks are interconnected, it required a constant rearward force to be applied by the Pilot on the left stick to keep the correct pitch attitude in flight. A second red bungee, which probably had been attached to the left seat stick for transport purposes, was found loose under the left seat in the vicinity of the main control linkages. To facilitate the inspection the doors and seat were removed (**Photo No. 2**).

Photo No. 2: General view of wreckage with doors and seat removed
