FINAL REPORT

AAIU Report No: 2011-002
State File No: IRL00909099
Published: 24/01/2011

Aircraft Type and Registration:	Boeing 737-3Q8, G-OBMP
No. and Type of Engines:	2 x CFM56-3C-1
Aircraft Serial Number:	24963
Year of Manufacture:	1992
Date and Time (UTC¹):	19 October 2009 @ 14.20 hrs
Location:	Ireland West Airport, Co Mayo, Ireland (EIKN)
Type of Flight:	Scheduled Public Transport
Persons on Board:	Crew - 5 Passengers - 127
Injuries:	Crew - Nil Passengers - Nil
Nature of Damage:	Significant damage to No. 1 engine, minor damage to No. 2 engine
Commander's Licence:	Airline Transport Pilot Licence
Commander's Details:	Male, aged 31 years
Commander's Flying Experience:	6,000 hours, of which 4,000 were on type
Notification Source:	Duty Airport Manager – Shannon Airport
Information Source:	AAIU Pilot Report Form

SYNOPSIS

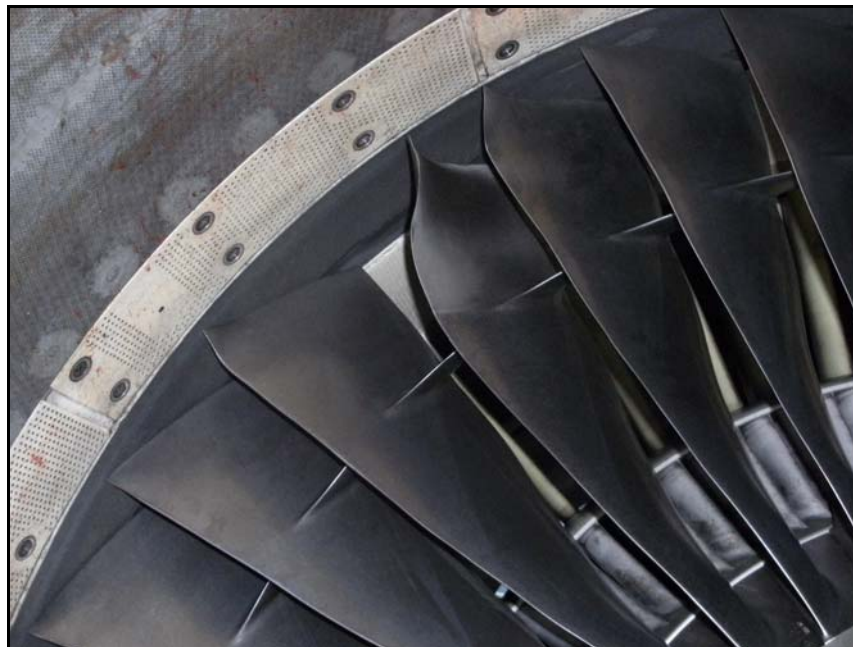
There was bending and distortion damage to a number of fan blades on No. 1 (port) engine, (**Photo No. 1**). The entire fan blade set (38 blades) was replaced at EINN.

Photo No. 1: No. 1 Engine Fan Blade Damage

The fact that the recorded fan vibration values for No. 1 engine were relatively high is consistent with what was later found by the maintenance personnel, in that the fan, part of the engine low pressure system, was found with bent and distorted blades. This also suggests that most of the debris bypassed the engine core, after passing through the fan blades.

1. The aircraft encountered a flock of lapwings and suffered multiple bird-strikes on take-off from RWY 09 in EIKN.
2. No.1 engine sustained bending and distortion damage to a number of fan blades.
