Air Accident Investigation Unit Ireland

ACCIDENT REPORT
Laverda SpA, F.8L Falco IV, EI-BMF
Powerscourt, Co. Wicklow
10 April 2010

AAIU Report No: 2011-013

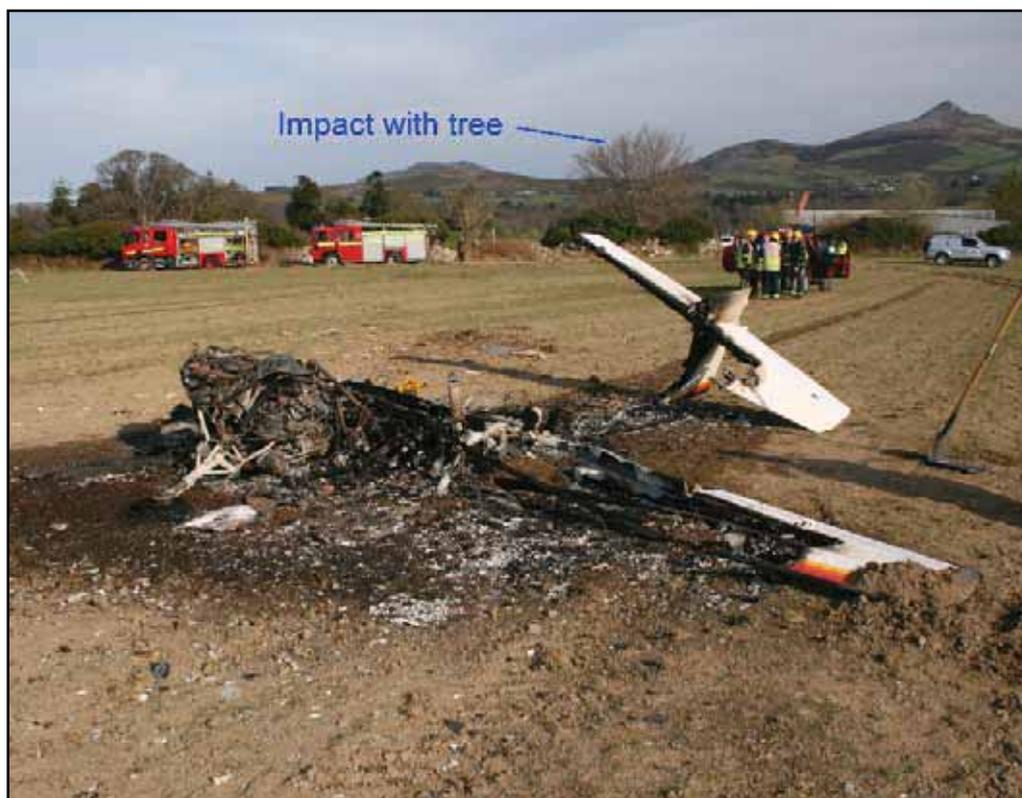
The left wing of the aircraft struck the upper branches of a single tree situated approximately 71 metres (m) beyond the runway end (**Photo No. 1**). The aircraft then contacted the ground with the left wingtip, and made a second, more substantial impact before coming to rest in an inverted position approximately 133 m beyond the tree. A fuel-fed fire then occurred which consumed most of the aircraft structure. The Passenger was fatally injured. The Pilot was airlifted to hospital by an Irish Coast Guard helicopter and died of his injuries two days later.

Photo No. 1: Final position of the wreckage, impact point with tree indicated.

The first evidence of ground contact was that made by the port wingtip at a distance of 114.7 m beyond the tree. A section of the port wingtip was found embedded in the ground at this point. Further ground contact in the form of a gouge occurred 5.8 m further on, followed by a shallow crater 2.5 m across. Small pieces of debris were found in this area, the largest portion being a section of wing skin. The aircraft finally came to rest in an inverted position 133 m beyond the tree.

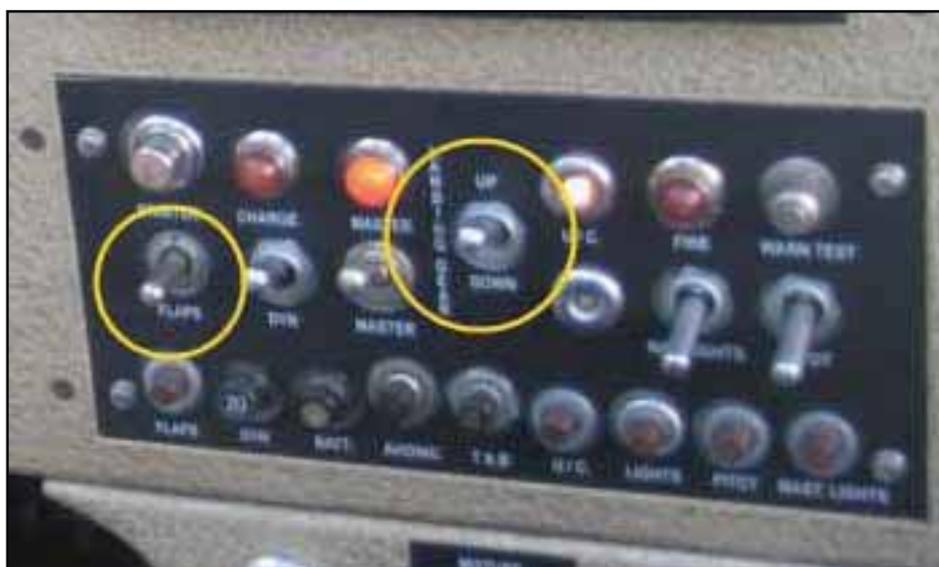
The flaps are extended and retracted by means of an electric motor located on the bottom of the fuselage behind the main spar underneath the baggage platform. This motor operates the flaps through a worm tube and two small connecting rods. Control of the Flaps was by means of a toggle switch. A mechanical flap position indicator was situated on the left side of the lower front panel, below the engine controls. Both the landing gear and flaps are operated by means of similar toggle switches and are both situated on the same panel (**Photo No. 2**).

Photo No. 2: Centre instrument panel of EI-BMF showing location of flaps and landing gear selector switches. (M. Nixon, 2009)

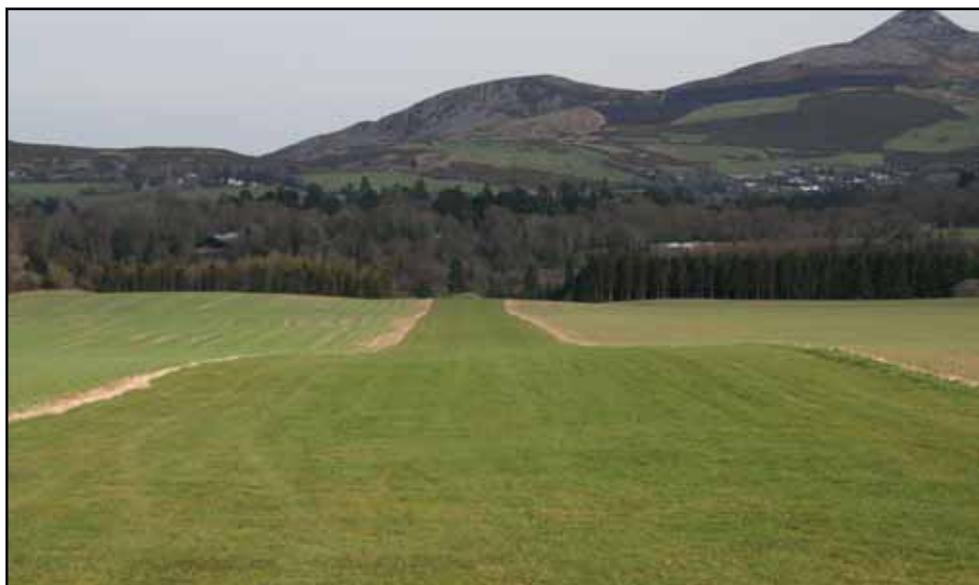
A pilot who had flown with the Pilot on previous occasions informed the Investigation that it was the Pilot's normal practice to take-off downhill on RWY 12 and land uphill on the reciprocal RWY 30. The downslope on RWY 12 is illustrated in **Photo No. 3**. The practice of landing on the reciprocal runway to that of take-off could only be carried out in calm or light wind conditions. This is further discussed in **Section 2.1**.

Photo No. 3: View of take-off direction RWY 12.

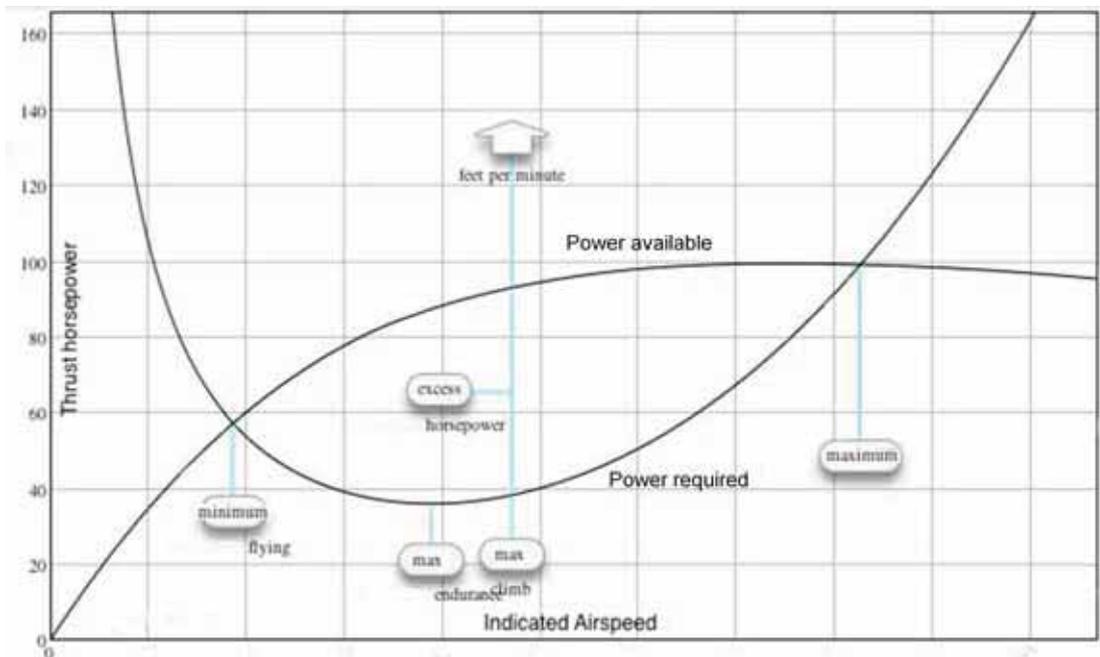
Generally the thrust power available from a normally-aspirated piston engine and propeller combination will increase as speed increases, but the rate of increase will reduce as the speed is increased. For a particular engine, under given atmospheric conditions, the power available can be represented by a curve plotted of power available against airspeed. This is illustrated in **Figure No. 1**.

Figure No. 1: Illustration of power available and power required (total drag) curves (Benchmark)

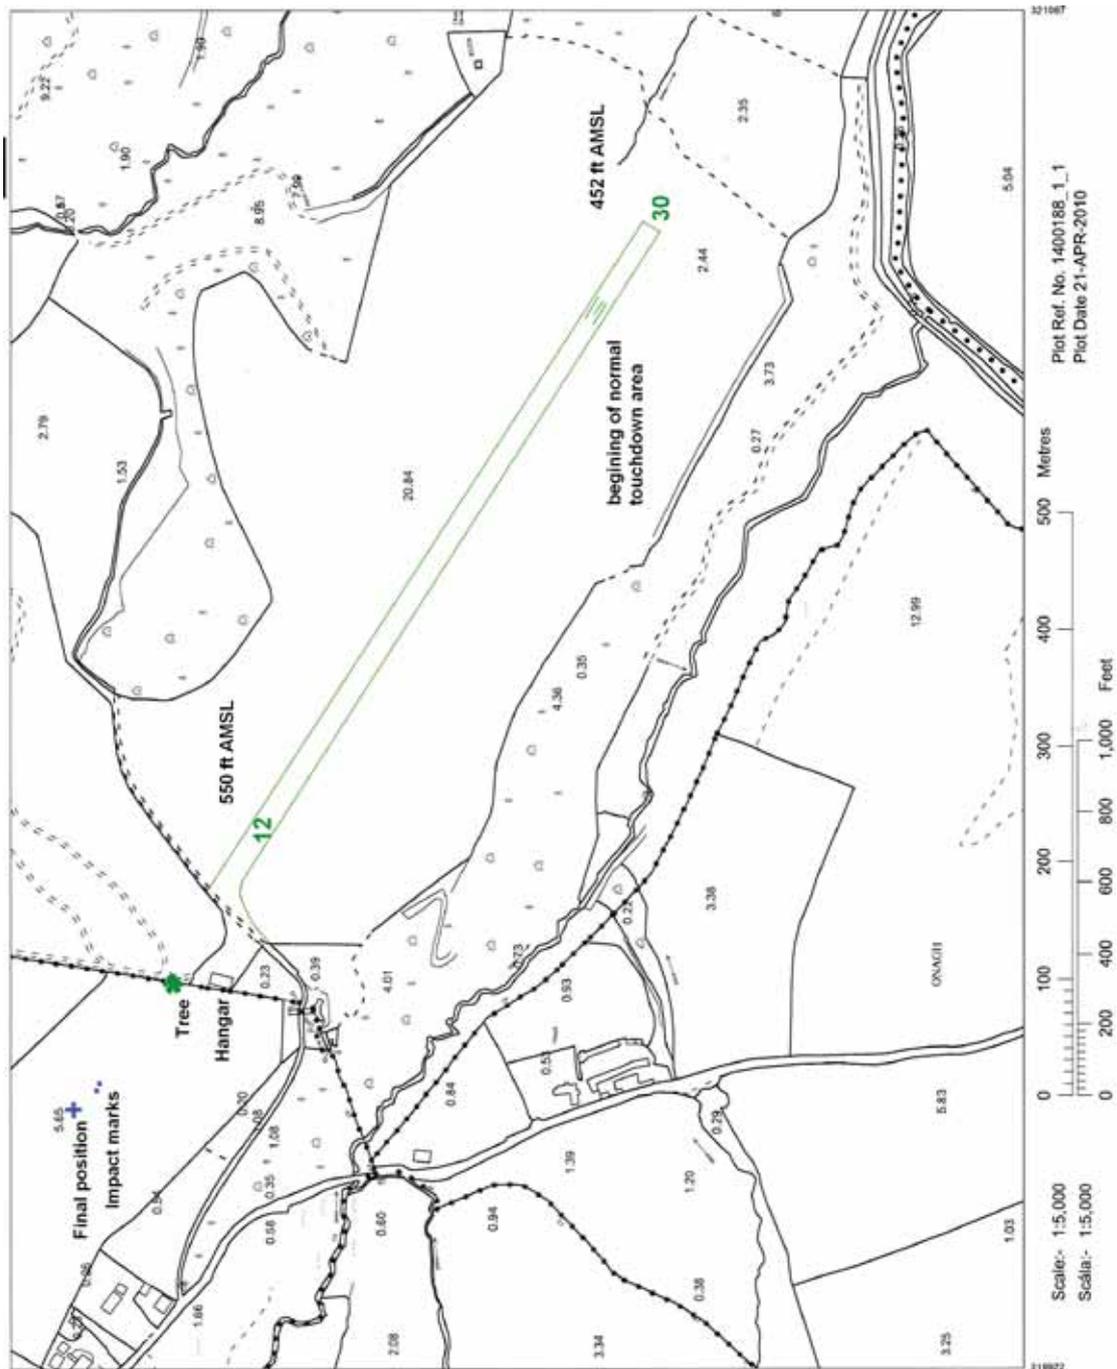
APPENDIX B

There is an upslope on RWY 30 of 5% (2.86 degrees), and a corresponding downslope on the reciprocal RWY 12. The northwest end of the runway is bounded by a paved road providing access to the hangar and a private house. A deer fence rising to 6 ft and a hedge encloses the boundary of the golf course adjacent to the road. A single windsock was situated to the right of the hangar. There was no equipment for recording wind speed or direction, and there was no requirement for such equipment to be installed. A map showing the location of the runway, the obstacle struck (tree) and final position of wreckage is reproduced in **Appendix B**.

1. A tree on the extended centreline of RWY 30, was allowed to grow and develop such that it became a significant obstacle to operations.
2. The proximity of the obstacle in the direct flight path may not have been apparent to the Pilot during the climb.
3. The ambient conditions on the day may have produced a tailwind condition during the approach and go-around.

Powerscourt Airfield showing location of Runway, obstacle struck (tree) and final position of wreckage

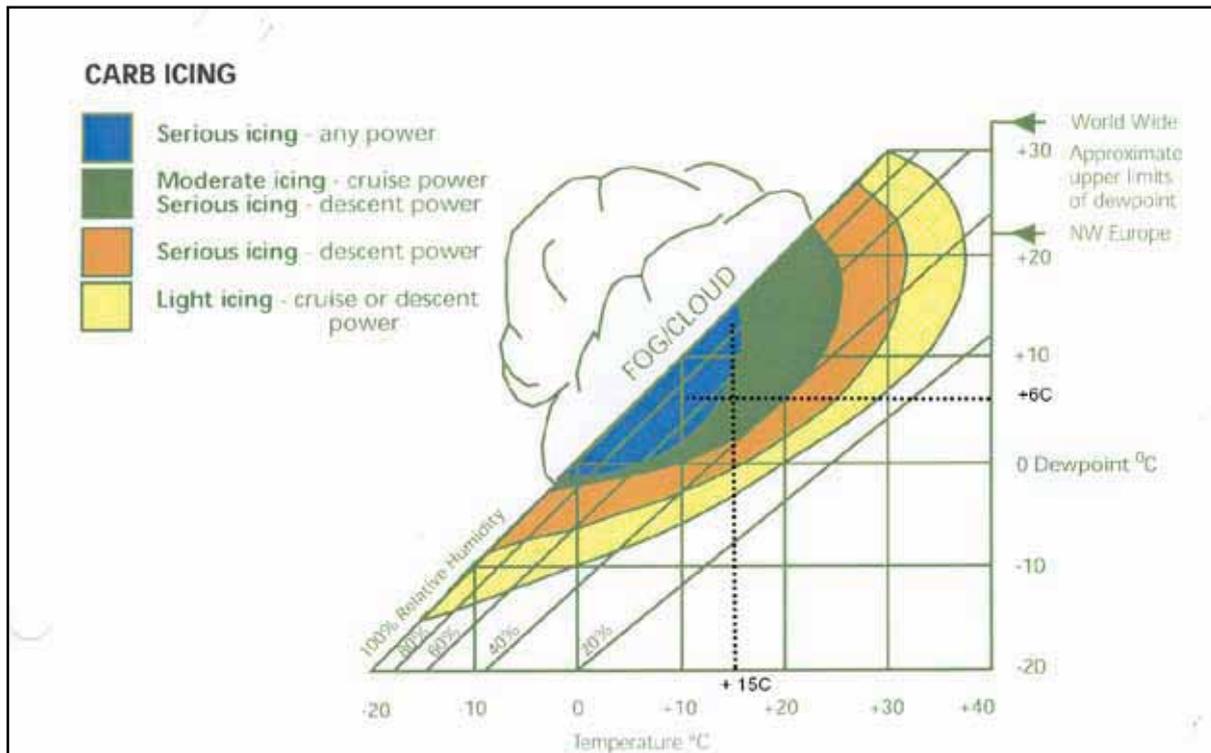
APPENDIX C

Plotting the ambient temperature and dew point for the conditions prevailing at the time of the accident showed that serious icing could be expected at descent power settings (**Appendix C**). Given the terrain on the approach, a period of descent at low power would have been required on the approach. Therefore it is possible that some icing may have occurred, which would have reduced the available power in the subsequent go-around. However the fact that the Pilot initiated the go-around, when flying towards rising terrain, indicates that he did not have concerns regarding the performance of the engine.

Chart showing conditions of possible Carburettor Icing

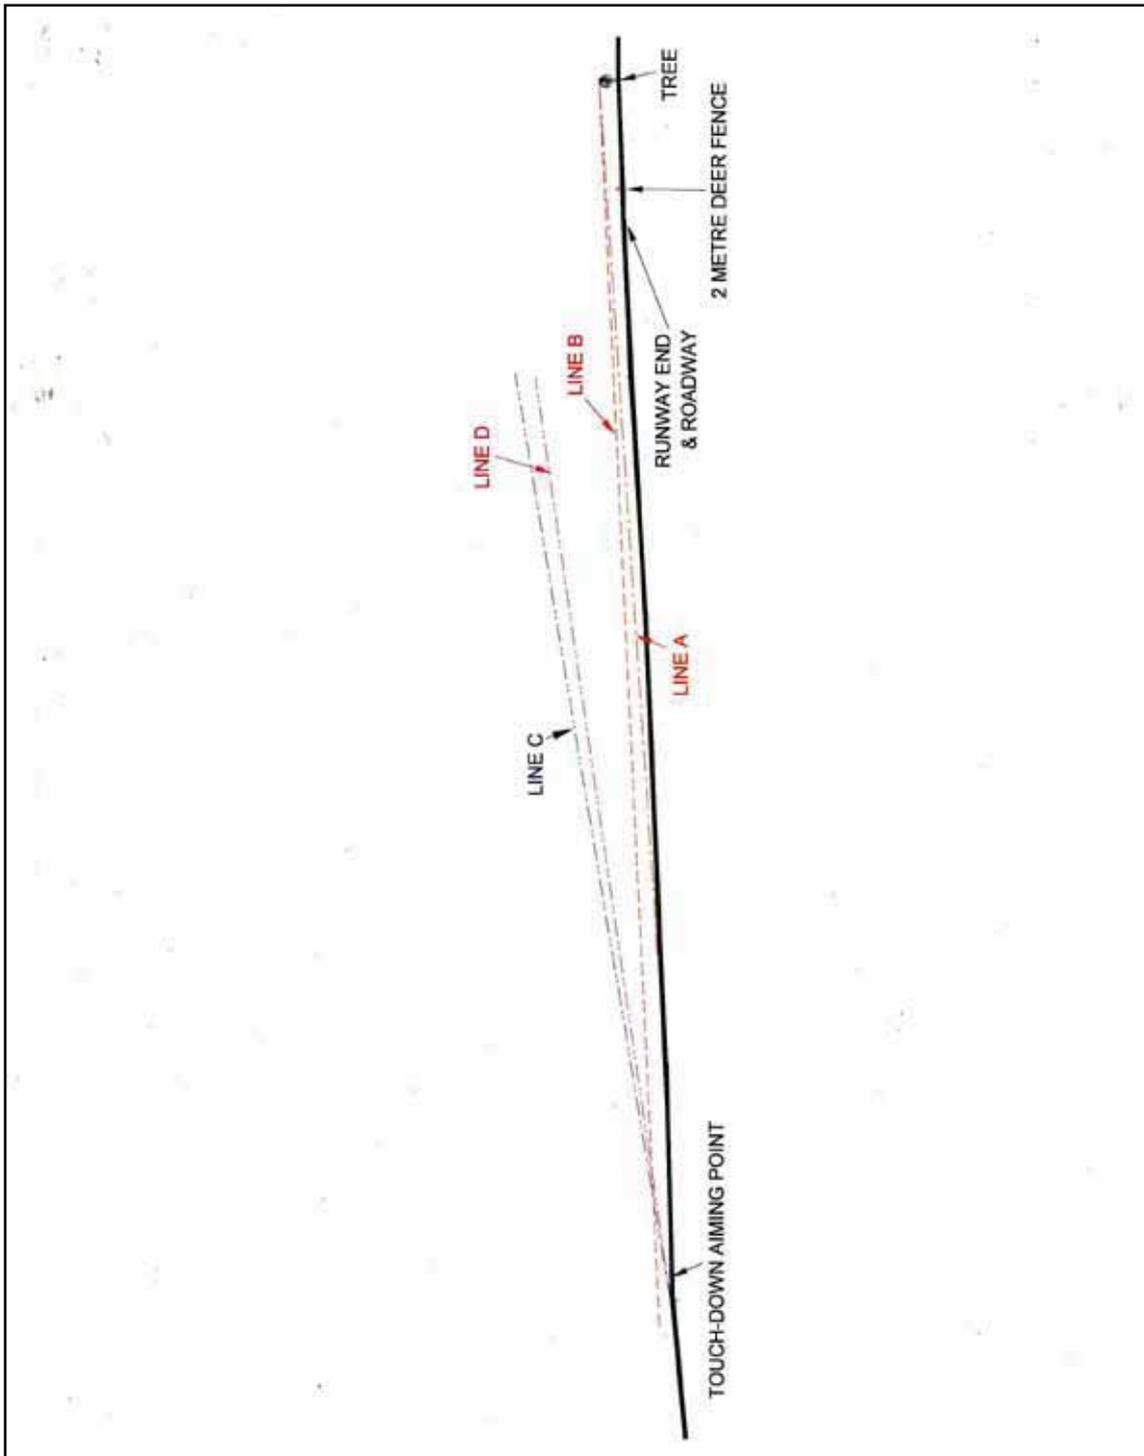
APPENDIX D

The achievable climb angle in the landing gear-up configuration is also shown, for both zero wind (line **C**) and 10 kts tailwind condition (line **D**).

Section of runway profile with performance lines superimposed
