Air Accident Investigation Unit Ireland

INCIDENT REPORT
Tecnam P2002JF, EI-LFC
Coonagh Airfield, Co. Limerick
29 September 2010

AAIU Report No: 2011-017

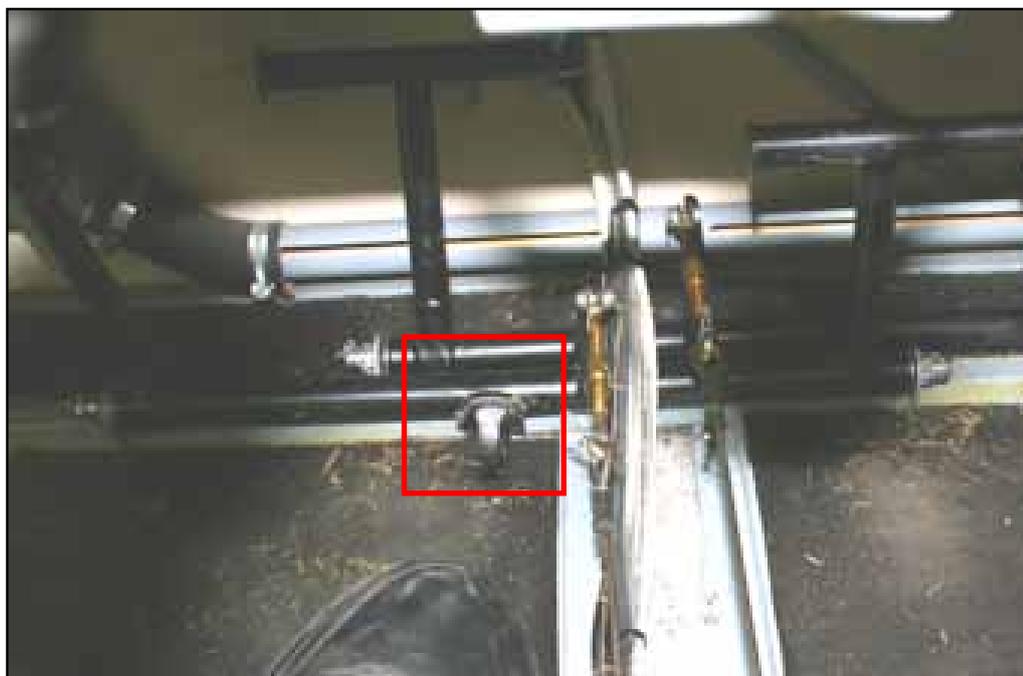
Following landing at EICN, the aircraft turning arc during ground manoeuvring was noted to be greater than usual. Inspection revealed that the left-hand side rudder pedal assembly had failed adjacent to a welded joint.

Photo No. 1: Fractured pedal assembly in-situ

4 The Investigation inspected the aircraft and noted certain residual distortion (from the previous accident) that might have resulted in misalignment and unintended stress causing rudder pedal failure. These matters were brought to the attention of the Operator, the maintenance organisation and the IAA. The maintenance organisation contacted the manufacturer and obtained dimensions other than those available in the aircraft publications, to assist with identifying the root cause of the series of rudder pedal failures. Inspection of the rudder system revealed that the "End Run Stop" on the left hand side was out of position and allowed less travel than the right hand stop. Aircraft records indicate that this stop was last adjusted during the post-accident re-build. However, the Maintenance Organisation found that the "End Run Stop" was subject to inadvertent movement if put under pressure; such pressure would be applied when executing tight turns.

The stop may have been misplaced either during the post-accident re-build or it may have moved due to pressure applied during tight turning manoeuvres. In either case, the misplaced stop allied with the Operator's ground manoeuvring procedures resulted in rudder pedal loads which exceeded the design loads of the assembly, causing pedal assembly distortion and ultimately pedal assembly failure. Re-alignment of the stop coupled with the Operator's revised turning procedures should reduce the likelihood of further such failures.

1. Misalignment of the left hand rudder stop.

1. Turning procedures which caused excessive loads on the rudder pedal assembly.

Subsequent to this event the incident aircraft and its sister ship, another Tecnam flown by the same operator, both exhibited rudder pedal distortion when inspected during scheduled maintenance. Following consultations with the Maintenance Organisation, the Operator has now amended their ground manoeuvring procedures to reduce the rudder pedal loading experienced during such manoeuvring. Specifically, the operator avoids tight turning manoeuvres whenever possible. When tight turns are necessary the Operator requires that the aircraft is brought to a complete halt, following which the brake is released and the aircraft is turned slowly using the minimum throttle and rudder pressure necessary to accomplish the turn. Since introducing the new turning procedures the Maintenance Organisation have not found any distortion problems with rudder pedal assemblies.
