Air Accident Investigation Unit Ireland

**SERIOUS INCIDENT
PA 31-350, G-VIPY,
Near LIFFY reporting point
in Dublin CTA,
9 February 2011**

AAIU Report No: 2011-020

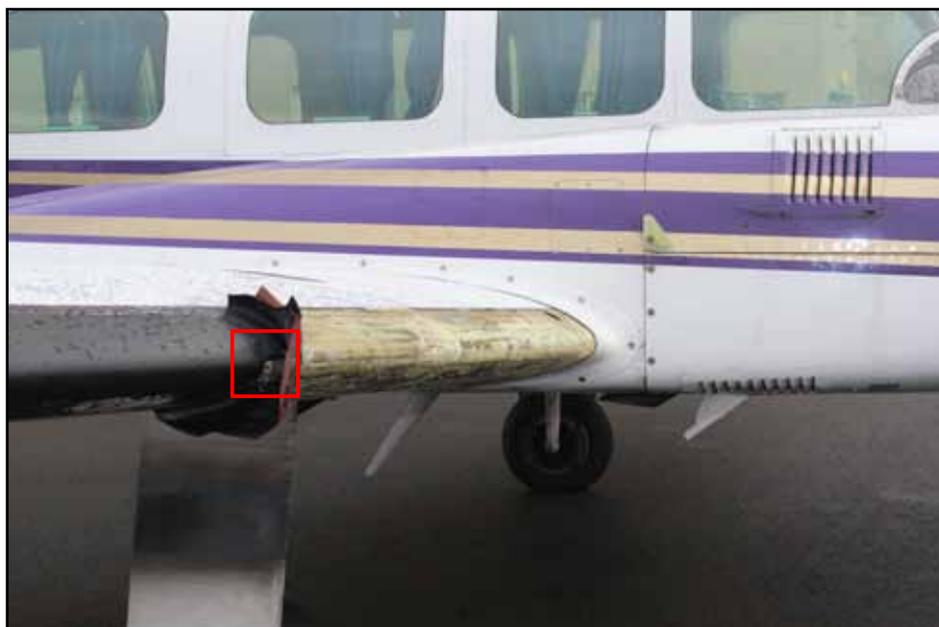
The aircraft departed East Midlands Airport, UK (EGNX) at 07.25 hrs on a scheduled cargo flight to Weston Aerodrome, Co. Dublin (EIWT). During the initial descent the Pilot activated the de-icing boots and noted a slight shudder, but had no other adverse indications. About 10 minutes later the aircraft suddenly experienced a violent rolling motion, but had no adverse pitch movements. The Pilot scanned outside the aircraft and noted that the starboard de-icing boot had partially detached and was flailing against the wing and aileron **(Photo No. 1)**.

Photo No. 1: De-ice boot peeling (stall warning vane marked in red)

Two Inspectors of Accidents travelled to EIWT to inspect the aircraft and interview the Pilot. On examination it was found that the inboard section of the starboard de-icing boot 1.55 m long had effectively "peeled" away from the leading edge and flailed, causing damage and marking to the starboard wing upper surface (**Photo No. 2**), the starboard aileron upper surface (**Photo No. 3**) and the outboard section of the starboard flap. The "peeling" appeared to be arrested by the presence of the stall warning vane and its attachment bracket.

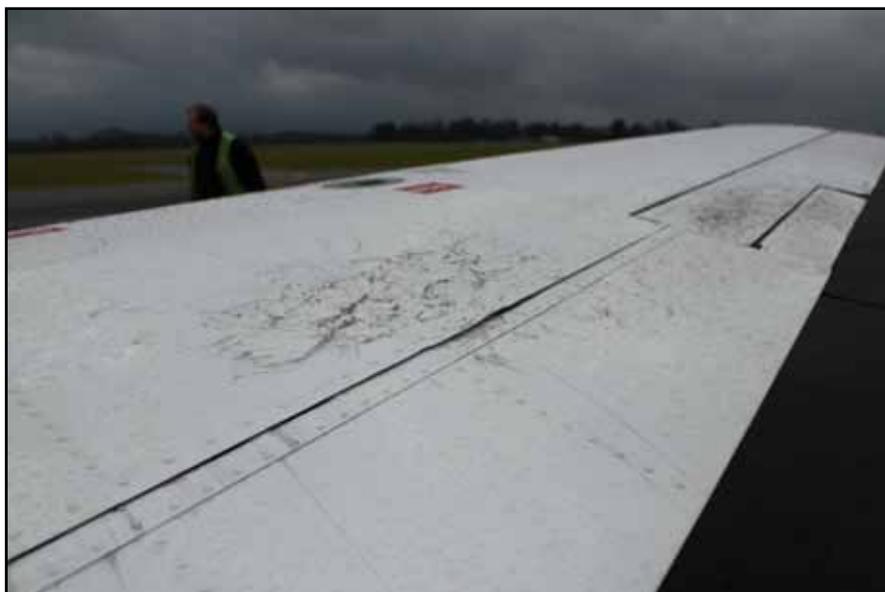
Photo No. 2 : Damage to the wing upper surface

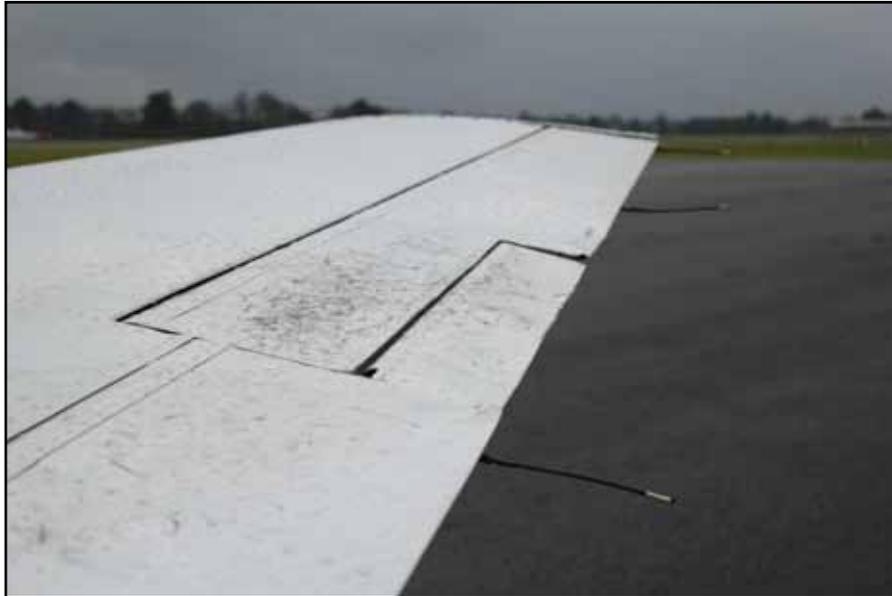
Photo No. 3: Damage to the starboard aileron
