Air Accident Investigation Unit Ireland

INCIDENT REPORT
Boeing B737-8AS, EI-DYI
Charleroi Airport, Belgium (EBCI)
1 March 2010 @ 08.40 hrs

AAIU Report No: 2012-010

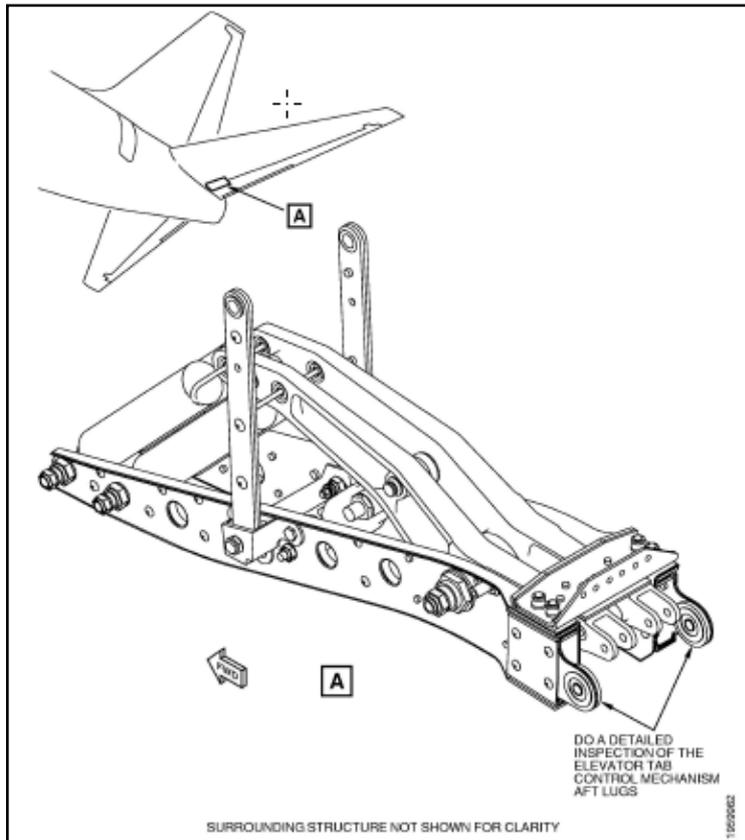
Figure No. 1: Schematic of failed assembly and its aircraft location

The primary damage that was discovered was to the elevator tab control mechanism, where the frame assemblies 251A2431-11 and 251A2431-12 were broken from the tab mechanism assembly, and accelerated wear was found to the elevator tab mechanism, thought to be as a result of oscillation of the elevator tab.

Figure No. 1 shows a general schematic of the location of the failed components on the aircraft and a more detailed engineering drawing of the assembly. **Photo No. 1** provides details of the nomenclature used in this report.

The damaged control mechanism was replaced and all functional tests as required by the Manufacturer were completed. The Operator then conducted a non-revenue ferry flight from EBCI to Stansted (EGSS) to conduct additional inspections as requested by the Manufacturer, with the involvement of the Manufacturer's Aircraft-On-Ground (AOG) team.

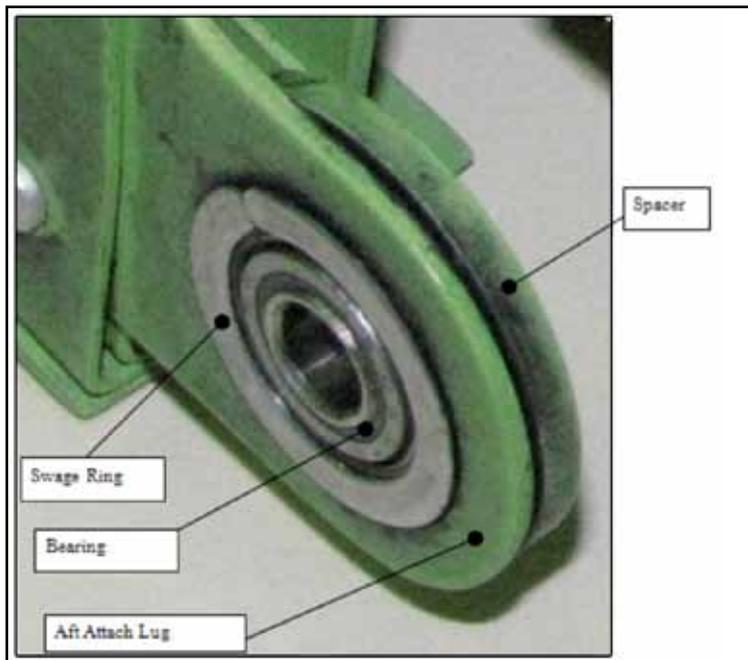
Photo No. 1: Nomenclature used in this report

As a result of EI-DYI's event, and also due to the findings from the inspections of other aircraft, the Manufacturer identified that wear of the bearing swage ring at the aft attach lugs of the elevator tab control mechanism resulted in accelerated degradation of the joint, after which the bearing could migrate out of the lug or cause complete lug separation resulting in severe vibration of the elevator tab. The Manufacturer determined that the bearing swage had worn because of *"workmanship escapement and improper tool usage"* that would have occurred during component manufacture. Furthermore, the Manufacturer identified that the design specification may not have been adequate for multiple layer clamp-up, resulting in unexpected wear at the joint.
