Air Accident Investigation Unit Ireland

ACCIDENT REPORT
Robinson R44 II, EI-WWI
Near Baltinglass, Co Wicklow, Ireland
23 November 2010 @ 13.30 hrs

AAIU Report No: 2012-006

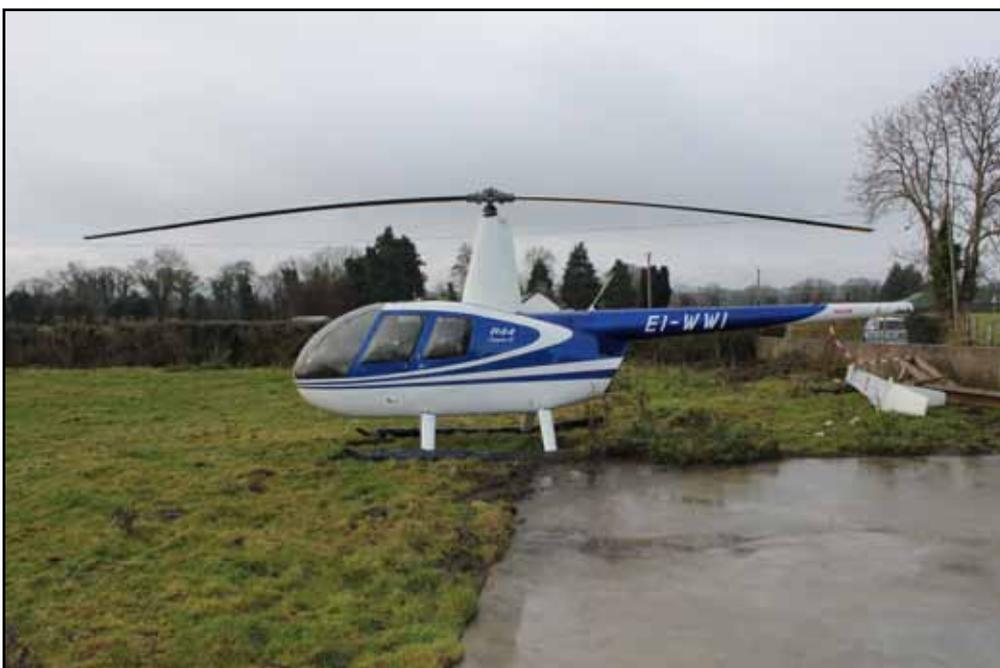
The Pilot then carried out his external pre-flight checks and strapped himself in. He was clear in his recall to the Investigation that there was normal full and free movement of all controls. He then carried out the cockpit checks, using a sheet of notes as an aide memoire. He went through the list 'as per normal'. He carried out all the required checks, and stated that 'everything went well'. At or about lift-off, the helicopter 'started to yaw or spin to the left, I tried to correct it but it wouldn't correct for me.....so I pulled the collective to lift, to try and get me out of trouble, whatever was going on.....I noticed it wasn't doing anything for me so I was happy to put it back down on the ground as quickly as possible and I turned around in a circle once maybe twice, I'm not quite sure....and on setting down on the ground the clattering and the banging out of it was very loud.' Once landed, he shut down and exited the helicopter. EI-WWI, now badly damaged, was pointing in a southerly direction, more than 20 feet from the lift-off point, on a grassy area adjacent to the concrete surface (**Photo No. 1**).

Photo No. 1: EI-WWI following the accident.

Ground marks indicated that the tail-rotor guard struck the ground with significant force. It is likely that the guard was then pushed upwards into the tail-rotor blades, with clear evidence of a guard/blade strike being visible on a fractured piece of tail-rotor blade. Both the blades and the guard were severely damaged in this strike. The overload forces associated with the tail-rotor strike are likely to have caused the tail-rotor gearbox and the empennage to separate from the rear of the tail-boom.
