Air Accident Investigation Unit Ireland

ACCIDENT REPORT
Van's Aircraft Inc. RV-6, EI-EOC
Limetree Airfield, Co Laois, Ireland
10 June 2011 @ 19.02 hours

AAIU Draft Final Report No: 2012-007

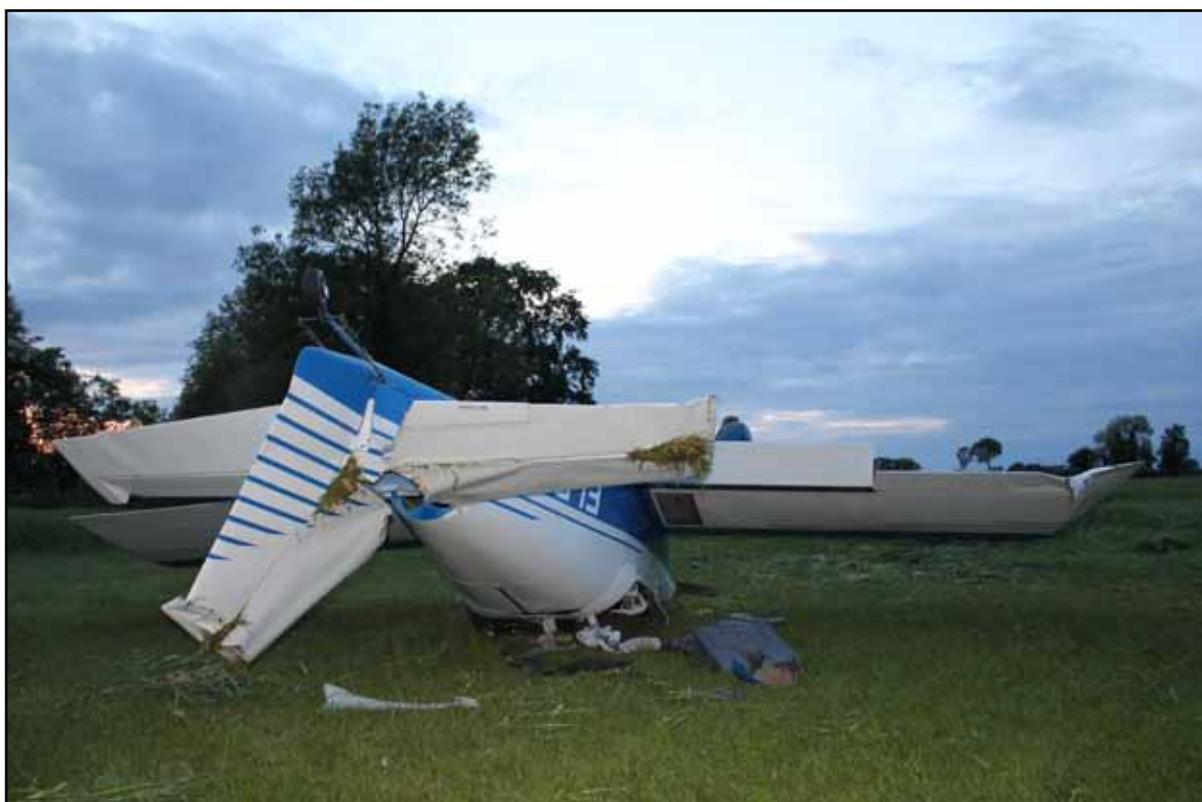
He stated that a normal approach was carried out with full flaps selected, at about 70 to 75 MPH. While he thought that there was little or no wind to affect him, he recalled that he was low on the approach to the runway threshold when he experienced *“a lot of sink”* for which he applied power to counteract. He said that the *“aircraft didn't pick up quickly enough”* and *“the wheels caught a crop of corn which pulled me in, the gear went into a little rut where the runway joins the field of corn and nosed over”*. *“It all happened in seconds”* he said. While inverted, he isolated the fuel, switched off the electrics and managed to extricate himself from the cockpit through the broken canopy (**Photo No. 1**).

The tail-wheel aircraft came to rest inverted on the runway, 9 metres from the threshold of RWY 19, pointing to the north (**Photo No. 1**). The canopy was crushed and the empennage damaged. The engine mounts were damaged and both propeller tips bent backwards from mid span outwards. There was no fire.

Photo No. 1: The inverted aircraft and smashed canopy.

The corn crop in the field adjacent to the threshold was approximately 0.4 metres high. The marks of the aircraft's wheels in the crop showed that the aircraft had actually landed, cutting tracks 26 metres long through the corn before the main gear impacted a small step or clay ridge at the edge of the cultivated area, immediately before the threshold of RWY 19.

Though landing unintentionally short of the runway, the Pilot was unlucky in that, while the corn field and the airfield were almost at the same level, there was a small ridge that the aircraft main gear struck and did not pass over. This abruptly arrested main gear progress and caused the aircraft to tumble and invert. Had that ridge not been there the aircraft might have rolled onto the runway without further mishap.
