# Air Accident Investigation Unit Ireland

**ACCIDENT REPORT**  
**Piper PA 16 Clipper, EI-EMT**  
**Letterkenny Airfield (EILT), Co Donegal**  
**29 April 2011 @ 12.30 hrs**

AAIU Report No: 2012-008

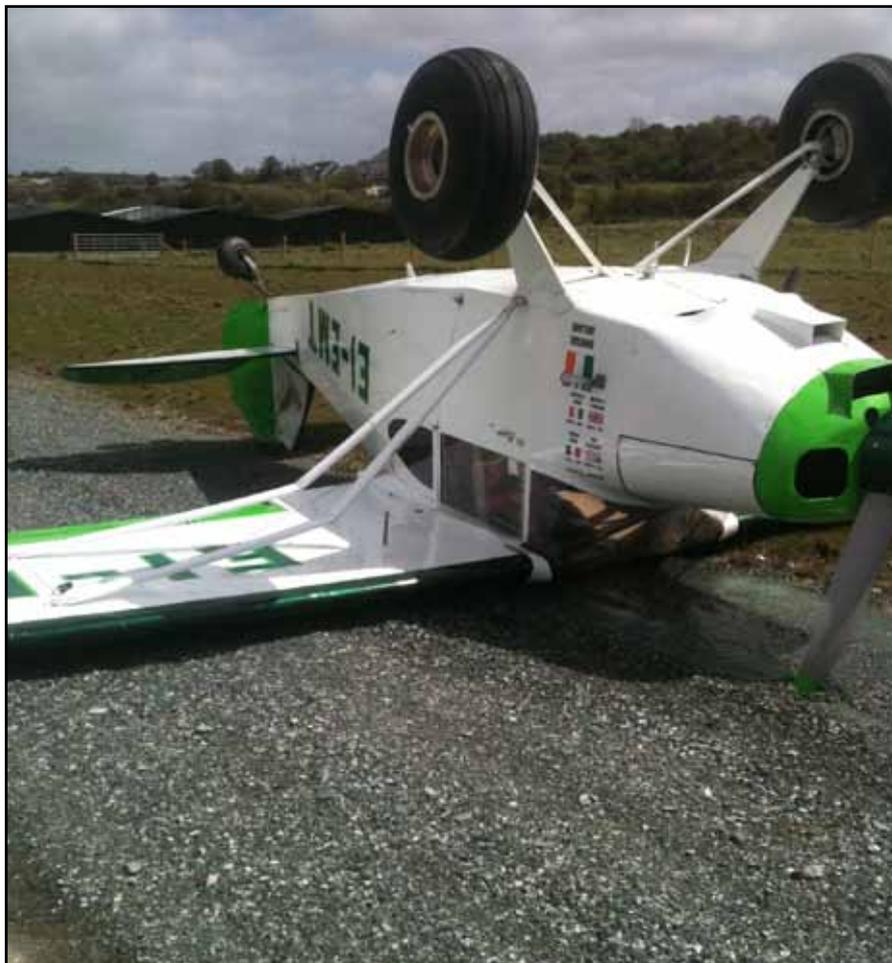
At the end of the landing roll-out (at about 2/3rds of the runway length), he initiated a turn to back-track along runway (RWY 07) in order to access the airfield hangars. When manoeuvring through 90 degrees of the 180 degree turn, a 'freak gust of wind lifted the tail and took the aircraft onto its nose...then right over on its back' (See **Photo No. 1**). While the Pilot and passenger exited the cockpit quickly and safely, there was substantial damage to the wings, tail, propeller and wing struts.

*Photo No. 1: Aircraft in final inverted position (Pilot's Photo).*

1. While executing an out of wind back-track turn on RWY 25, an unexpected gust of wind lifted the tail and the aircraft nosed over and inverted.
2. Operation in gusty conditions was the main factor in this accident, as reports from the Pilot and Met Éireann show that blustery winds were a feature of the weather at Letterkenny Airfield at the time of the accident.
3. While there were no injuries to the occupants, the aircraft was substantially damaged.

Ground manoeuvring out of wind in blustery wind conditions.
