Air Accident Investigation Unit Ireland

**ACCIDENT REPORT
YAK-52, G-CDFE
Ballyboy Airfield, Athboy,
Co. Meath, Ireland (EIMH)
24 July 2010 @ 08.12 hrs**

AAIU Report No: 2012-009

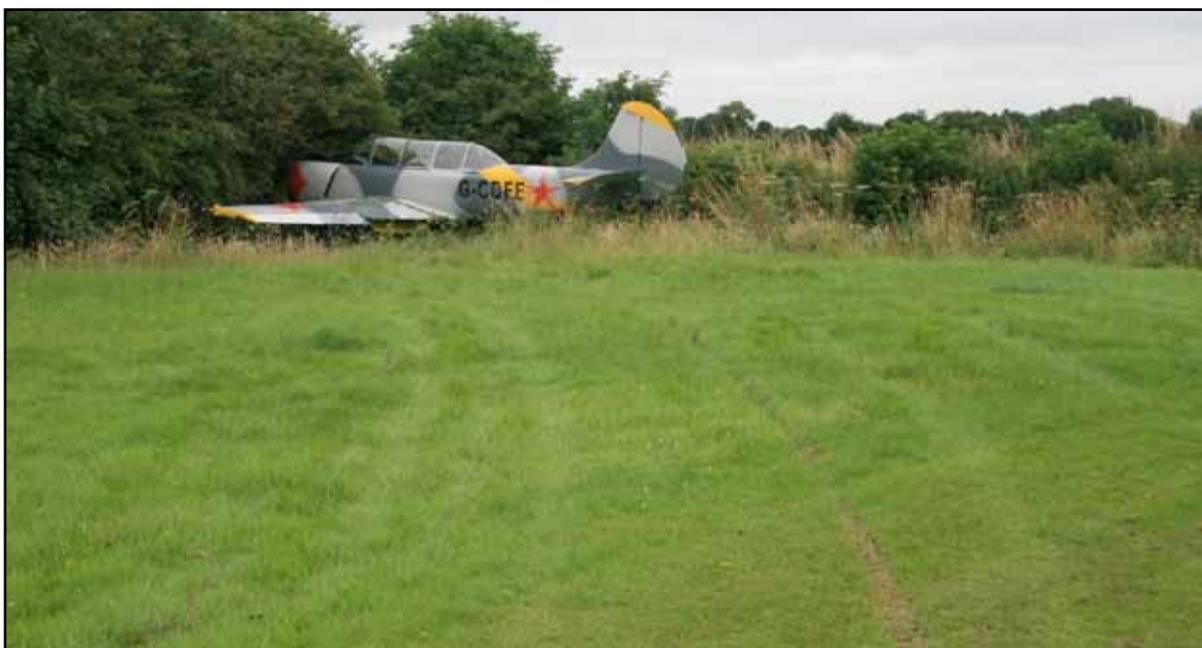
Shortly after becoming airborne, the Pilot decided that he would not continue the flight to Weston due to multiple showers being present en route and he elected to return to his departure airfield. On joining overhead, the windsock showed a light wind mostly across the runway but slightly favouring RWY 11, to which he carried out what he recalled to be a normal approach and landing. During the landing roll, as he stated in his Report, braking failed to achieve the desired deceleration and the aircraft over ran the runway into the left boundary hedge of the airfield at taxi speed. While the aircraft was still moving, the Pilot switched off the ignition and the propeller was stationary prior to contact with the hedge. **(Photo No. 1).**

Photo No. 1: Final resting position of G-CDFE to left of RWY 11

One wooden propeller blade fractured on impact with the boundary hedge. The left wing tip structure was holed and a section of its skin deformed as a result of striking a tree stump in the hedge.

The aircraft overran RWY 11 and impacted with the airfield boundary hedge due to poor braking action encountered on the damp grass runway surface.
