FINAL REPORT

AAIU Synoptic Report No: 2008-012

Aircraft Type and Registration:	Schweizer 300 CBI ¹ , G-CDTK
No. and Type of Engines:	1 x Lycoming HIO-360-G1A
Aircraft Serial Number:	0216
Year of Manufacture:	2005
Date and Time (UTC):	12 September 2007 @ 15.15 hrs
Location:	Clonshanny, Co. Offaly
Type of Flight:	Private
Persons on Board:	Crew - 1 Passengers - 1
Injuries:	Crew - 1 Passengers - 1
Nature of Damage:	Helicopter suffered severe damage
Commander's Licence:	PPL (H) USA
Commander's Details:	Male, aged 38 years
Commander's Flying Experience:	107 hours, of which 25.5 hours were as pilot-in-command
Notification Source:	Tullamore Gardaí
Information Source:	AAIU Field Investigation

SYNOPSIS

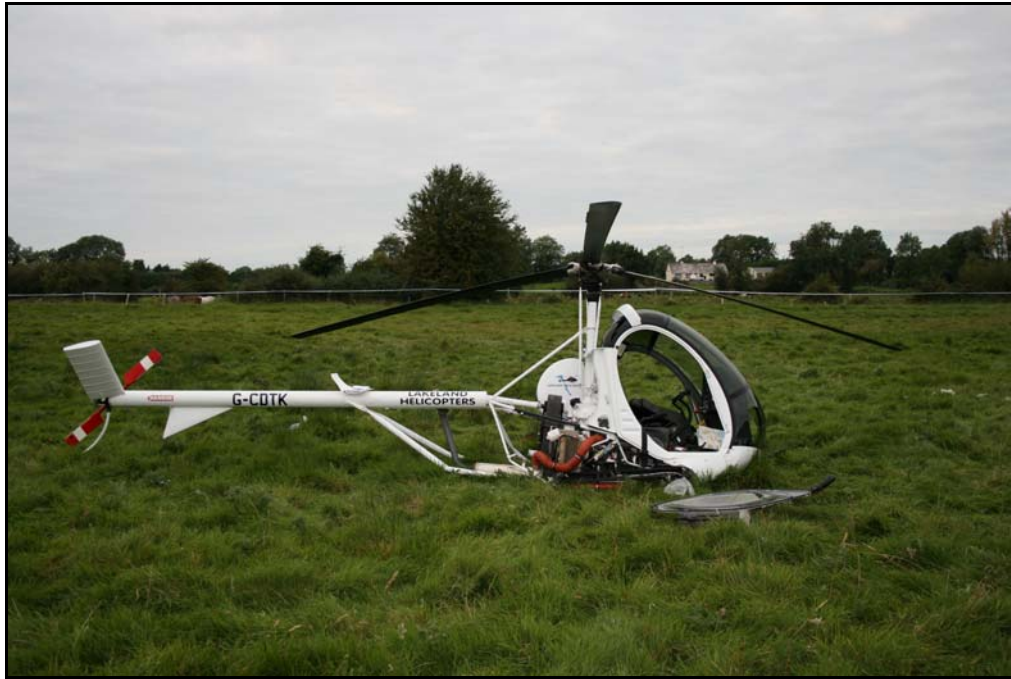
Photo No. 1

The helicopter suffered extensive damage, consistent with a heavy vertical impact. The skid undercarriage collapsed completely, the bottom of the fuselage suffered ground impact damage, the cabin floor and instrument panel were distorted, the main tail boom supports failed and the main blades suffered kinking damage. The extent of the damage to the helicopter probably rendered it beyond economic repair (**Photo No. 1**).

This photograph shows the helicopter at the accident site, prior to removal to the AAIU facility at Gormanston

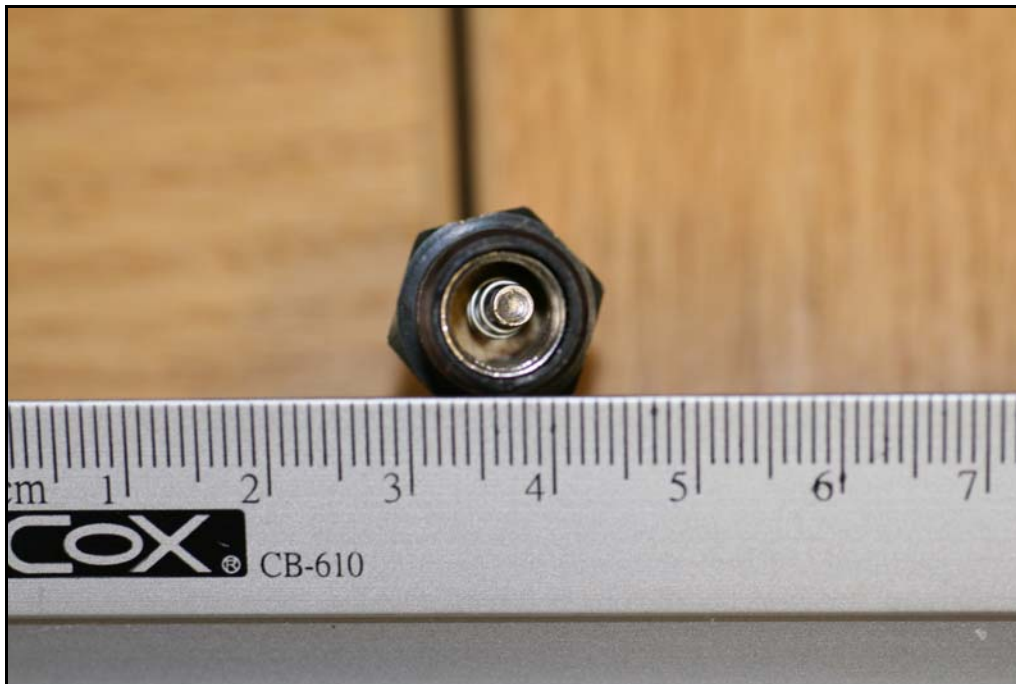
Photo No. 2

The Investigation was unable to determine when the central contact in the bulb holder of the fuel low contents warning system was damaged. This damage resulted in the warning system becoming defective, and the press-to-test feature being intermittent/inoperative. No record of such a problem was recorded prior to the departure of the helicopter from Enniskillen; nor did the Pilot report such a defect. The Investigation is aware that the spring contact in such bulb-holders is prone to damage by excessively robust use of the press-to-test facility.

3. The helicopter's low fuel contents warning light failed to illuminate as the fuel contents reached a critical level.
4. The failure of the low fuel contents warning light was caused by a damaged contact in the bulb-holder. This contact was probably damaged due to excessively robust use of the press-to-test facility.

This photograph shows the bent central contact of the fuel contents low warning light bulb holder. The contact can be seen to be significantly off-centre
