FINAL REPORT

AAIU Synoptic Report No: 2009-025

Aircraft Type and Registration:	Boeing 737-8AS, EI-DYD
No. and Type of Engines:	2 x CFM 56-7B26
Aircraft Serial Number:	33632
Year of Manufacture:	2008
Date and Time (UTC):	11 September 2008 @ 10.33 hrs
Location:	Dublin Airport, Co. Dublin
Type of Flight:	Public Transport
Persons on Board:	Crew – 6 Passengers – 148
Injuries:	Crew – Nil Passengers – Nil
Nature of Damage:	Nil
Commander's Licence:	JAA Airline Transport Pilot Licence
Commander's Details:	Male, aged 41 years
Commander's Flying Experience:	10,114 hours, with 7,680 on type
Notification Source:	Airside Duty Manager, Dublin Airport
Information Source:	AAIU Field Investigation

SYNOPSIS

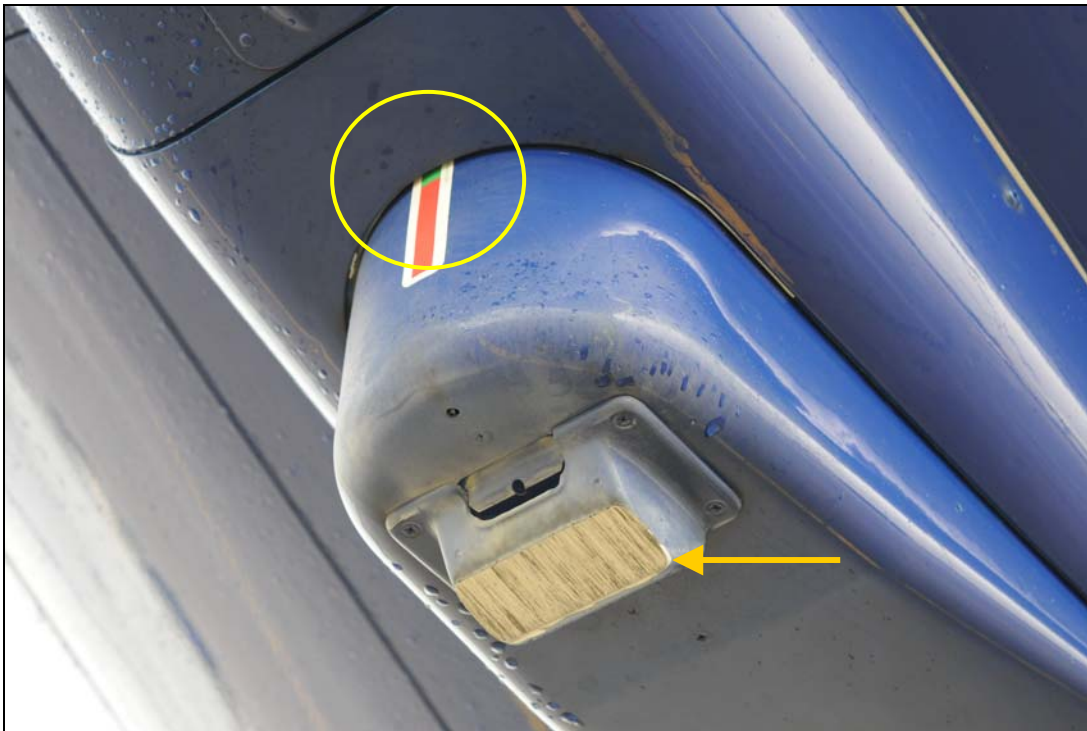
The Boeing 737-800 series incorporates a 'Tail Skid Assembly' which provides a degree of protection to the fuselage in the event of an over rotation. The assembly consists of a cartridge, fairing, skirt enclosure and shoe. The cartridge contains crushable honeycomb material, which compresses when the shoe makes sufficiently hard contact with the runway surface. A red and green decal on the skirt indicates the relative severity of a tailstrike, the aircraft is serviceable if the green area is visible (**Photo No. 1**).

Photo No. 1: Tailskid Skirt Assembly as inspected by the AAIU.
Note contact shoe scraping (indicated by arrow) and green decal visible.

The AAIU were informed of the occurrence by the Airside Duty Manager, Dublin Airport Authority (DAA) shortly after the aircraft landed and by the Operator. One Inspector of Air Accidents inspected the aircraft at Dublin Airport and interviewed the Flight Crew and Cabin Crew. External inspection of the aircraft revealed no damage to the underside of the fuselage, with superficial scoring of the tailstrike 'shoe' and the Tailskid indicator green band visible (**Photo No. 1**).

Regarding the tailstrike itself, the longer Boeing 737-800/900 series is more susceptible to tailstrikes than the shorter-fuselage versions. A tailstrike is not necessarily a serious event, in this particular case the tailstrike shoe contact was light enough for the indicator to remain in the green band. Inspection of the aircraft by the Investigation revealed only a light scoring of the tailskid 'shoe' with no damage to the underside of the aircraft.
