## FINAL REPORT

AAIU Synoptic Report No: 2010-001

<b>Aircraft Type and Registration:</b>	Beech Duchess 76, EI-BUN
<b>No. and Type of Engines:</b>	1 x Avco Lycoming O-360-A1G6D 1 x Avco Lycoming LO-360-A1G6D
<b>Aircraft Serial Number:</b>	ME 371
<b>Year of Manufacture:</b>	1980
<b>Date and Time (UTC):</b>	04 June 2009 @ 15.48 hrs
<b>Location:</b>	Weston Airport (EIWT), Co Kildare
<b>Type of Flight:</b>	Training
<b>Persons on Board:</b>	Crew - 2      Passengers - 1
<b>Injuries:</b>	Crew - Nil      Passengers - Nil
<b>Nature of Damage:</b>	Significant
<b>Commander's Licence:</b>	Air Transport Pilot Licence (Aeroplanes) issued by the Irish Aviation Authority
<b>Commander's Details:</b>	Male, aged 37 years
<b>Commander's Flying Experience:</b>	11,500 hours, of which 250 were on type
<b>Notification Source:</b>	Weston Airport Manager
<b>Information Source:</b>	AAIU Pilot Report Form submitted by Pilot. AAIU Field Inspection.

### **SYNOPSIS**

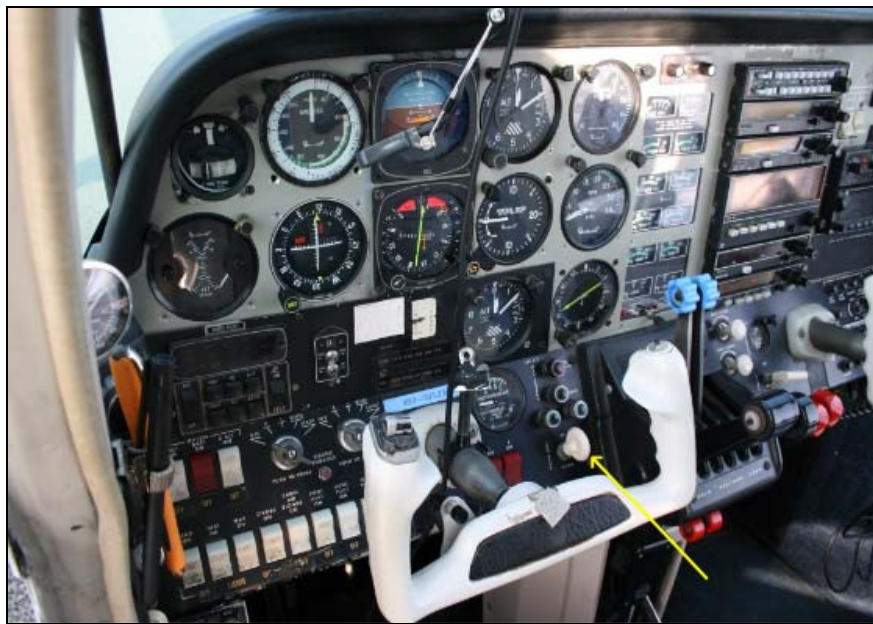
The landing gear is controlled by a two-position selector handle located on the left sub-panel, (**Photo No. 1**). The handle must be pulled out of a safety detent before it can be moved to the opposite position.

**Photo No. 1: Location of Landing Gear Selector**

The landing gear position indicator lights are located above the selector handle. Three green lights, one for each wheel, are illuminated whenever the landing gear is down and locked. The red light illuminates whenever the gear is in transit or in any intermediate position. All of the lights are extinguished when the gear is up.

The landing gear selector which had been in its correct DOWN position at touchdown moved into the UP position very shortly thereafter. The Investigation considers that there are only two possible explanations for this movement in the circumstances, firstly that the selector was moved by hand as an instinctive reaction after the landing, or secondly that it was accidentally moved by contact with the right knee of the student in the left seat. He stated unequivocally that he had not manually selected the gear up. The fact that he was seated relatively far forward, with his right knee within 5 cm of the selector, makes the more likely scenario that when he moved his feet upward onto the brakes, his knee made contact with the selector and moved it out of its detent and upwards into the UP position. The Investigation noted that this was the student's first training flight on the retractable landing gear Beech 76 and his first full-stop landing as handling pilot on type. It is reasonable to conclude that he may have had a lack of awareness of the proximity of his right knee to the selector and also of the possibility of his knee striking the selector as he raised his feet onto the brake pedals.

The landing gear retracted due to the inadvertent movement of the landing gear selector switch from the DOWN to the UP position in the moments after touchdown.

Hawker Beechcraft Corporation should review the design and location of the Beech Duchess 76 landing gear selector switch so as to eliminate the possibility of inadvertent selection to the UP position. [\(SR 01 of 2010\)](#)

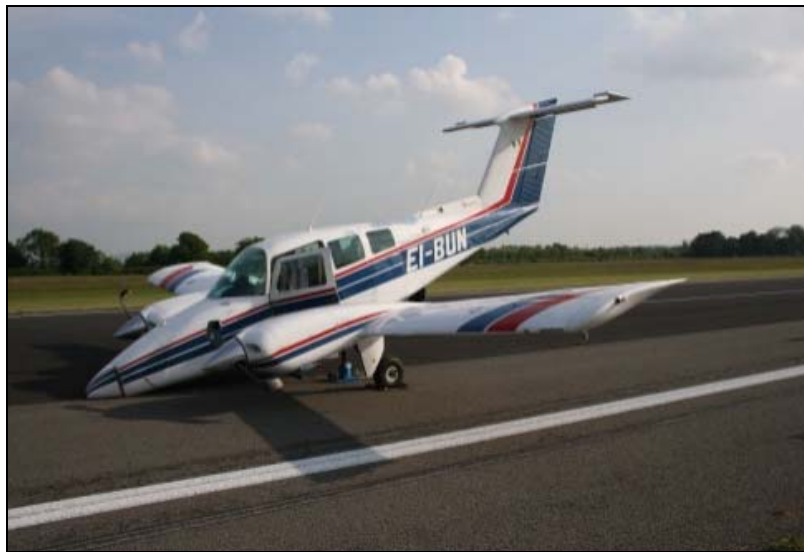
Two Inspectors from the AAIU arrived at Weston within an hour of the accident occurring. Other than jacks being placed under each wing for safety, the scene had been preserved for examination, (**Photo No. 2**).

**Photo No. 2: EI-BUN Final Resting Position**

The aircraft was sitting on its main landing gear and on its nose. It remained on the runway although it veered to the left during its slide and finished up with the port wing tip very close to the left hand runway edge. The nose gear was fully retracted and the nose gear doors were closed. The port landing gear leg had moved inboard by approximately 10° from the vertical while the starboard leg appeared to be in or close to the vertical position. The Investigation noted that the landing gear selector handle was in the UP position. The Investigation then placed the selector in the DOWN position and electrical power was switched on. The red landing gear in-transit light illuminated and by manually closing the main gear microswitches it was possible to illuminate the left and right “gear down” green lights. It was decided to attempt to extend the nose gear by taking the weight off the nose, using the landing gear circuit breakers to control the process. This operation was successful.

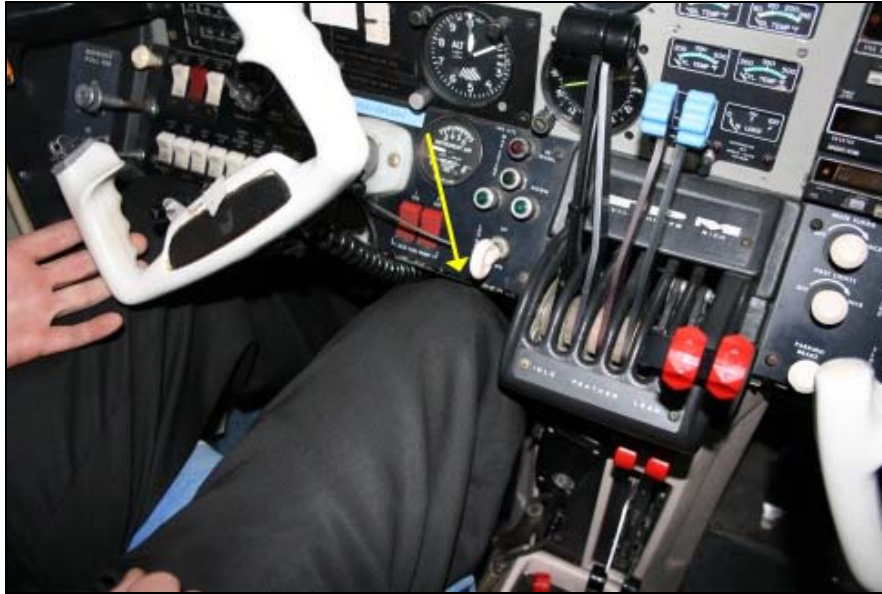
After the aircraft had been recovered to a hangar, the student sat into the left hand seat, which was in the same fore/aft position as when he had been flying. It was noted that the seat position was relatively far forward and that consequently his knee was within 5 cm of the landing gear selector, (**Photo No. 3**).

**Photo No. 3: Student Seating Position**

When he moved his feet upwards onto the brakes, which are located at the top of the rudder pedals, it was possible for his right knee to come into contact with the selector. It was also noted that, while it was necessary to pull the selector out of a detent to move it from DOWN to UP, the pulling action required was minor. A deliberate upward motion of the student's knee, while seated in his flying position, did in fact move the selector handle from the DOWN position to UP.

The inexperience of the student on type is likely to have led to a lack of awareness of the relative proximity of his right knee to the landing gear selector switch when seated in his normal flying position.
