# Air Accident Investigation Unit Ireland

**ACCIDENT REPORT**  
**Irish Air Corps 265, PC-9(M)**  
**Cornamona, Connemara, Co. Galway**  
**12 October 2009**

AAIU Formal Report No: 2011-016

Operator:	Irish Air Corps (IAC)
Manufacturer:	Pilatus Aircraft Ltd
Model:	PC-9(M)
Nationality:	Ireland (Military)
Registration:	265
Location:	Crumlin East, Cornamona, Connemara, Co. Galway, Ireland N53°32.192' , W009°30.436'
Date/Time (UTC <sup>1</sup> ):	12 Oct 2009 @ 16.57 hrs

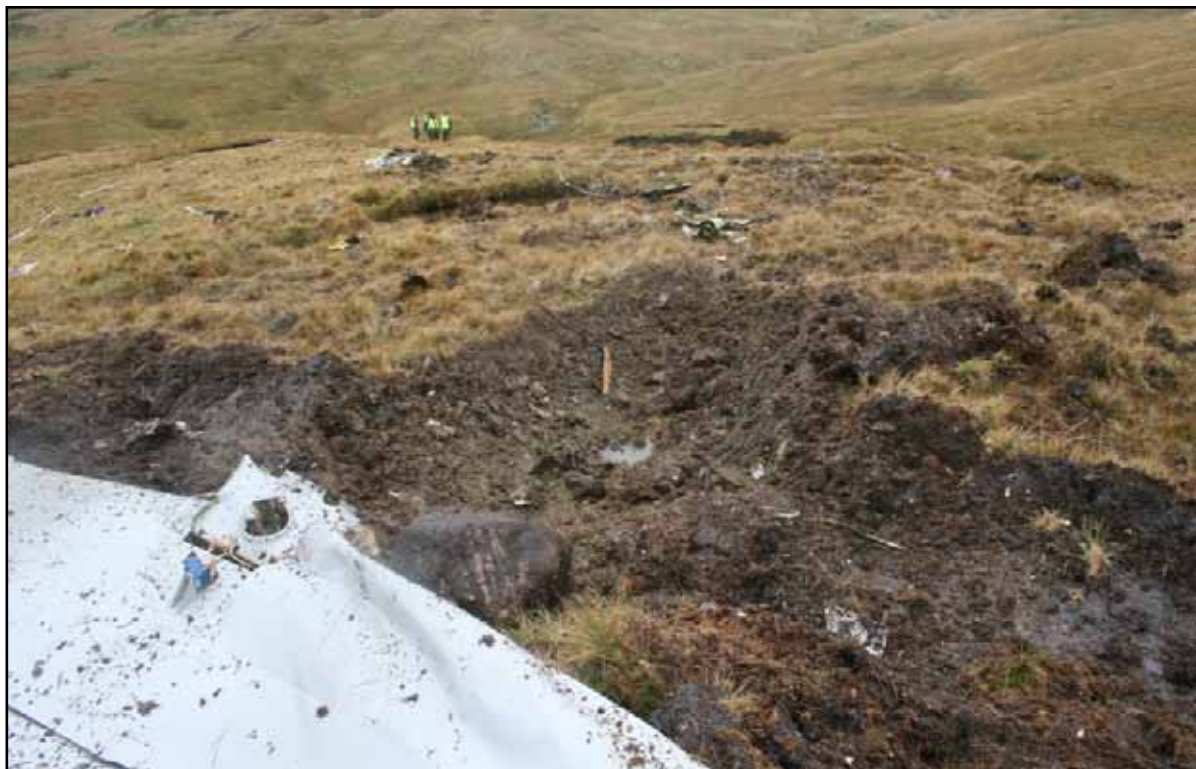
*Photo No. 1: Tailplane, impact crater and initial debris trail (in the direction of travel)*

Examination of the debris trail showed that the aircraft impacted with a significantly nose down attitude (circa  $-45^\circ$ ) and approximately wings level. The debris trail, as measured from the initial impact point to the fuselage, was on a track of approximately  $330^\circ$ M. A large boulder (circa 0.5 m in diameter) had been unearthed in the crater. Scoring on the boulder indicated that the aircraft had made significant contact with this object on impact.

The horizontal tailplane had separated immediately at impact and remained on the rim of the impact crater. The boulder had penetrated the rear fuselage immediately forward of the tail attachment points causing these points to fail and brought the tailplane to an immediate stop. Both wing tip fairings and navigation lights had dislodged and were found embedded in the ground at the extremities of the impact crater in a position consistent with a wings level impact. Both wings, with significant ruptures and deformation, were separately found about 35 m forward of the impact point along the debris trail.

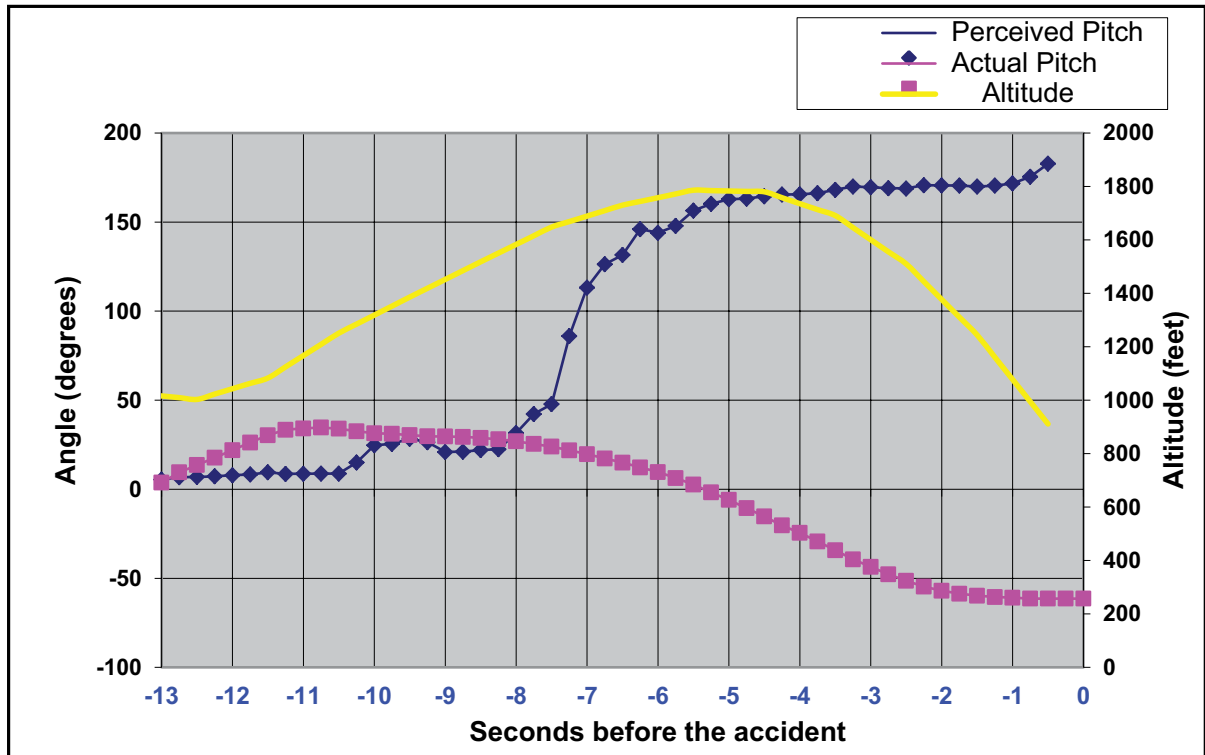
Figure No. 4: Perceived versus Actual Pitch, with Altitude

The FDR data elevator position showed that an increasing nose down displacement was commanded over -9 to -6 seconds prior to impact, which resulted in a continual reduction in pitch attitude (see **Figure No. 4** and **Appendix D** for detail). The normal (Gz) and longitudinal (Gx) F265 FDR acceleration data were then used to calculate the magnitude and direction of the Gravitoinertial vector during the final manoeuvre thus giving the perceived pitch attitude at that moment. This resulted in the blue line in **Figure No. 4**.

This plot of the Gravitoinertial force indicates that a False Climb Illusion probably commenced at 8 sec before impact. This False Climb Illusion rapidly progressed into an Inversion Illusion over a very short period.

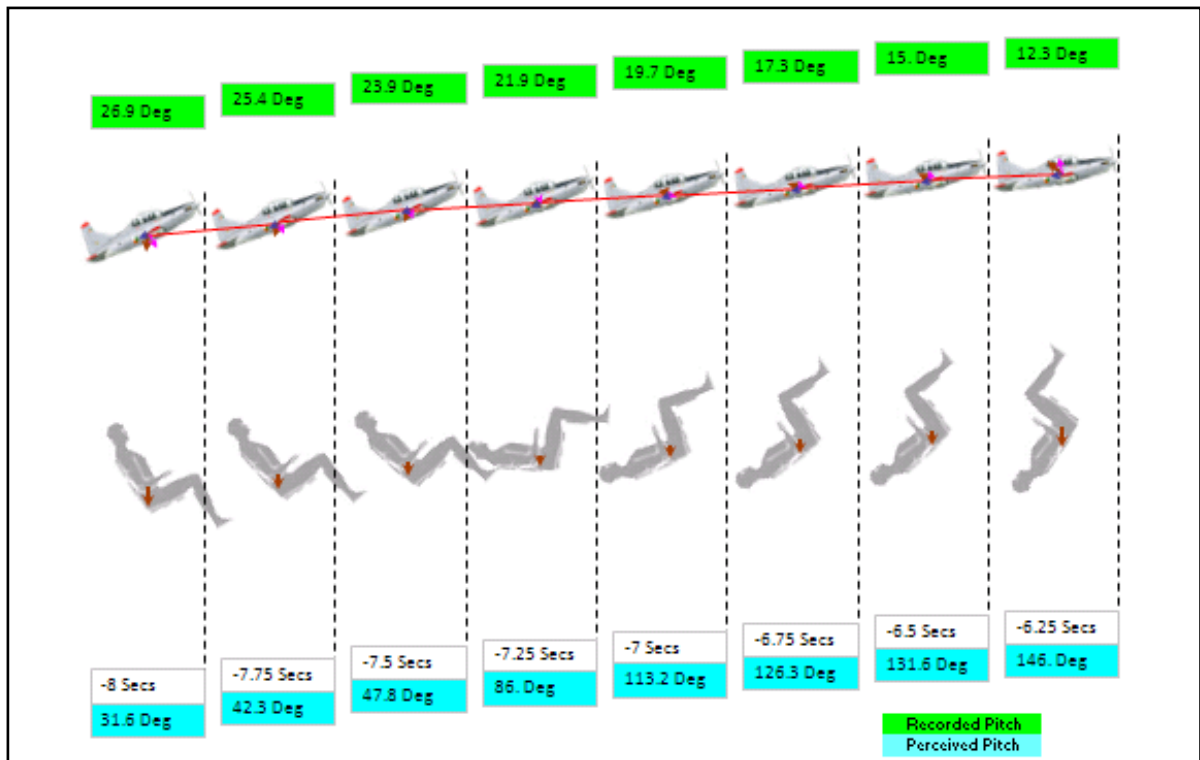
**Figure No. 5: Actual Pitch versus Perceived Pitch**

This is shown in **Figure No. 5** where the aircraft symbol is the actual recorded pitch attitude of the aircraft and the lower figure is the perceived pitch that would result from the Gravitoinertial force.

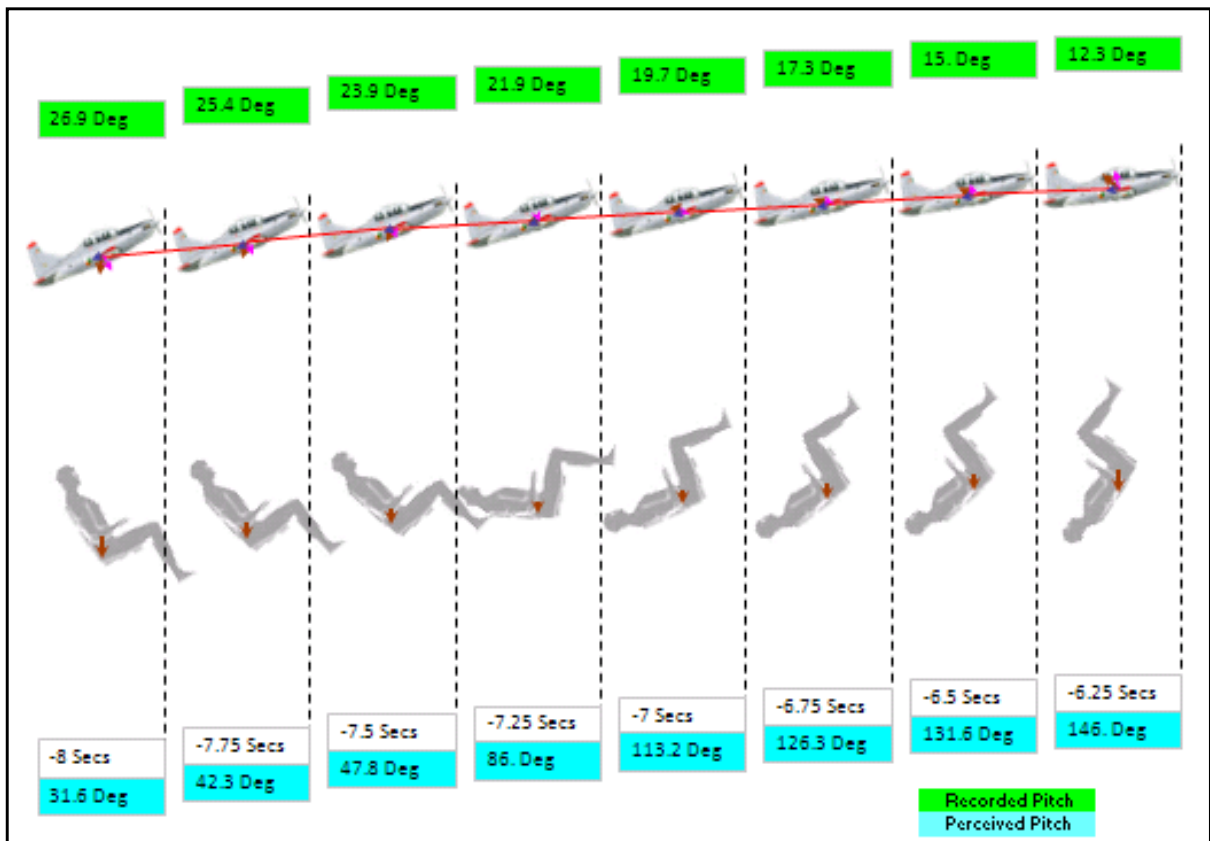
Figure (i): Emergence of False Pitch and Inversion Illusions

**Figure (i)** (reproduced in larger format as **Figure (v)**) shows eight successive images of the accident aircraft, at 0.25-second intervals<sup>25</sup>. This sequence is taken from the aircraft's final climb, before the aircraft reaches its apogee. Time-points -8 sec, -7.75 sec and -7.5 sec of **Figure (i)**, show the three (successive) 0.25-second recordings over which the False Climb Illusion emerges. The upper symbol (aircraft) for each time-point shows the aircraft oriented according to the actual recorded pitch angle. Superimposed on the aircraft is a representation of the Gx (blue) & Gz (pink) vectors, along with the resultant Gravitoinertial vector (brown); these are more easily seen in **Figure (v)**. The lower symbol (figure) is orientated to align the resultant Gravitoinertial vector with the normal (expected) direction of the gravity vector.

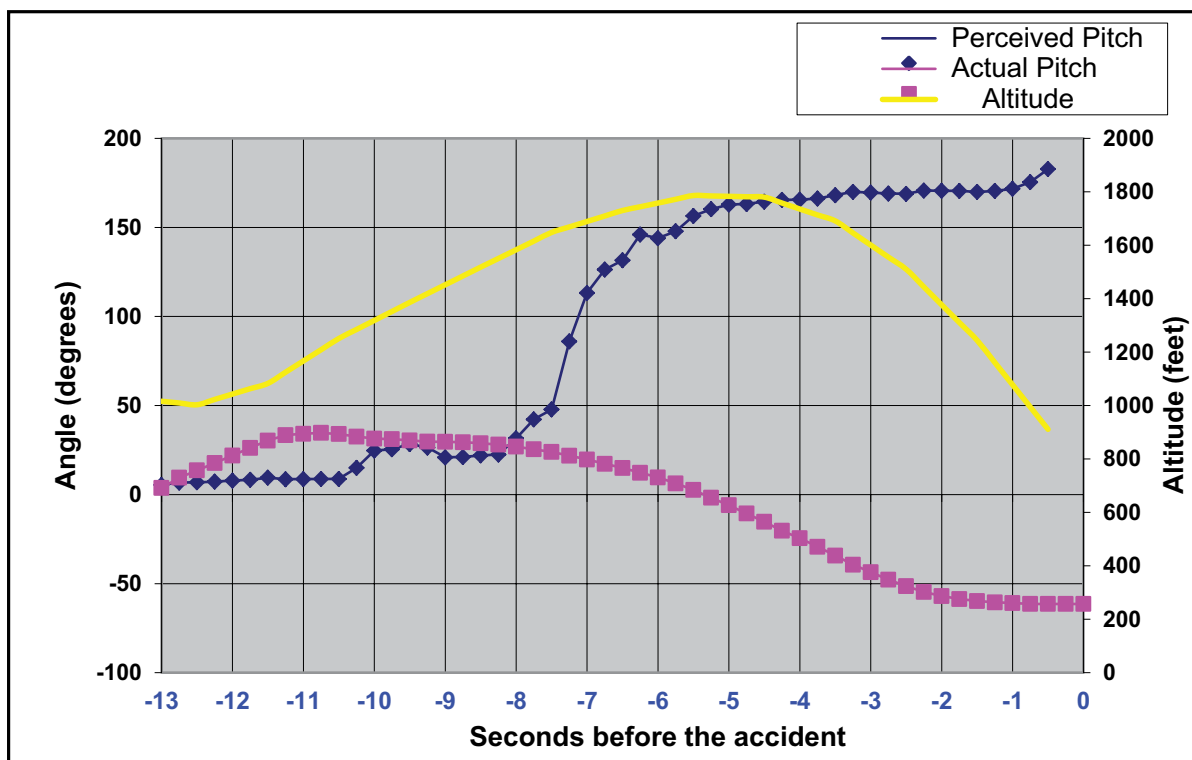
Figure (ii): Perceived versus Actual Pitch, with Altitude

The Investigation calculated the perceived pitch angle ( $\text{ArcTan } G_x/G_z$ ), and compared this with the actual pitch recorded on the aircraft. This comparison is presented in **Figure (ii)** & **Figure (iii)**. For ease of reference, the aircraft altitude was also plotted on the right axis of **Figure (ii)**, while elevator position is plotted on the right axis of **Figure (iii)**. **Figure (ii)** & **Figure (iii)** show the divergence between actual and perceived pitch at time-point -8 sec. This divergence develops rapidly and then persists.
