**AAIU Report No:-** 1998- 017  
**AAIU File No:** 1996-0072  
**Published:** 26/11/1998

**Type of Aircraft:** Home-design Model Aircraft  
**Registration:** Nil  
**No & Type of Engines:** One Titan 23 cc spark ignition  
**Owner:** Private  
**Year of Manufacture:** 1996  
**Crew:** Nil  
**Persons on Board:** Nil  
**Injuries:** None  
**Location:** Dublin Airport  
**Type of Flight:** Private  
**Date & Time (UTC):** 7th. December 1996, 1418 hrs.  
**Information Source:** Field Investigation

### **Synopsis**

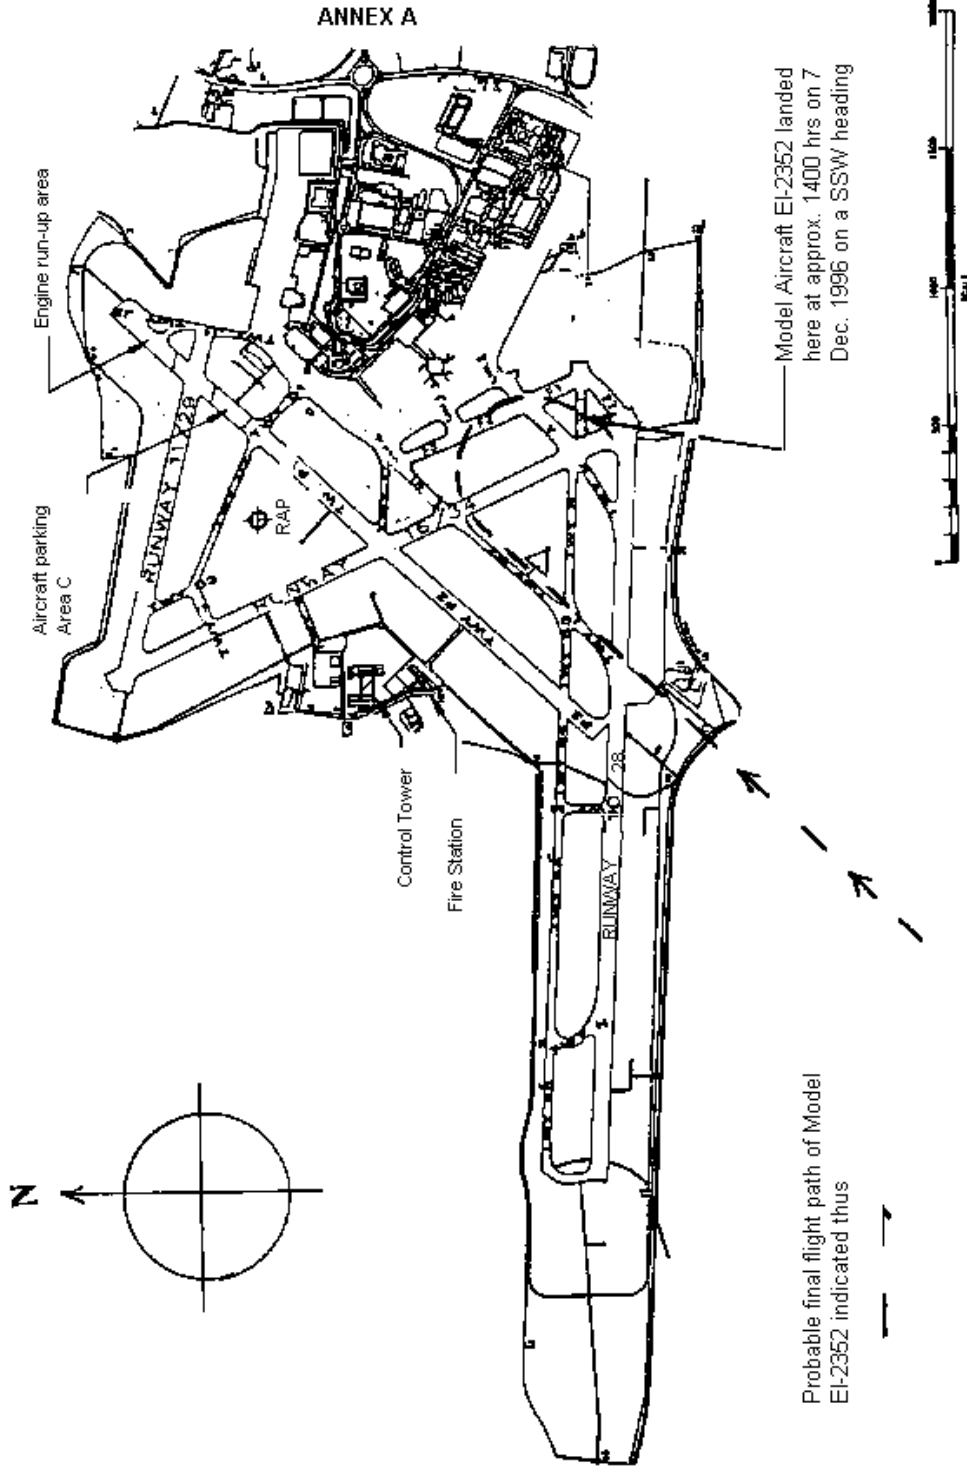
# DUBLIN AIRPORT

**2.1** Using data derived from the impact marks on the taxi way and marks on the model, the probable final flight path of the model is shown on Annex A. The final turn to the right was probably caused by the trim change when the engine stopped due to fuel exhaustion.

Model Aircraft EI-2352 landed here at approx. 1400 hrs on 7 Dec. 1996 on a SSW heading

Probable final flight path of Model EI-2352 indicated thus
