## FINAL REPORT

*AAIU Report No: 2004-004*

<b>Operator:</b>	UPS
<b>Manufacturer:</b>	Boeing
<b>Model:</b>	B747-200
<b>Nationality:</b>	U.S.A.
<b>Registration:</b>	N520UP
<b>Location:</b>	Dublin Airport
<b>Date/Time (UTC):</b>	12 May 2000 @ 13.25 hrs

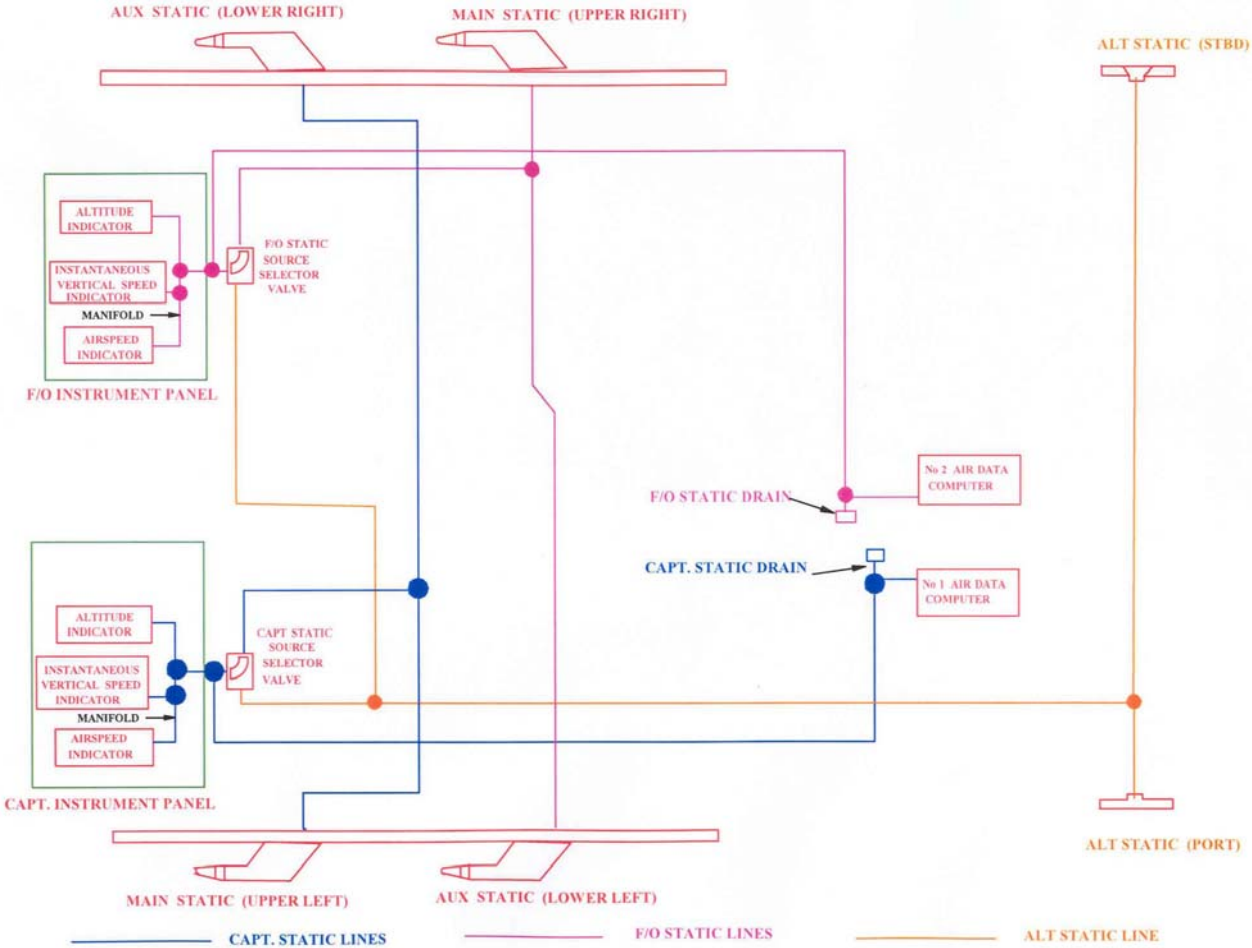
Appendix A

Both Air Data Computers and their associated drains are located in the forward A&E Bay. The drains are to drain moisture from the system. Normally these drains are sealed by means of blanking caps. However, it is possible to connect instrumentation onto these drains for the purpose of performing leak checks on the static system. This requires removal of the blanking caps.

The other static ports on the main and aux probes are not connected to flight instruments (nor to the drains in the A&E bay that are connected to the flight instrument static system) but are used to supply static air pressure to a variety of other systems, including flight control modules. The connections of these other static ports are not shown in the diagram of **Appendix A**, for reasons of clarity.

Flight Instrument Static System Simplified Schematic`

This schematic shows only the static system that is connected to the flight instruments
